KLM Bubbler updates

return side bubbler flowrates

Michele, Noah, Sayan, Soeren; 18th October, 2023

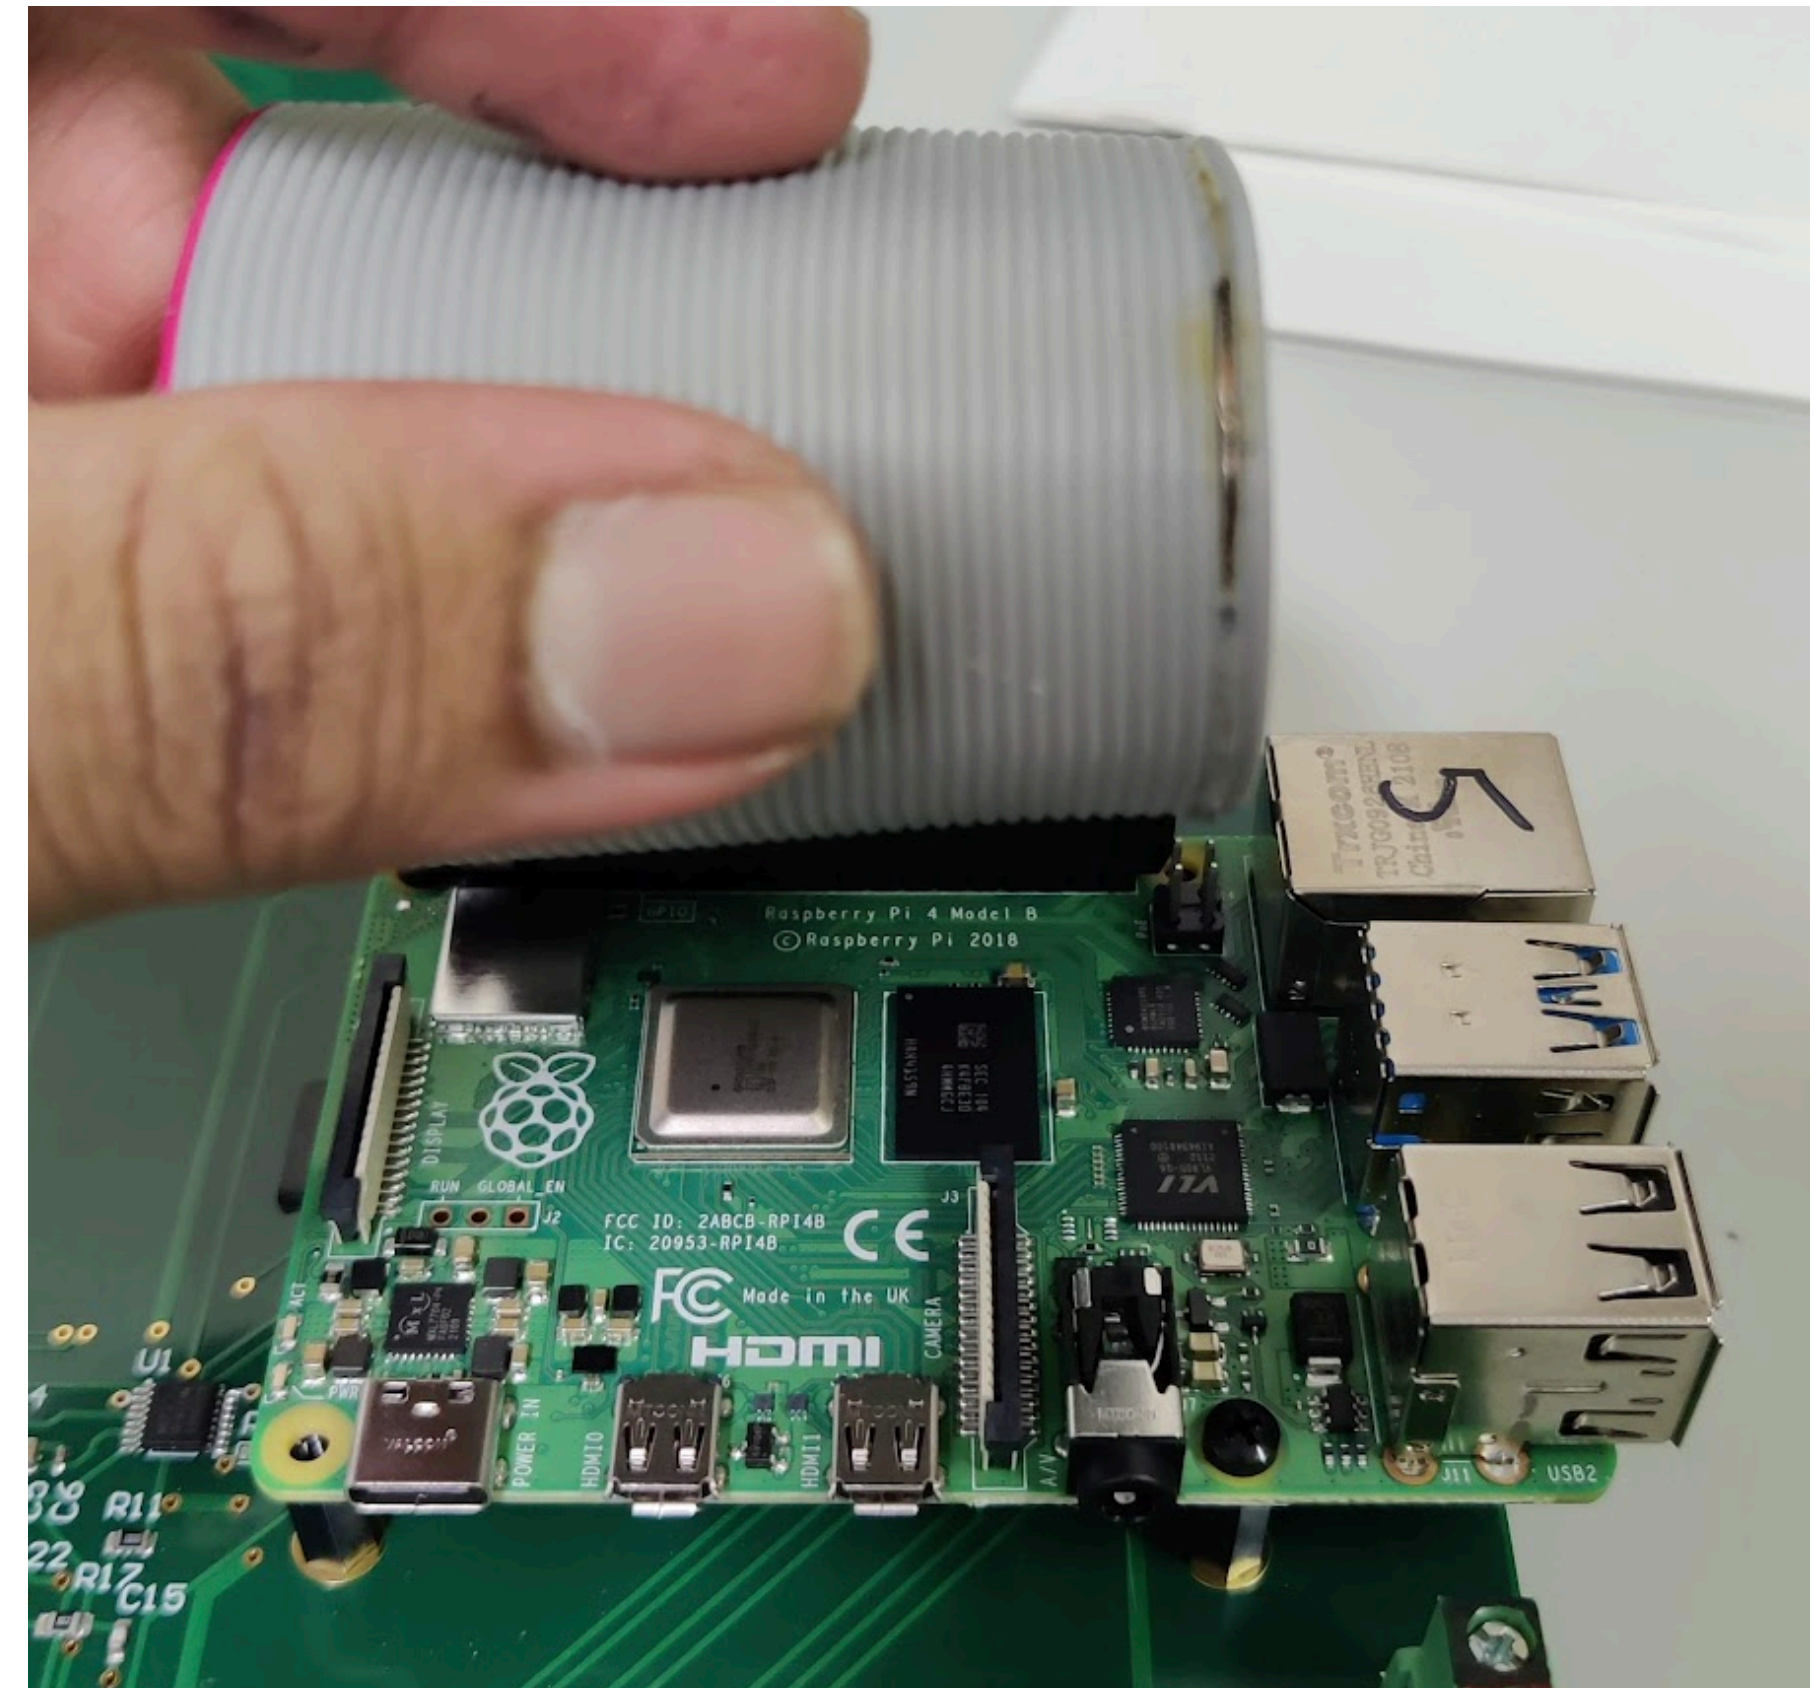
- Burnt ribbon cable on board 1(fixed)
 - One of 40 ribbon cables' plastic melted
 - Happened while running, closing the enclosure
 - Due to open power cable shorting with ground
- One of 2 fuses blown on board 5(not fixed)
 - Observed immediately on testing
 - No power to readout board, only pi receiving power

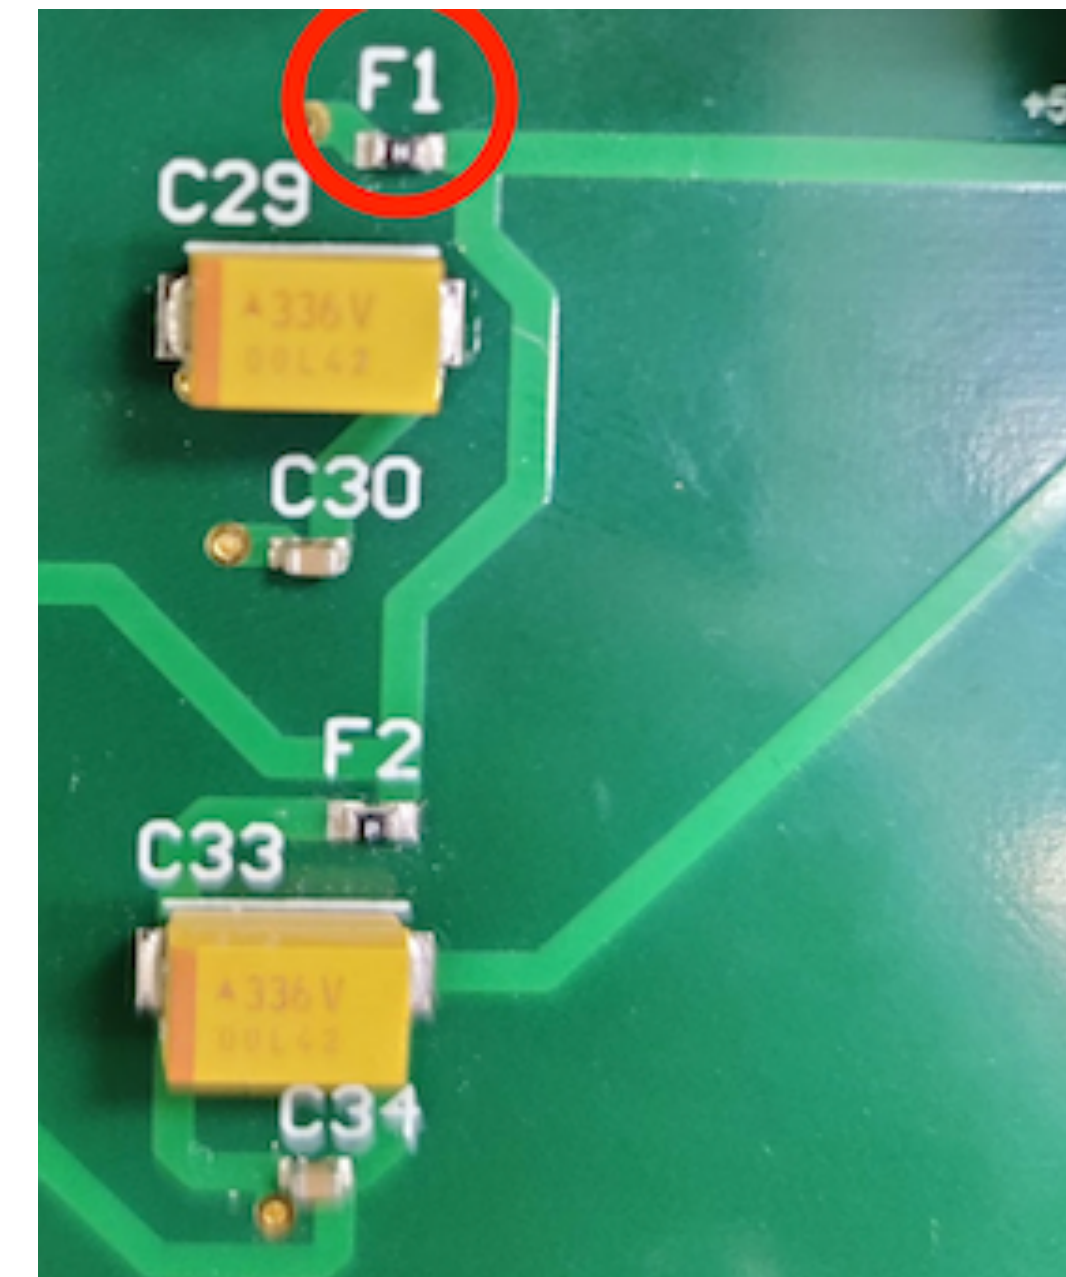
- Burnt ribbon cable on board 1(fixed)
 - One of 40 ribbon cables' plastic melted
 - Happened while running, closing the enclosure
 - Due to open power cable shorting with ground
- One of 2 fuses blown on board 5(not fixed)
 - Observed immediately on testing
 - No power to readout board, only pi receiving power
