# Belle II operation issues and how they have been addressed

Giuliana Rizzo, Katsuro Nakamura  
18 December, 2025  
ARC-BPAC joint review

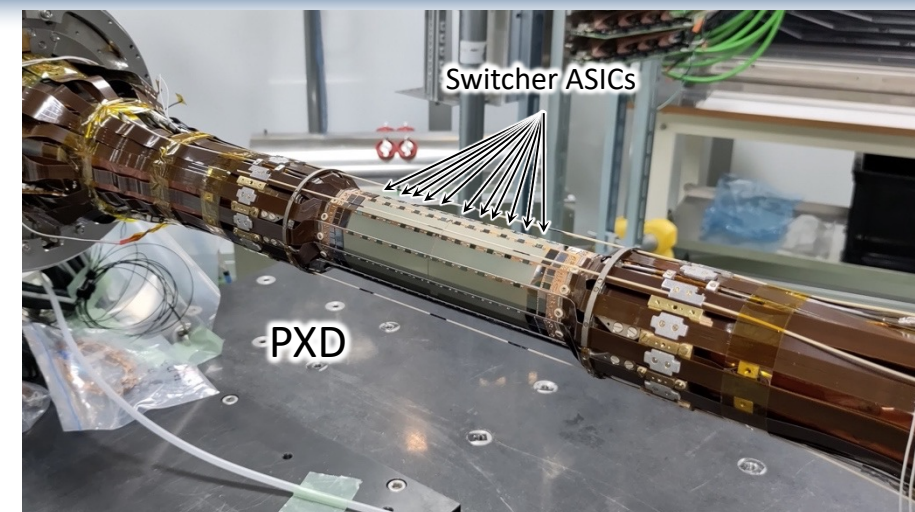
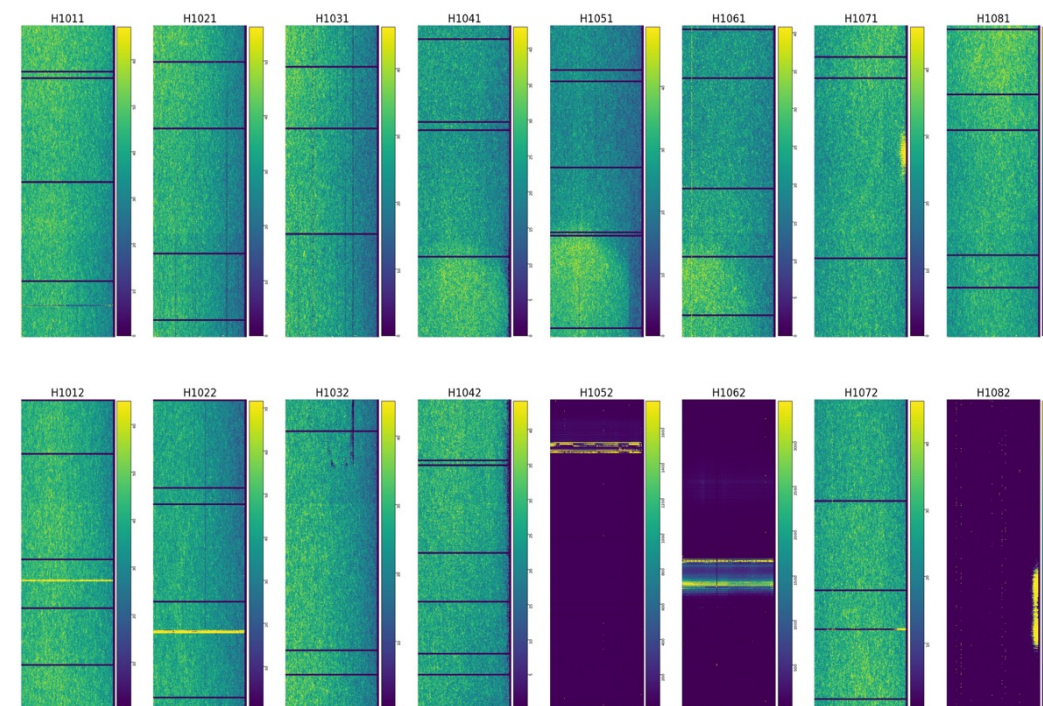
- **Damages of switcher ASICs due to huge IR beam losses at SBLs (22 Apr, and 5 and 6 May, 2024)**
  - Increase in switcher current that increases the PXD temperature
    - Two ladders had to be additionally turned OFF.
    - → In total, 8 out of 40 modules had to be turned OFF.
  - ~2% dead gates
  - Unstable (noisy) regions appears
- **On 7th May 2024, we decided to temporarily turn off the PXD during beam operation to avoid additional damage until the safe conditions for PXD are realized by sufficient measures and good machine stabilization.**

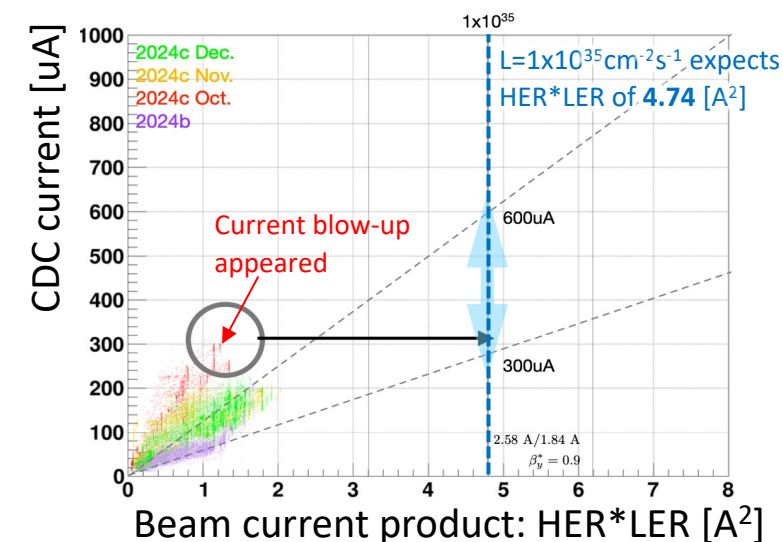
## CDC current v.s beam currents in 2024

- Current blow-up in inner layers of sect.3 (Oct 29) under high beam background (→ resulting in high CDC current) and low water content (~1300ppm): Possibly caused by Malter effect (irreversible aging)
  - Reduced HV of inner layers in sect.3 by 500V (effectively OFF, no hits from there)
  - Increased water content from ~1500ppm to ~3000ppm (known to be beneficial to prevent Malter effect)
  - Limit set on acceptable chamber current to control the beam background levels (so far, up to 260 uA/layer)
- Gain degradation was observed in 2024 as an overall trend; however, isolating the contributions from the aging effect and possible gas pollution due to the avalanche was difficult because of other effects from the gas condition.

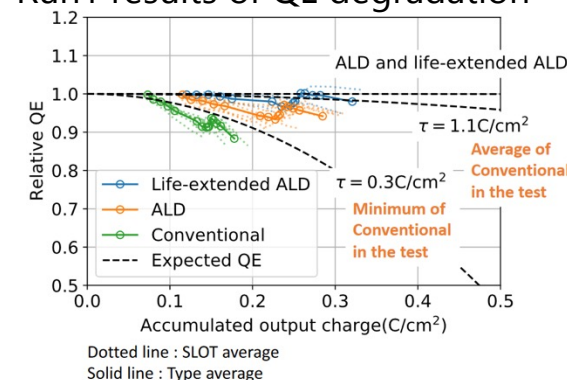
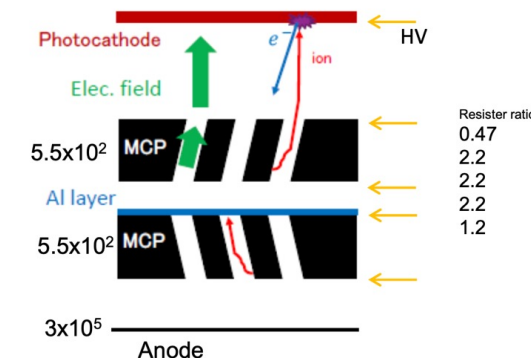
## Run1 results of QE degradation

- Accumulated charge on the Photocathode (PMT output charge), which is mainly created by beam background, degrades PMT quantum efficiency (QE).
  - So far, the PMT hit rate due to single-beam background is limited to 5 MHz.

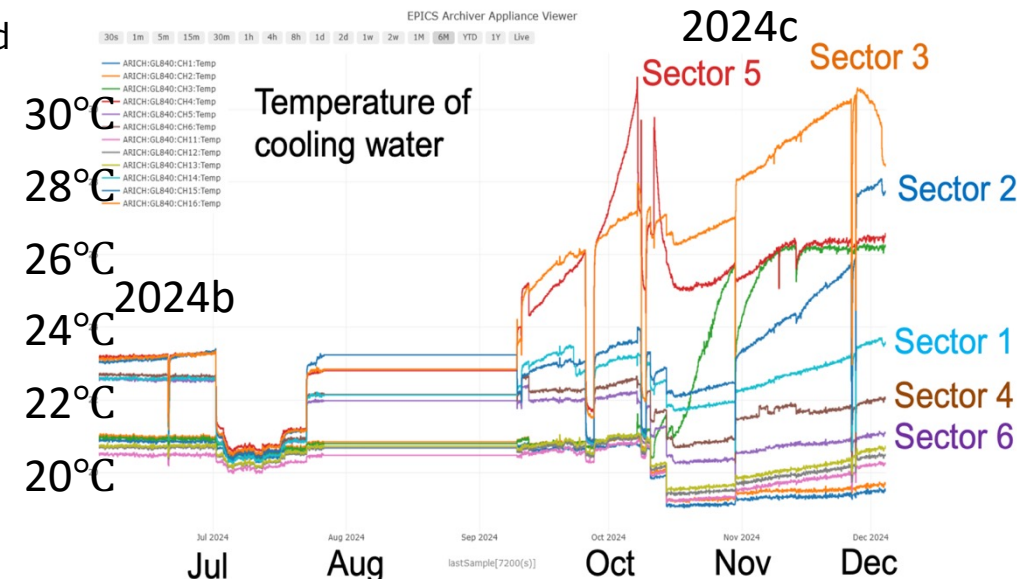
- The cooling water flow gradually decreasing after LS1 and stopped in Sectors 3 and 5 during the 2024c run. Resulted in too high temperature in those sectors.
  - About 13% of ARICH had to be turned OFF to keep the HAPD temperature below 50 degC.

- Quick-joint couplers were identified as the cause of clogging.
  - O-ring inside was swollen and filled the water path. Possibly, due to the anticorrosion agent () injected just after LS1.
- Removed the quick-joint couplers as a countermeasure.

ARICH cooling in 2025c restored and working fine
