Status of PXD2

Fabian Becherer
on behalf of the PXD group

Deutsches Elektronen Synchrotron, DESY
Belle II Experiment, KEK

September 25, 2023

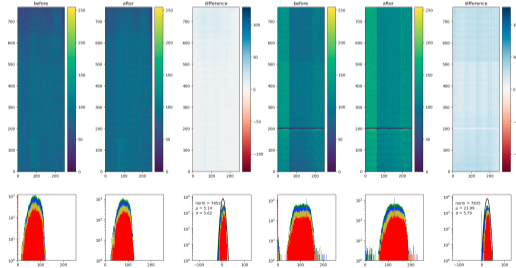
- Pedestals and source scan taken
- Stable working conditions for both HS found
- For one HS isolation to beam-pipe broken
- Significant bending observed for edge L2 ladders
 - Unclear if caused by setup
- De-commissioning at DESY
- Transport of both HS and services to KEK

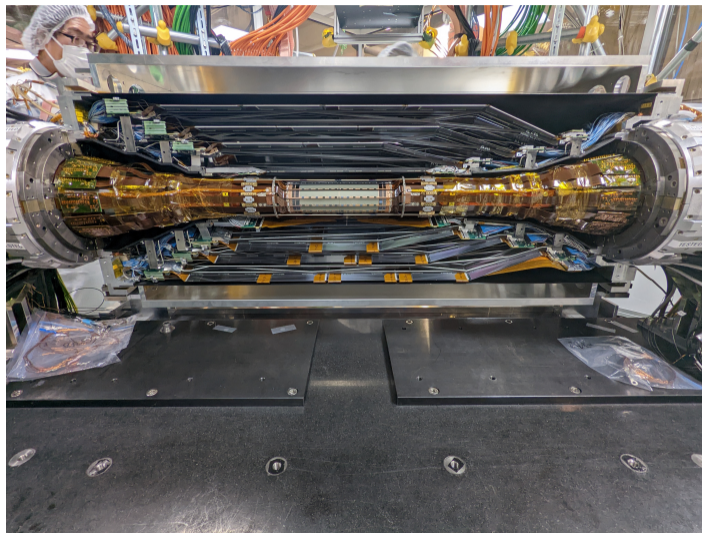
- Significant ladder bending for L2.7 and L2.8
- Reduced fwd screw torque for these ladders
- Acceptable bending of 500 μm remained
- Bending studies at DESY and PXD1

- Air temperature increased above 30°C
- To high temperature for long term operation
- Reduced CO2 temp. from -20°C to -25°C
- Increased N2 flow rate
→ Air temperature stabilized below 30°C

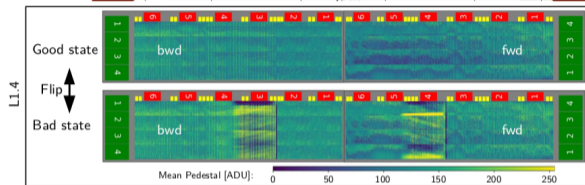
Unstable Switcher States in L1.4:

- "good" and "bad" mode
- Problematic gate(s) or switcher?
- Temporary solution by reducing gate-on voltage

Pedestal Glitches:

- Significant pedestal shifts within indiv. frames
- Dominant structure in L2.4 bwd and L2.12 bwd
→ Large noise

- Esp. L2.12 introduce high noise
 - ▶ DHPs have to reset in short intervals
 - ▶ Increase for now noise threshold
 - ▶ Needs further investigations

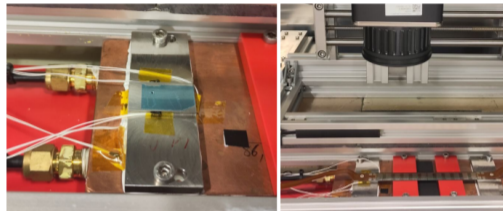
Raiding the Thermal Mock-up

- Dummy Si ladder with resistors for heating
 - 8.9 W the design power consumption
 - 8 W DHP/DCD
