Ladder Bending Tests

BPAC Concerns & Recommendations

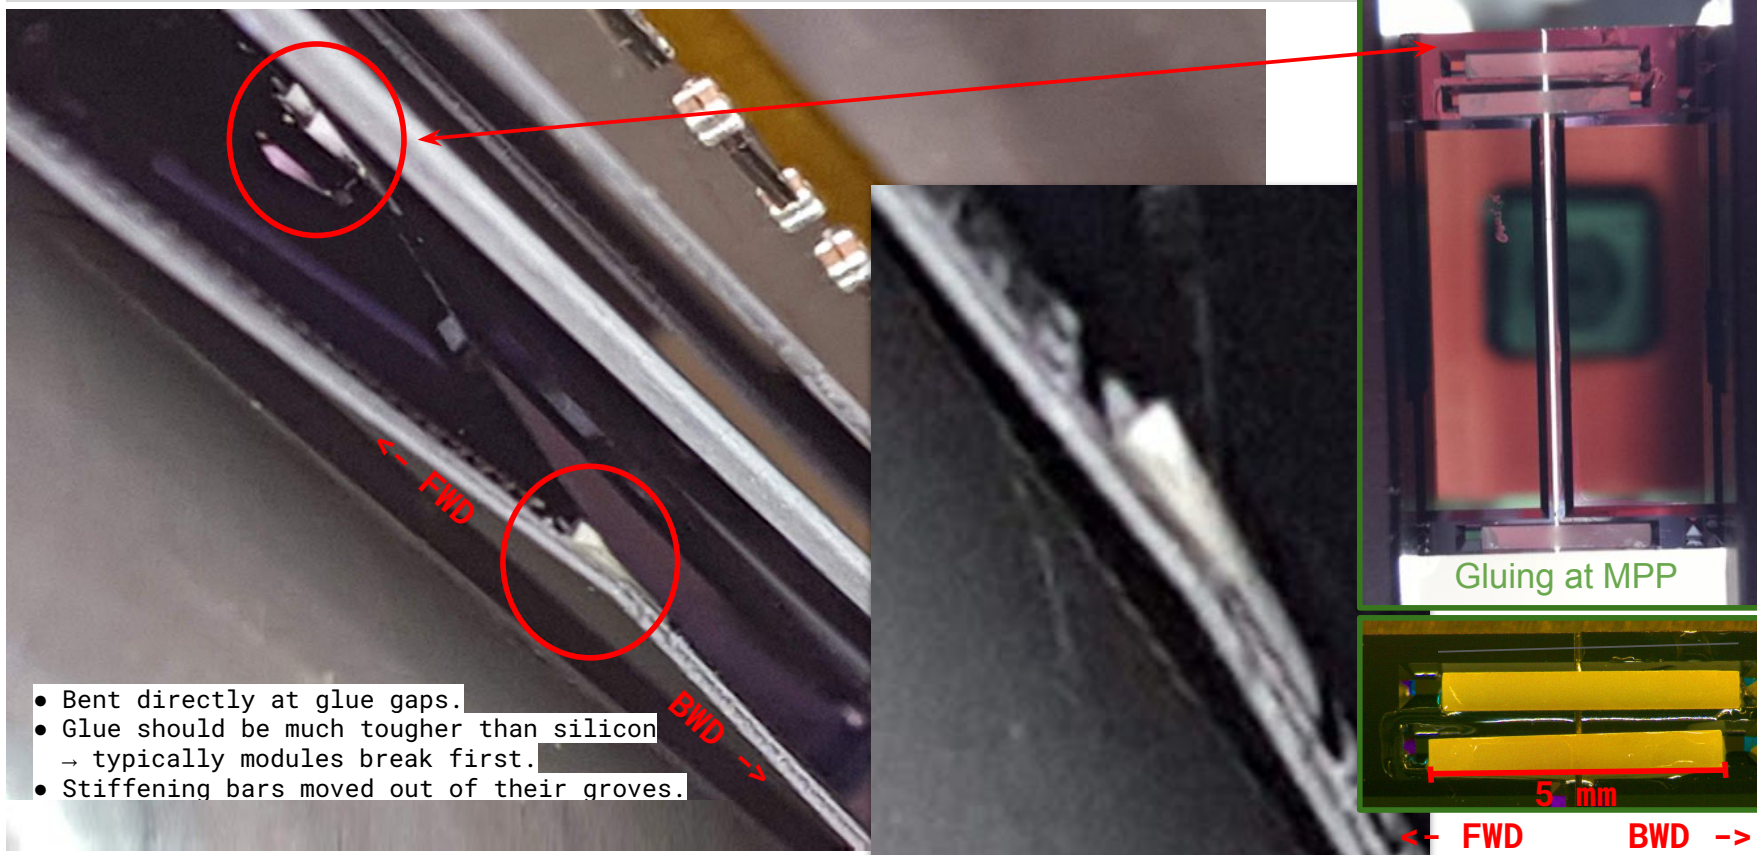
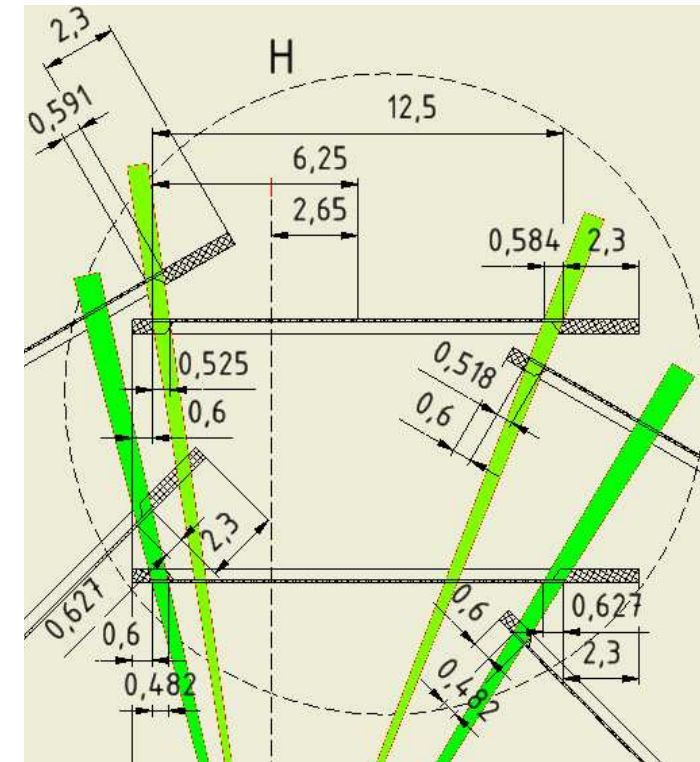
Reminder: Broken L1 Ladders in DESY Setup

- Fortunately, ladders 2.7 and 2.8 bend in the opposite direction to the sensor surface
- Even if glue joint opens, ceramic stiffeners do not push into neighbouring sensor

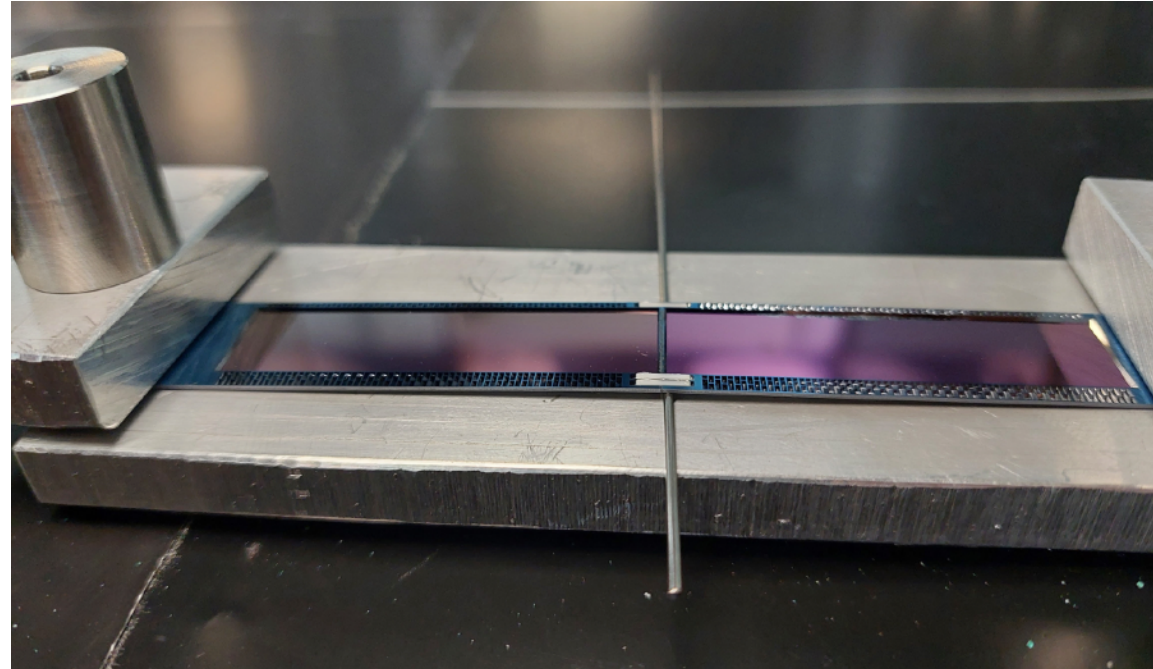
Stress Tests of Glue Joint at MPP in September 2022

Ladder	Layer	Joint type	Thickness	Sagitta	Time	Temp	Result
LK38	L2	face-up	525	1,4 mm	48h	25°C	ok
					72h	25°C	bent
LK60	L1	face-up	450	1,0 mm	24h	25°C	ok
					3h	40°C	ok
					3h	60°C	bent
dummy #6	L2	face-up	525	2,0 mm	48h	25°C	ok
dummy #4	L2	face-down	525	2,0 mm	48h	25°C	ok
					3h	60°C	ok
					3h	85°C	bent

- Statistics very small, but
 - face-up adhesive joint possibly a bit weaker than face-down joint
 - ▶ may be due to the difference in the way how glue is dispensed
- Avoid temperatures above 40°C for longer periods of time
 - lap shear strength reduced by 50% at 60°C
- Conclusion
 - adhesive joint not as rigid as previously assumed
 - no reason to believe that affected adhesive joints were particularly problematic

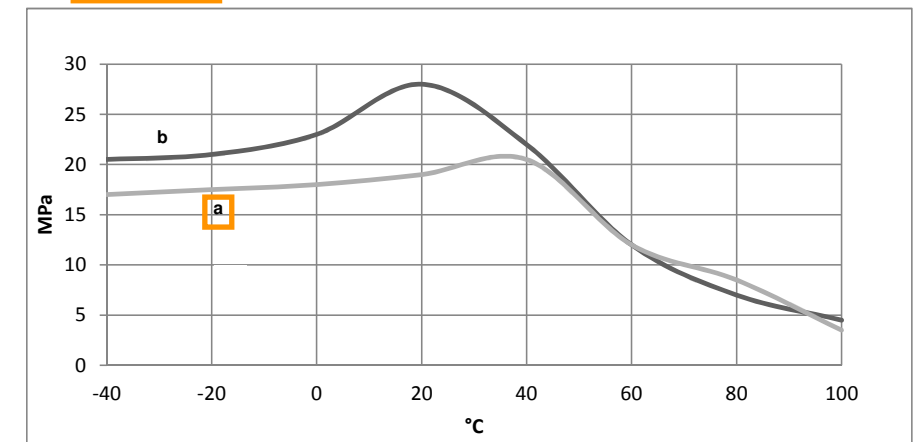
Araldite 2011

Lap shear strength versus temperature (ISO 4587) (typical average values)
Cure: (a) = 7 days /23°C (b) = 24 hours/23°C + 30 minutes/80°C

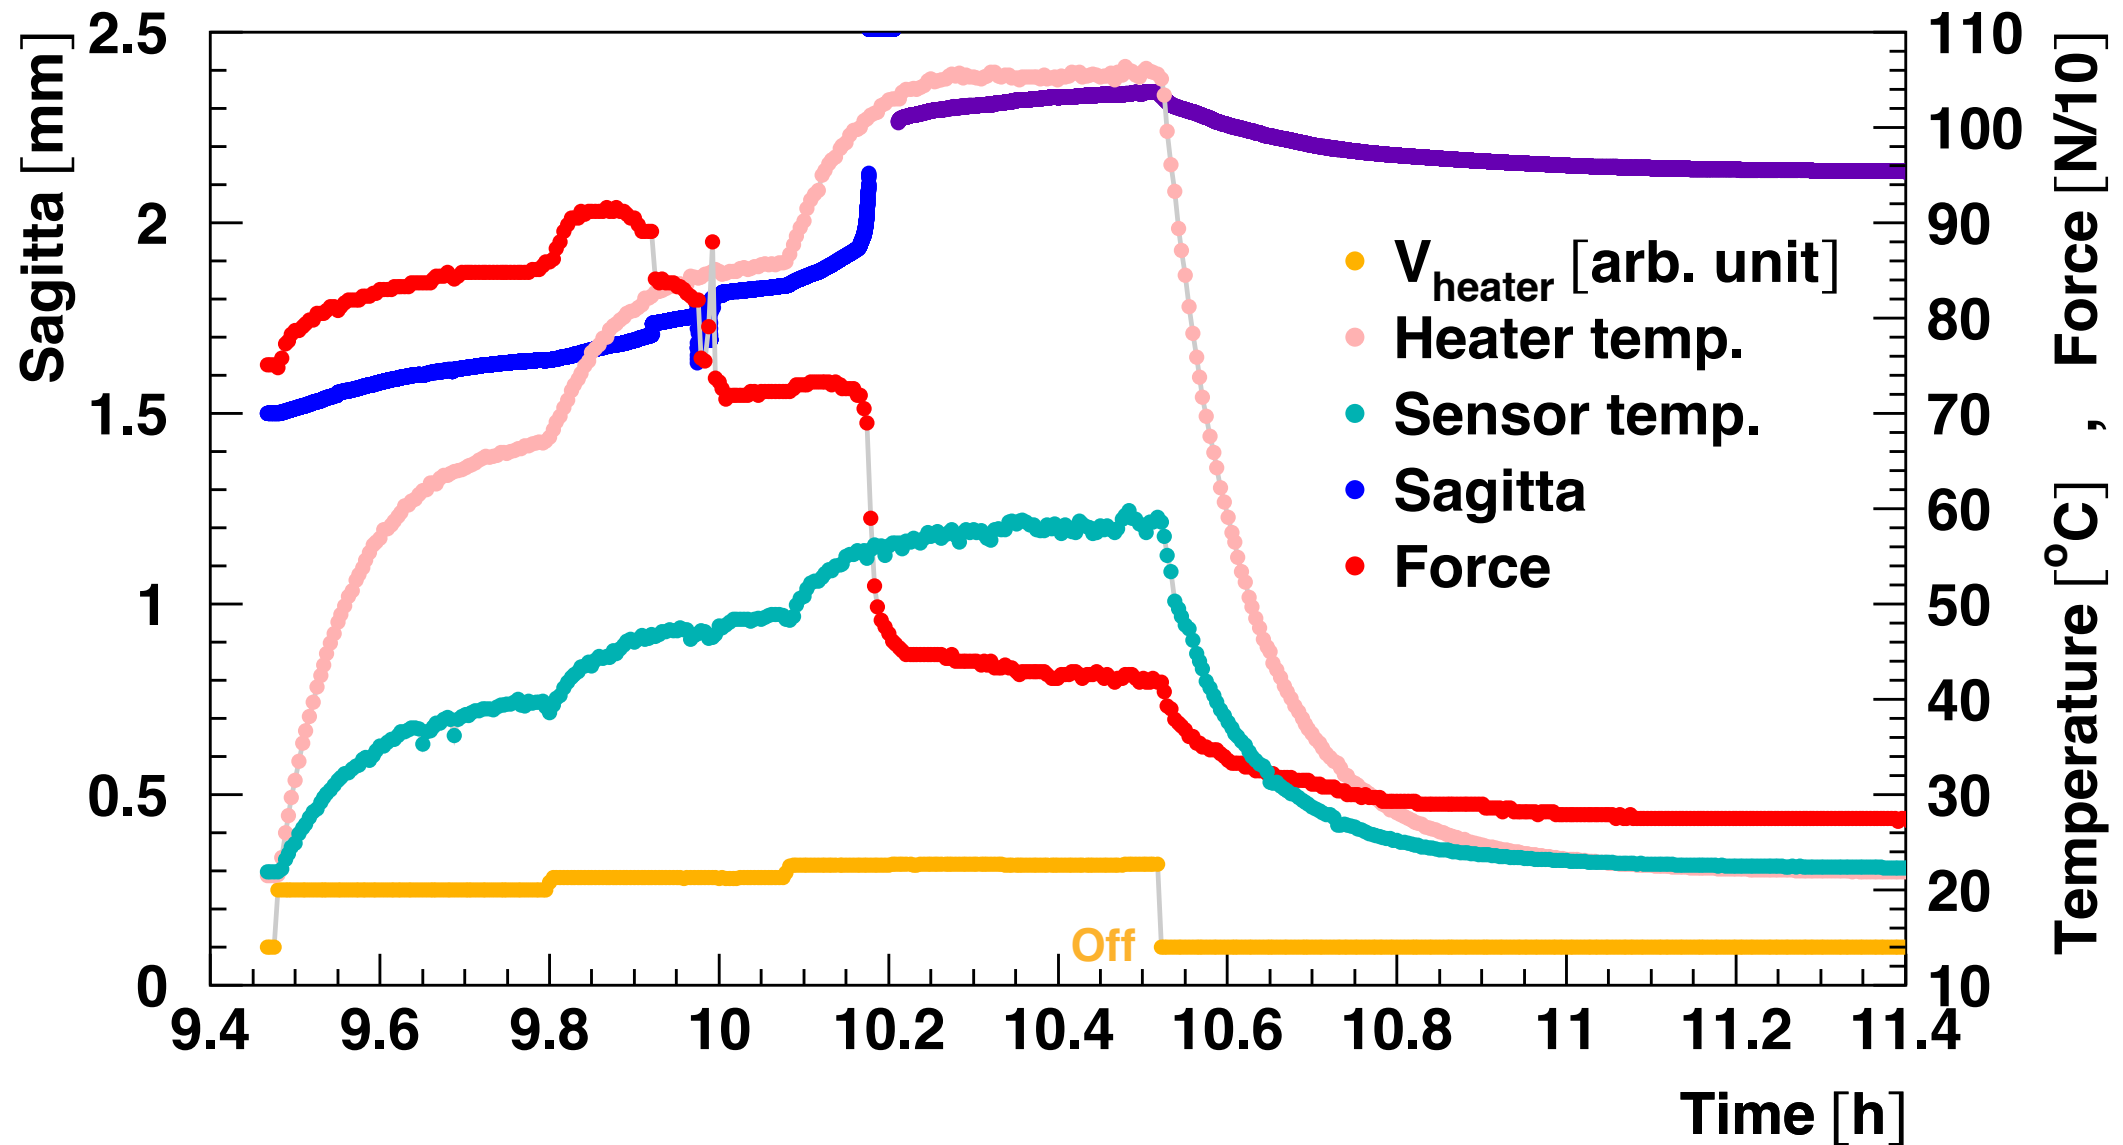
LK79 Heating Test: Pre-bent with 1.5 mm Sagitta

- In the test setup, the Araldite softens at a sensor temperature of $\sim 46\text{--}48^\circ\text{C}$
 - after repeating the heat cycle ceramic stiffeners stay in place and modules stay connected

- above temperature is only a lower limit as the NTC is only lightly touching the sensor surface
 - in general the result is in accordance with adhesive specifications

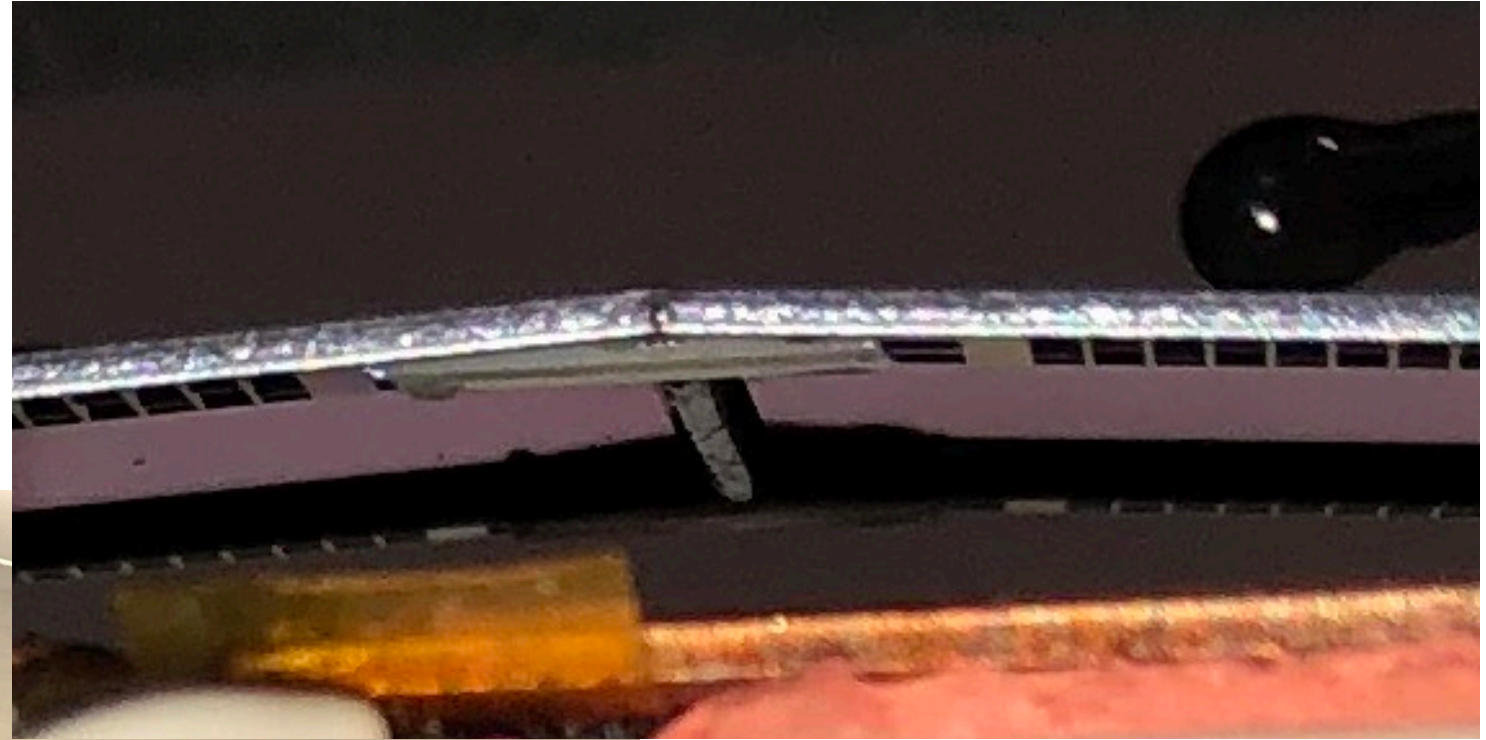
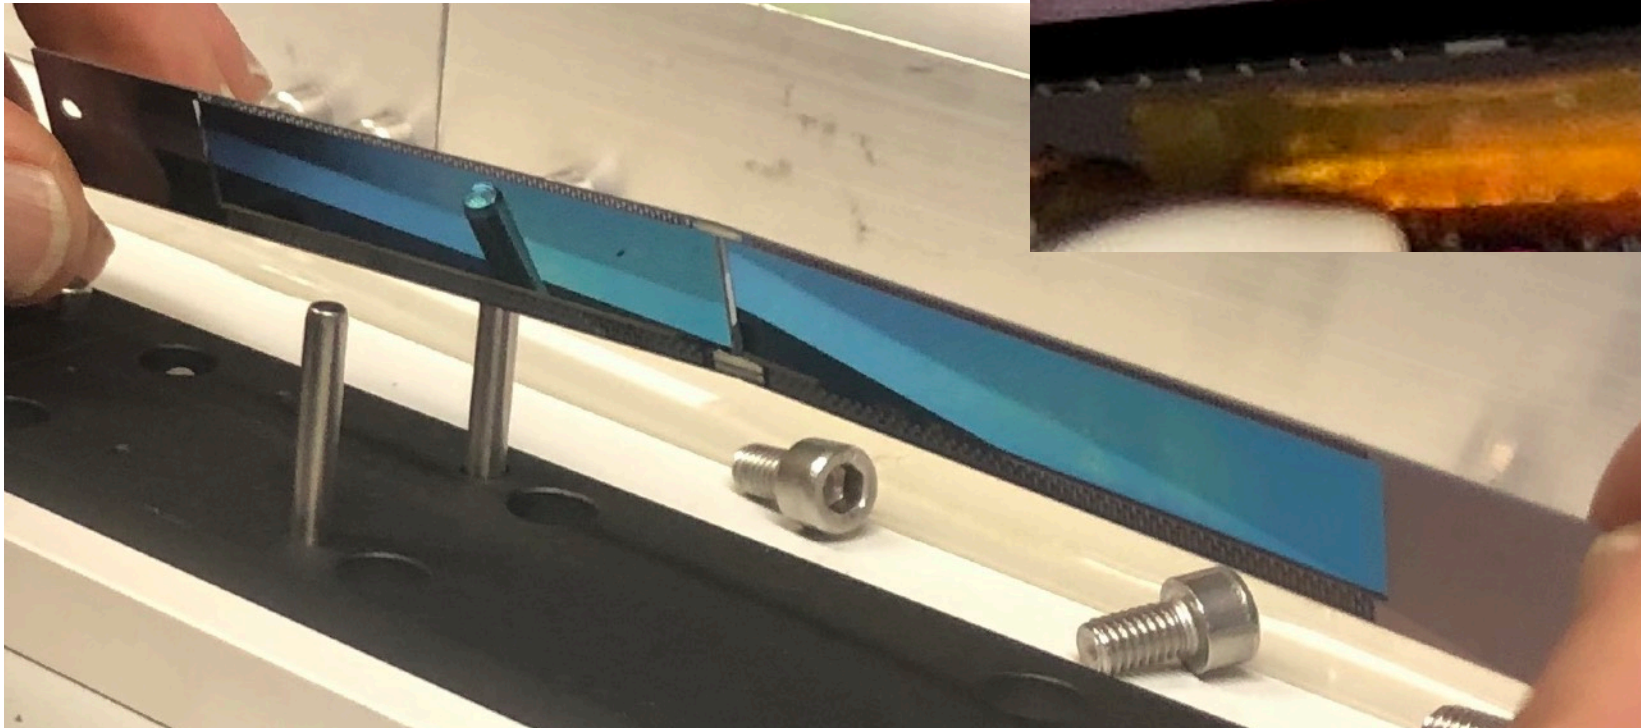
LK79 Glue Joint after 2nd Heating

- Ceramic stiffeners remain in place after second heating cycle
- Bend remains but modules are mechanically intact and still firmly connected at room temperature

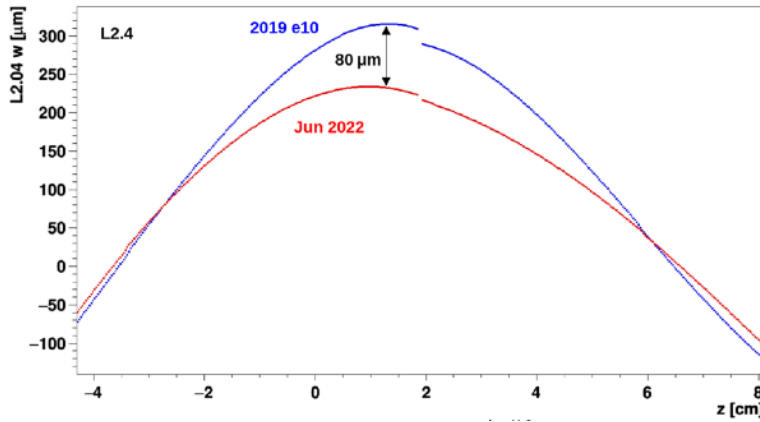
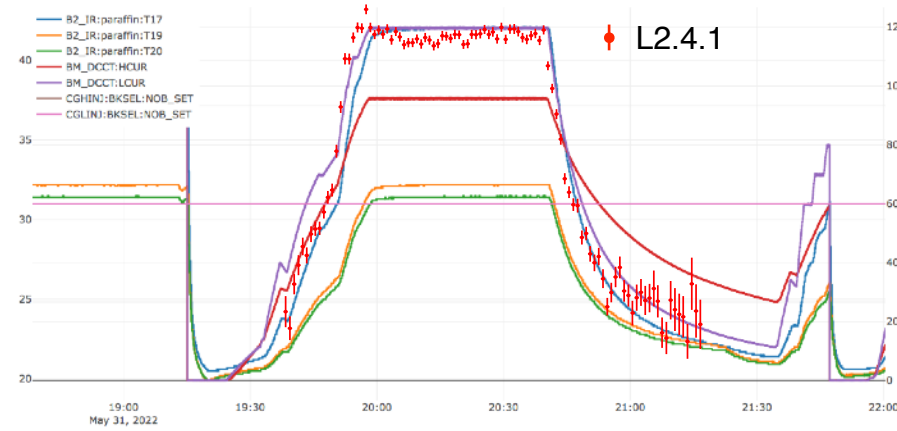
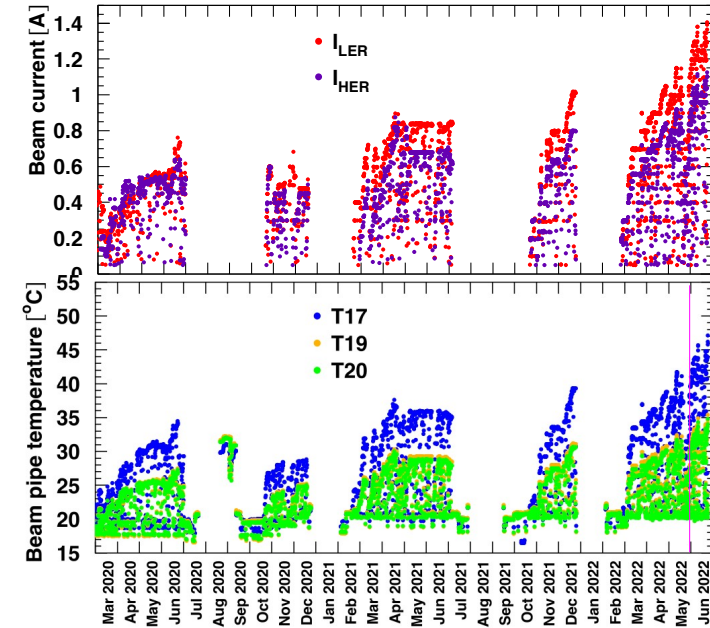
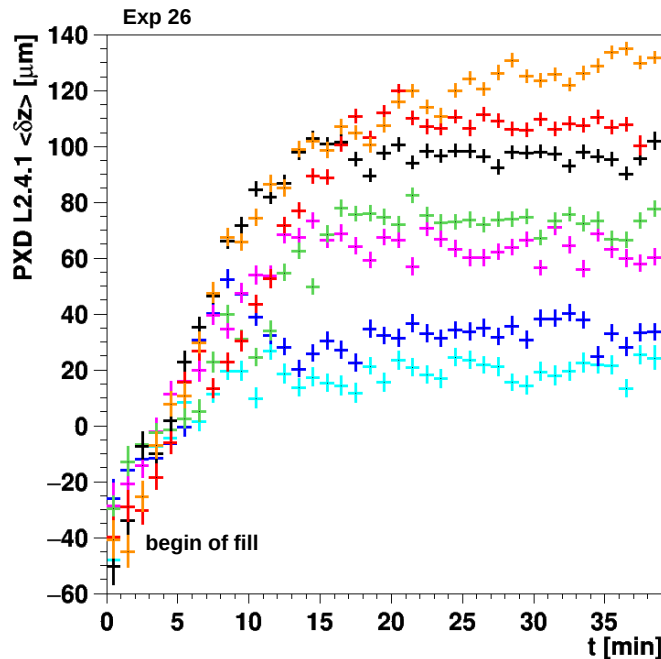
Ladder Bowing in PXD1 L2 due to Beam Pipe Heating

• PXD L2.4.1 vs SVD tracks: $-\delta z$

Improved beam pipe cooling implemented in LS1

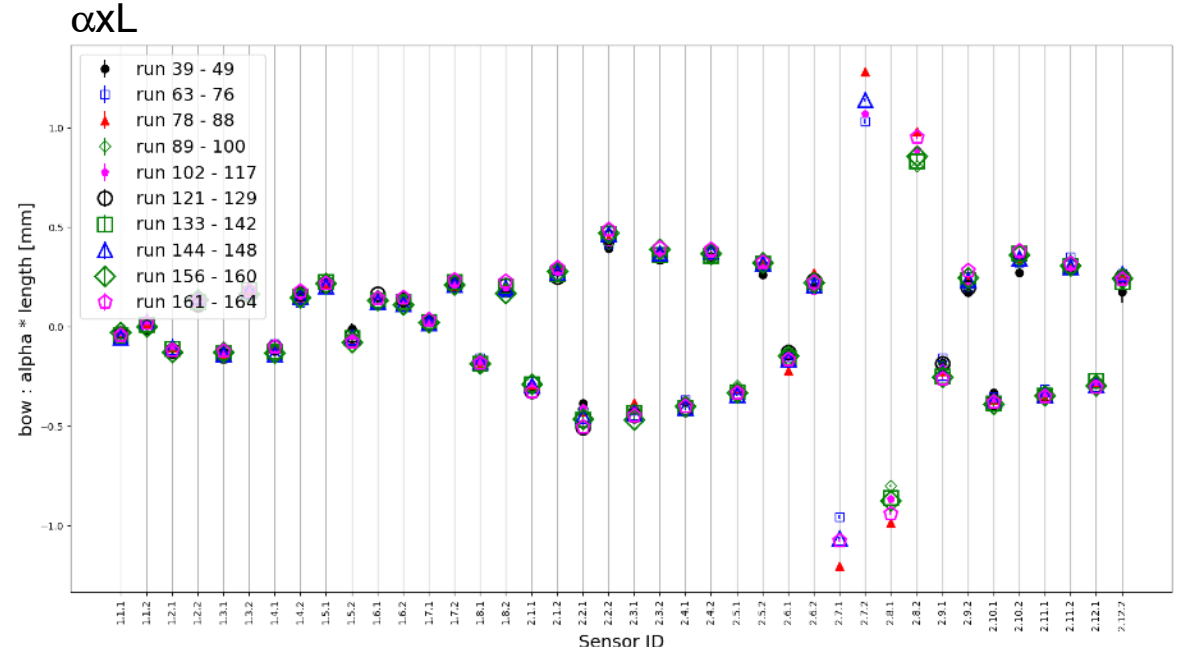
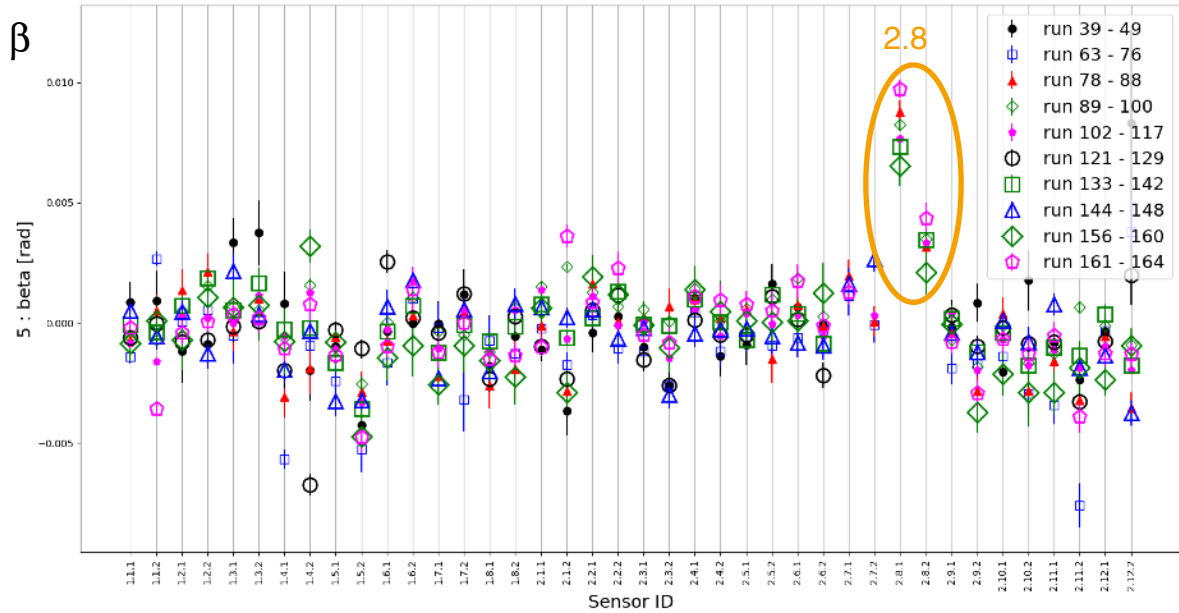
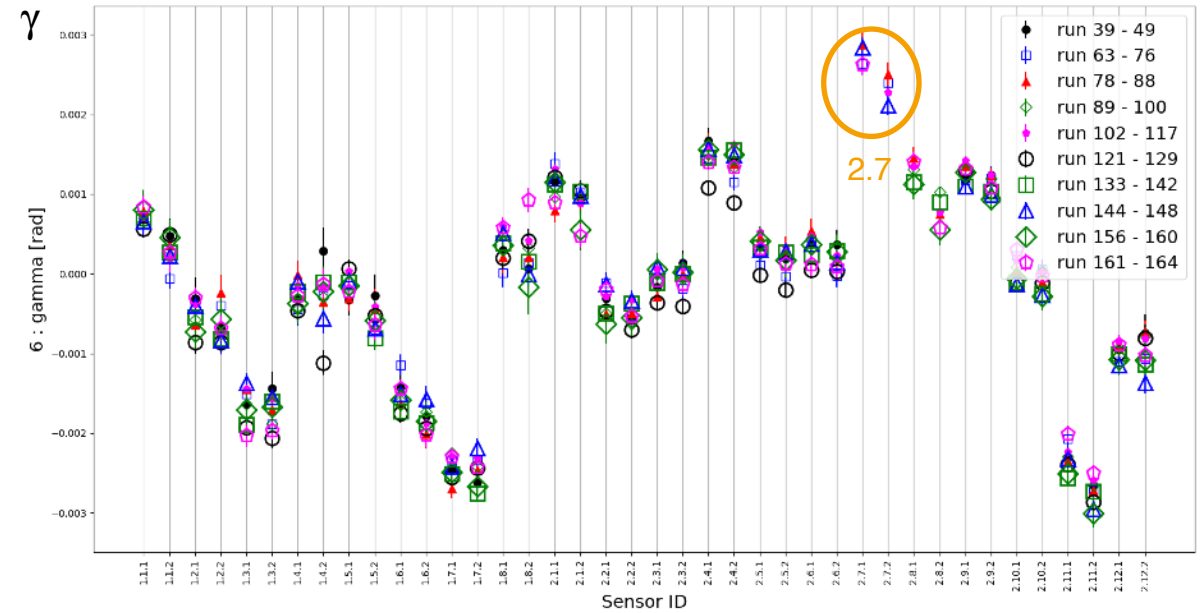
Ladder Bending Studies with Field-off Cosmics

- Most bent ladders 2.7 and 2.8 also have large β and γ values
- Suspect that gliding impossible as these ladders are not optimally mounted on SCBs
- Reminder: Unlike other half-shell, this one not disassembled at DESY

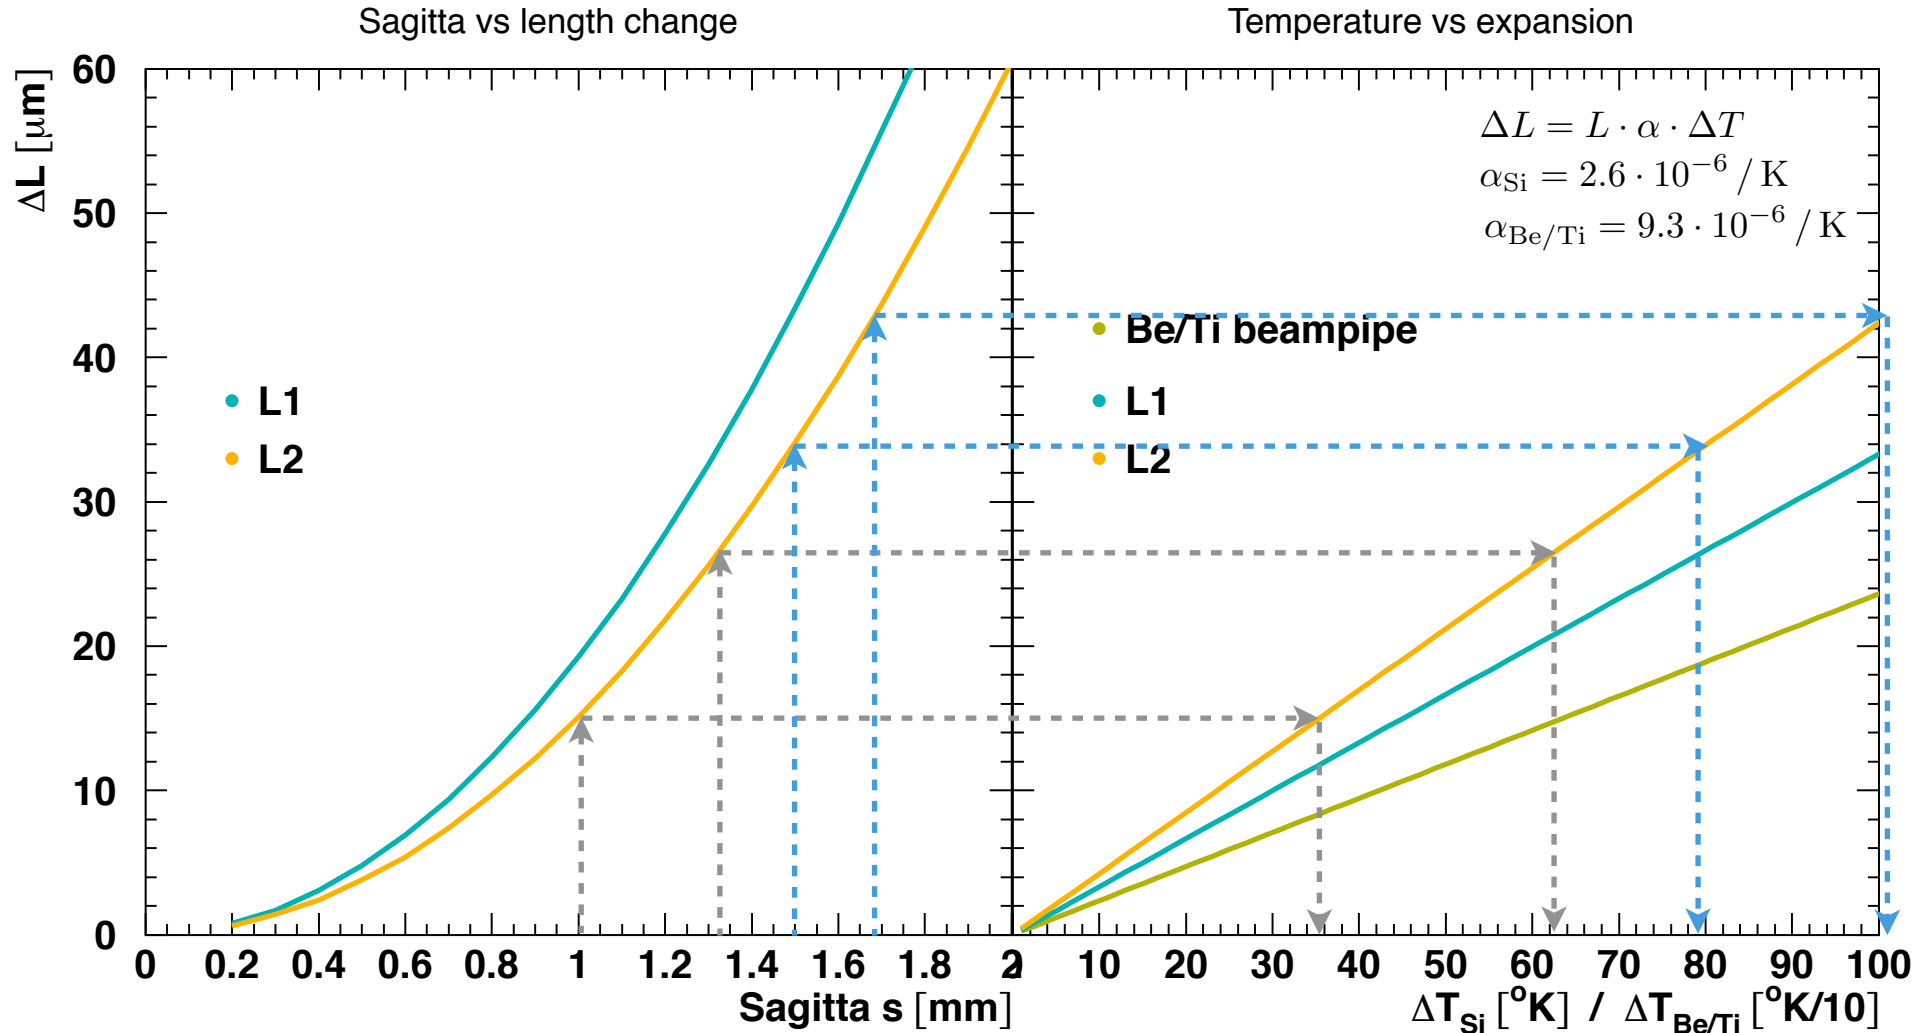
Expected Relation between Sagitta and Temperature

- Under the simplifying assumption of a constant temperature profile along the ladder
 - KEK: for bent ladder EOS probably hotter than sensor area
 - DESY test setup: radiant heating only in L1 area → EOS colder than sensor area
