CAT7 cable problem

Mikihiko Nakao (KEK)

2021.6.11

DAQ meeting

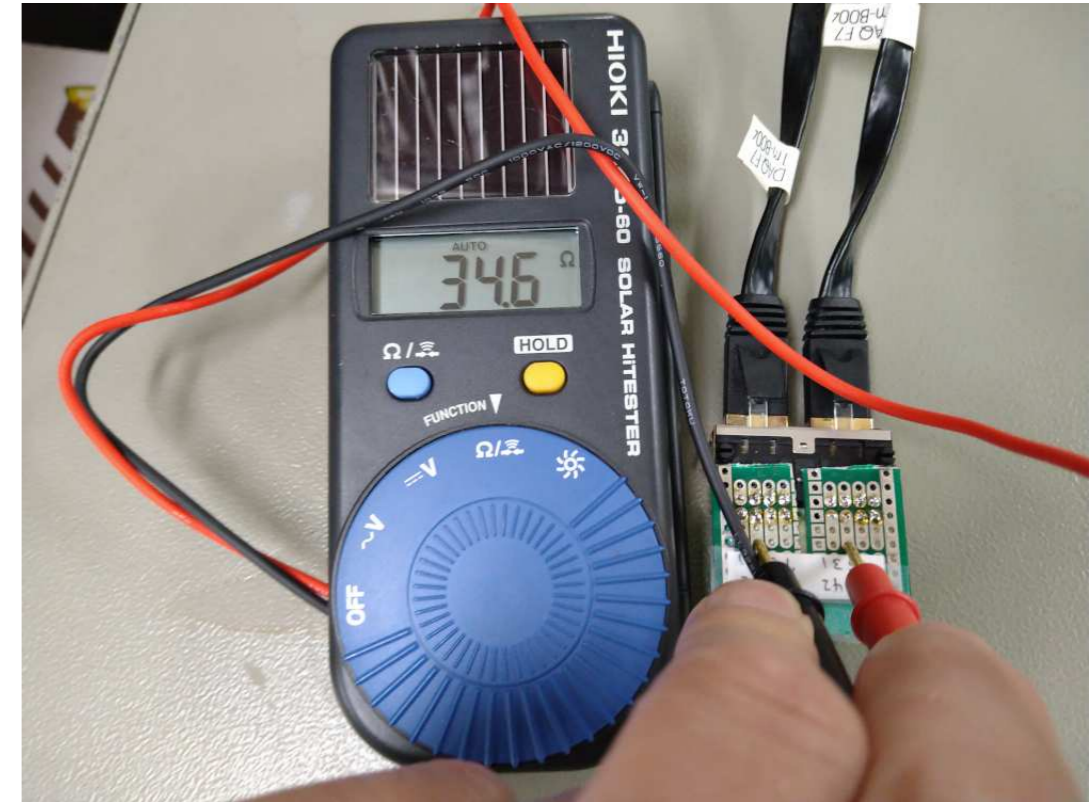
Cable Resistance

- Handmade cable checker
 - Just to secure the multimeter probe contact
 - Amphenol RJ45 connector for FTSW is used
- KB-T7 0.5m (thick CAT7)
 - 0.2–0.3 Ω for any of 1–8 pins (very good)
- KB-FLU7 1m (good flat CAT7)
 - 0.6–0.7 Ω for any of 1–8 pins (good enough)
- KB-FL7 0.5 and 1m (bad flat CAT7), 6 cables
 - 7 and 8 pins are typically around 1–2 Ω (best one: 0.5 Ω , worst: 8.7 Ω)
 - 1 and 2 pins are somewhat worse, typically around 1–5 Ω (best one: 0.8 Ω , worst: 19.6 Ω)
 - 3, 4, 5, 6 pins are **much worse**, typically one or two pins have $O(10 \Omega)$, and sometimes up to **2 k Ω (!)**

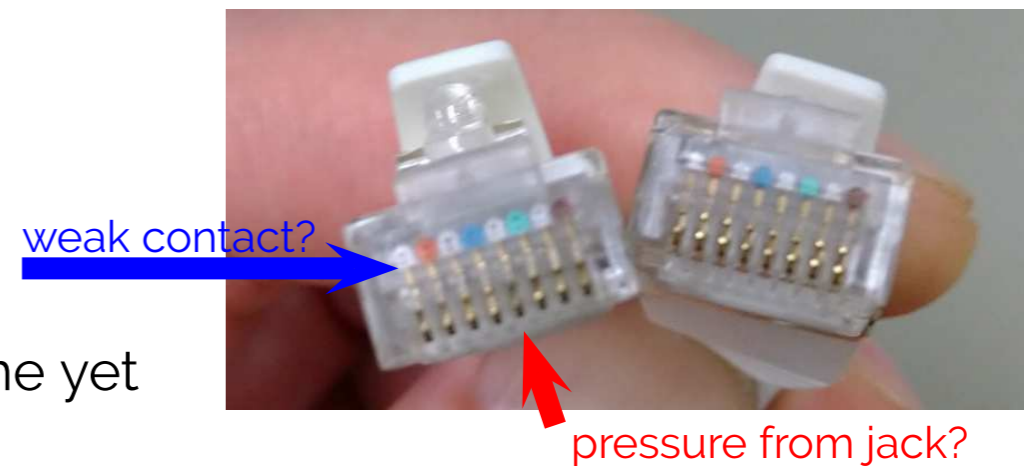
● Probably the contact between the wire and blade?

- There must be some push from the jack pin to the blade
- Swapping the connectors changes the result
- It also explains why replugging sometimes fixes a problem
- I should have tried to press the connector, but have not done yet
