PXD2 Pre-Commissioning

Anselm Baur (DESY)

Belle II Germany Meeting, Munich, Sept. 20th 2022

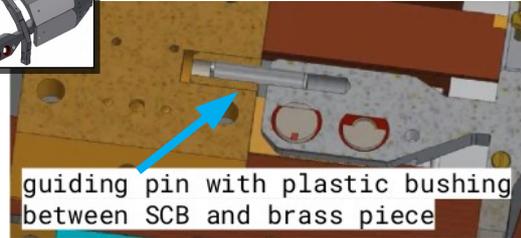
- Forward SCB not fixed on BP → **guiding/sliding pins**
- Forward modules have **elongated hole**

guiding pin with plastic bushing between SCB and brass piece

elongated hole which allows ladder to move longitudinal

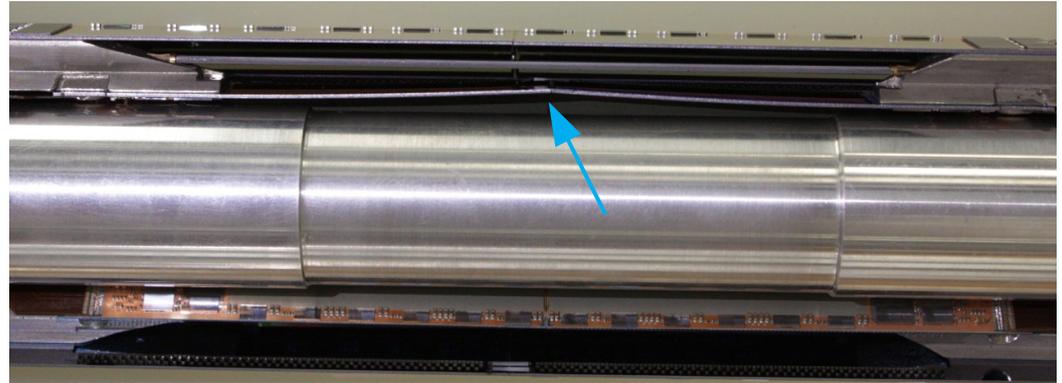
After Testing 1st Half-Shell:

- **2 broken inner ladders** L1a, L1b
- **Kink height** of ~1.5 mm
 - Equivalent thermal expansion of Si at ~140 K (this we did not have)
 - Ladder were still under tension, relaxed when releasing screws
- **Outer ladders not affected**
- **Unclear if L1a and L1b still functional**

Possible Causes (Combination?):

- S.th. **prevented SCB from gliding** under thermal/mechanical stress
- Ladder **tightening torque** too high → **no module gliding**
- Explanation of large kink, an **asymmetric** process must have **periodically** enhanced stress → **accumulated bending**
- Influence of massive **Al beam pipe mockup**
(Al ~10 times higher thermal expansion than Si)
- **Glue loses strength** at ~60 °C under stress (tests at MPP)
- Incident: once **CO2 cooling broke down** in forward SCB
(ASIC temperatures up to 80-90 °C for a few seconds)

Repair 1st Half-Shell:

- **2 good** L1 ladders for replacement
- **1 more** L1 ladder can be **glued** from good modules
- **Risk analysis**

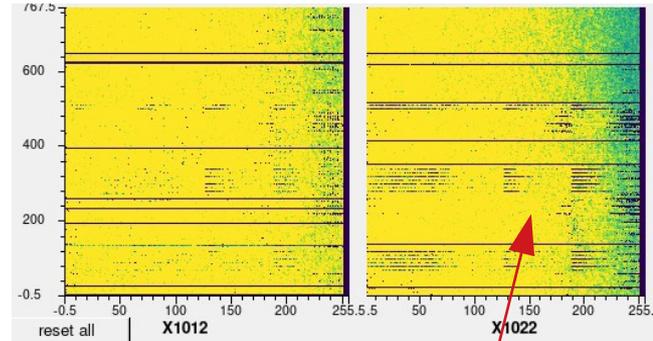
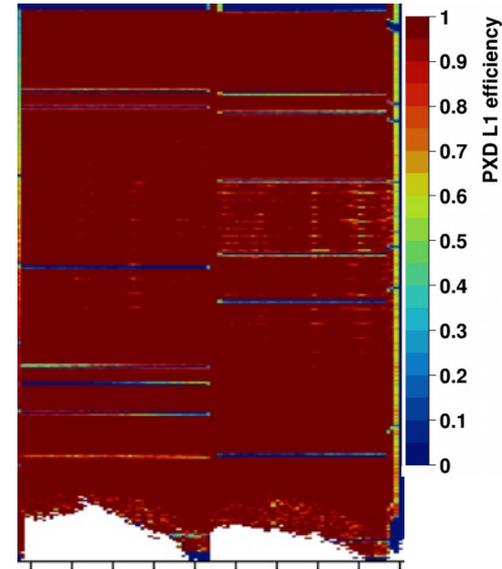
Pedestal Aging

- Pedestals slowly drifting out of dynamic range
- Regions with deteriorated efficiency appear
- Periodic pattern visible

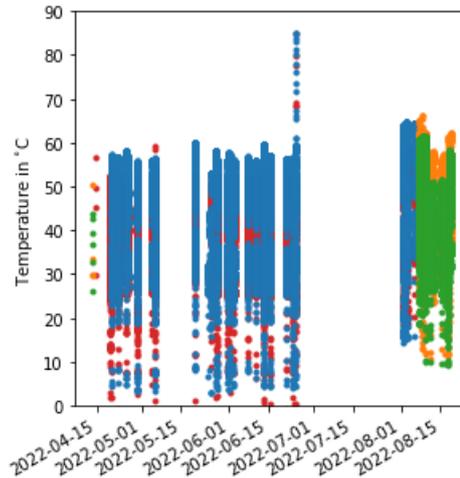
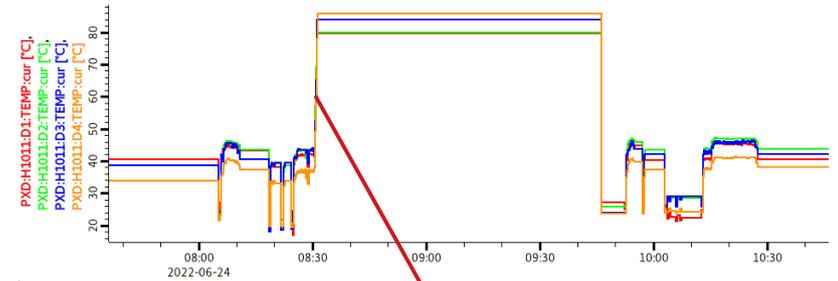
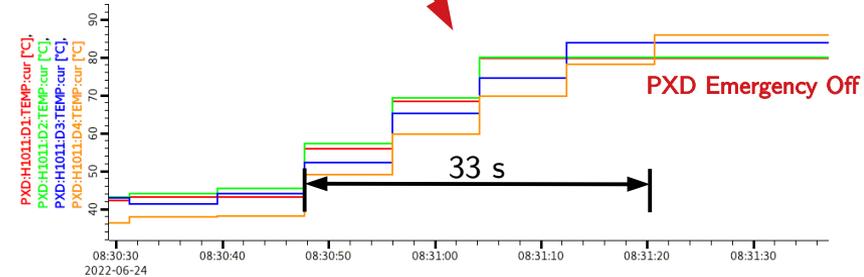
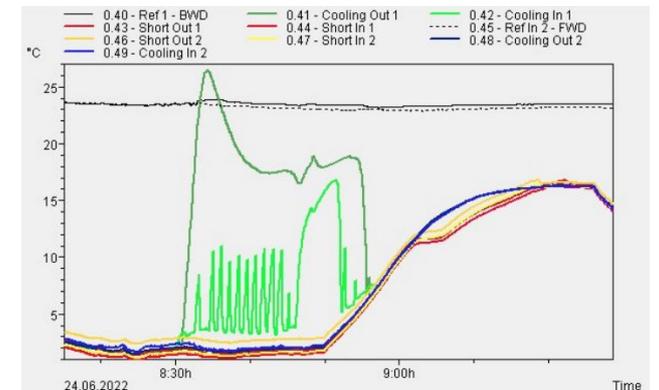
MARCO Cooling Incident

Cooling Incident Friday June 24th:

- During operation the CO2 cooling in FWD line broke down
- DHP temperatures increased rapidly
- Modules shut of after approx. 33 s
- Tried to stabilize MARCO
 - Warm up, higher flow
- Afterwards issues to power on modules due to dhp-io voltage to high
 - This anyhow prevent us to power the modules
 - DHI power off did not work
 - Can also be seen when dhp-core voltage is shut down before dhp-io
- Elog: <https://elog.belle2.org/elog/PXD-Commissioning-DESY/136>

- DHP temperatures of all modules divided by:
 - if, ib
 - of, ob

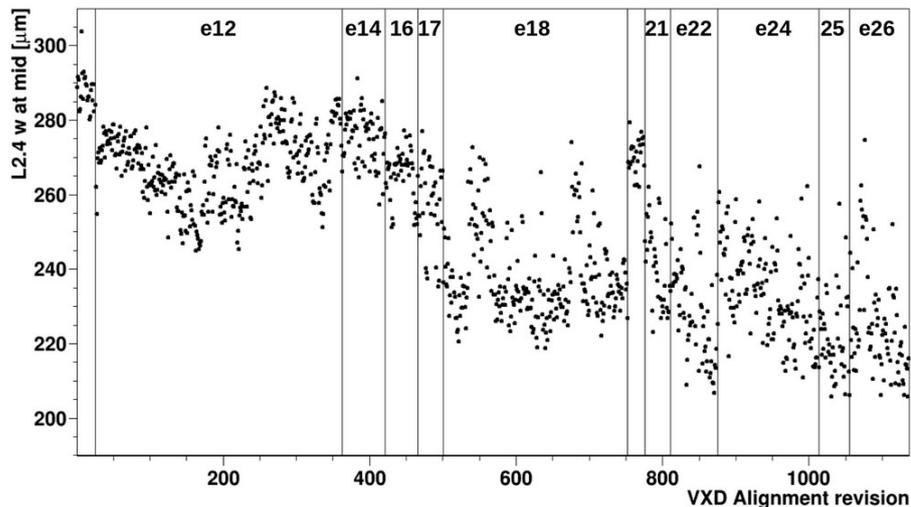
PXD1 SCB Tilt

Beam Pipe Temperature

- Beam currents heat up beam pipe
- Cooling pipes are fixed at SCB
- SCB is tilt by this fixation and the beam pipe extension
-

w at ladder mid (z=1.9 cm) vs time: 100 mu variation

LS1: avoid overconstrained fixations

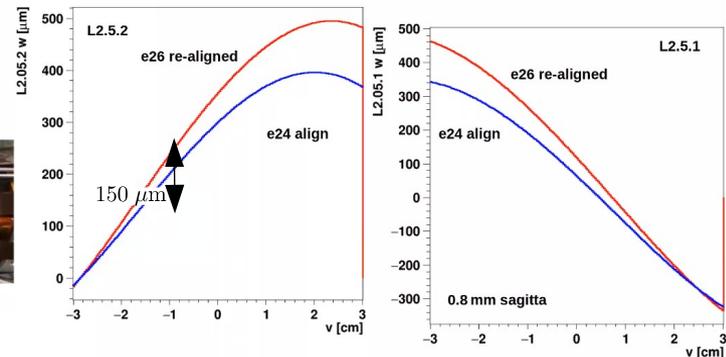
L2.5 alignment

- w = up from sensor surface
 - nominal: $w = 0$
 - L2.5 already had tilt and bow
- e26 run 1699:
 - extra tilt and shift
 - fixpoints at ends
