News from KEK

Michele & Seema
ISU KLM Meeting
30/09/2022

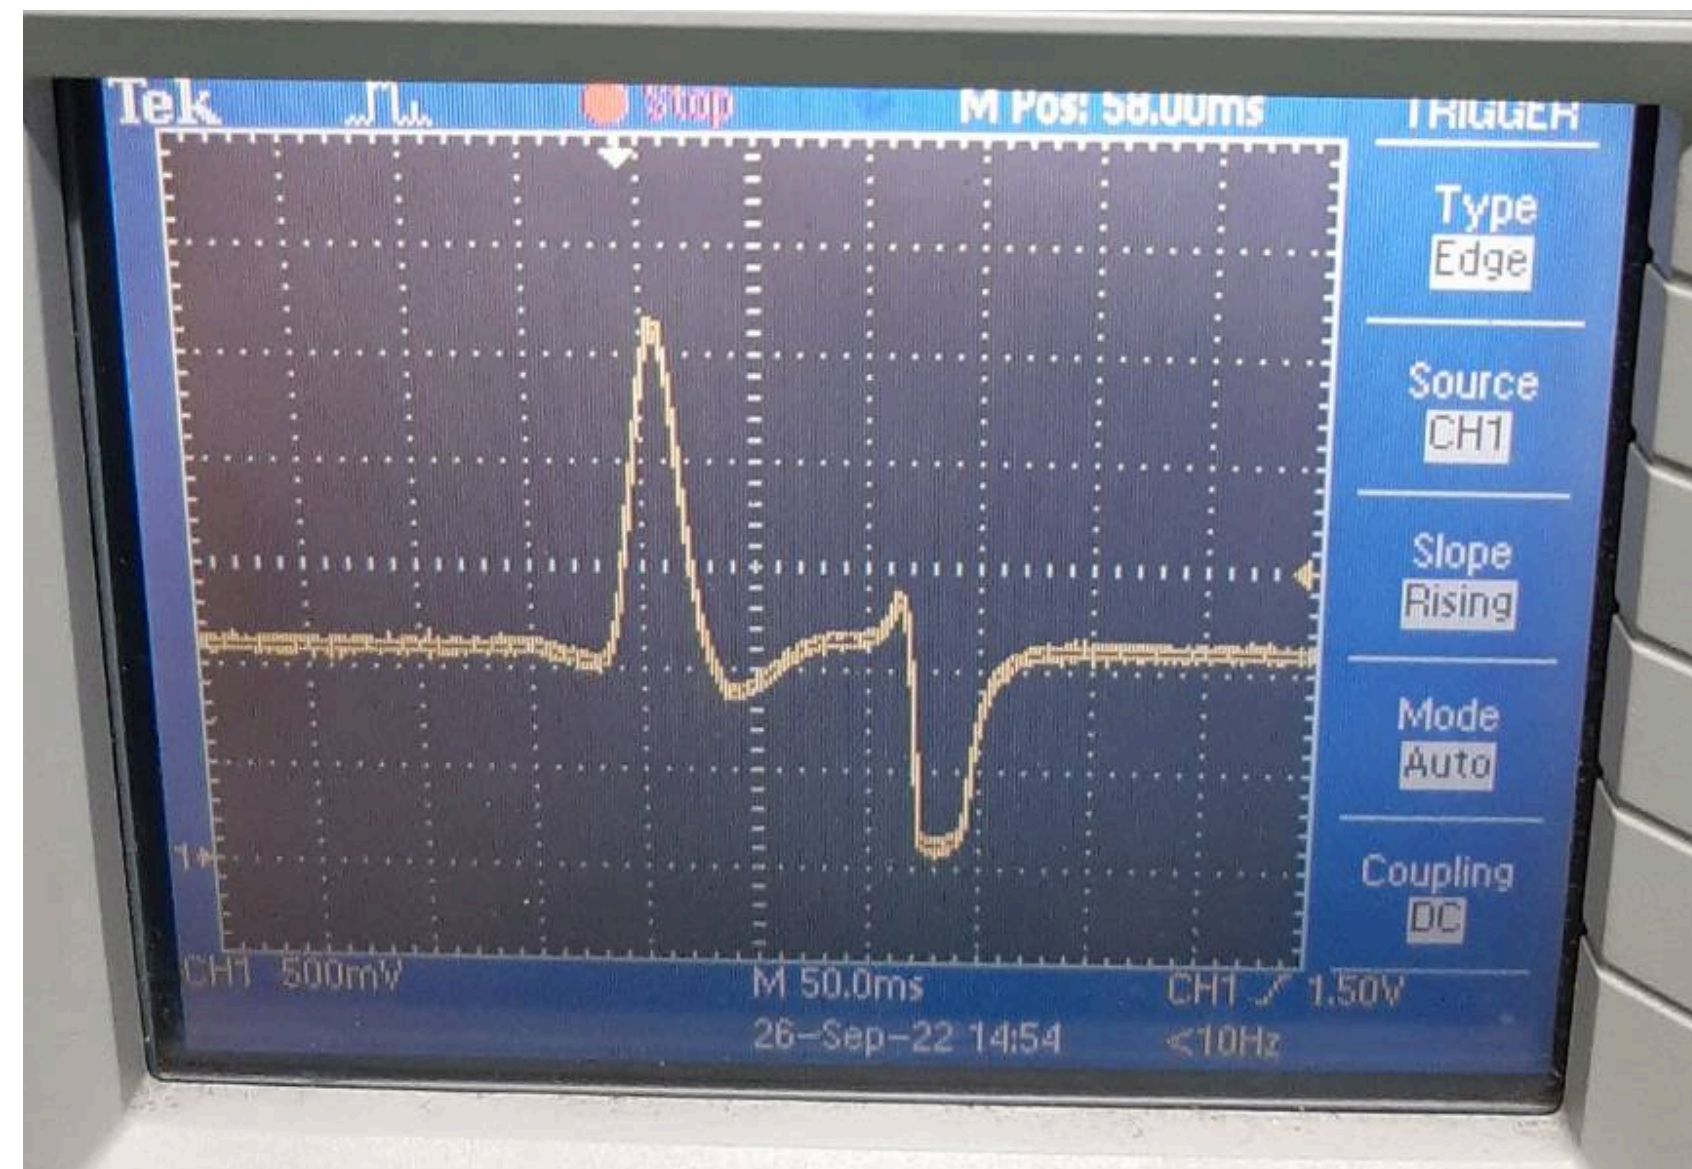
“Standard”

- Inspected bubbler signals in BB2 inner & outer return panels (odd channel numbers {3,5..29} on circuit)
 - Most channels show “standard” pulse (see next slide)
 - Some channels show a “low” pulse (ch. 7, 11, 13, 15, 17 of BB2 inner side)
 - Some “noisy” channels (need to double check probe connection)
 - No signal in channels 29 inner/return (stable flat baseline voltage at 1V)
- Difficult to measure signal from other sectors due to very low bubbles rate
 - Tried a few in BB1 outer return, which were showing a “standard” pulse
 - Sumisawa-san will close the N2 gas flow for all inner RPCs, thus doubling the flow rate for all outer RPCs (10%→20% wrt nominal)
 - To test the supply side, we can use a mechanical pump with a connector to the bubbler panels

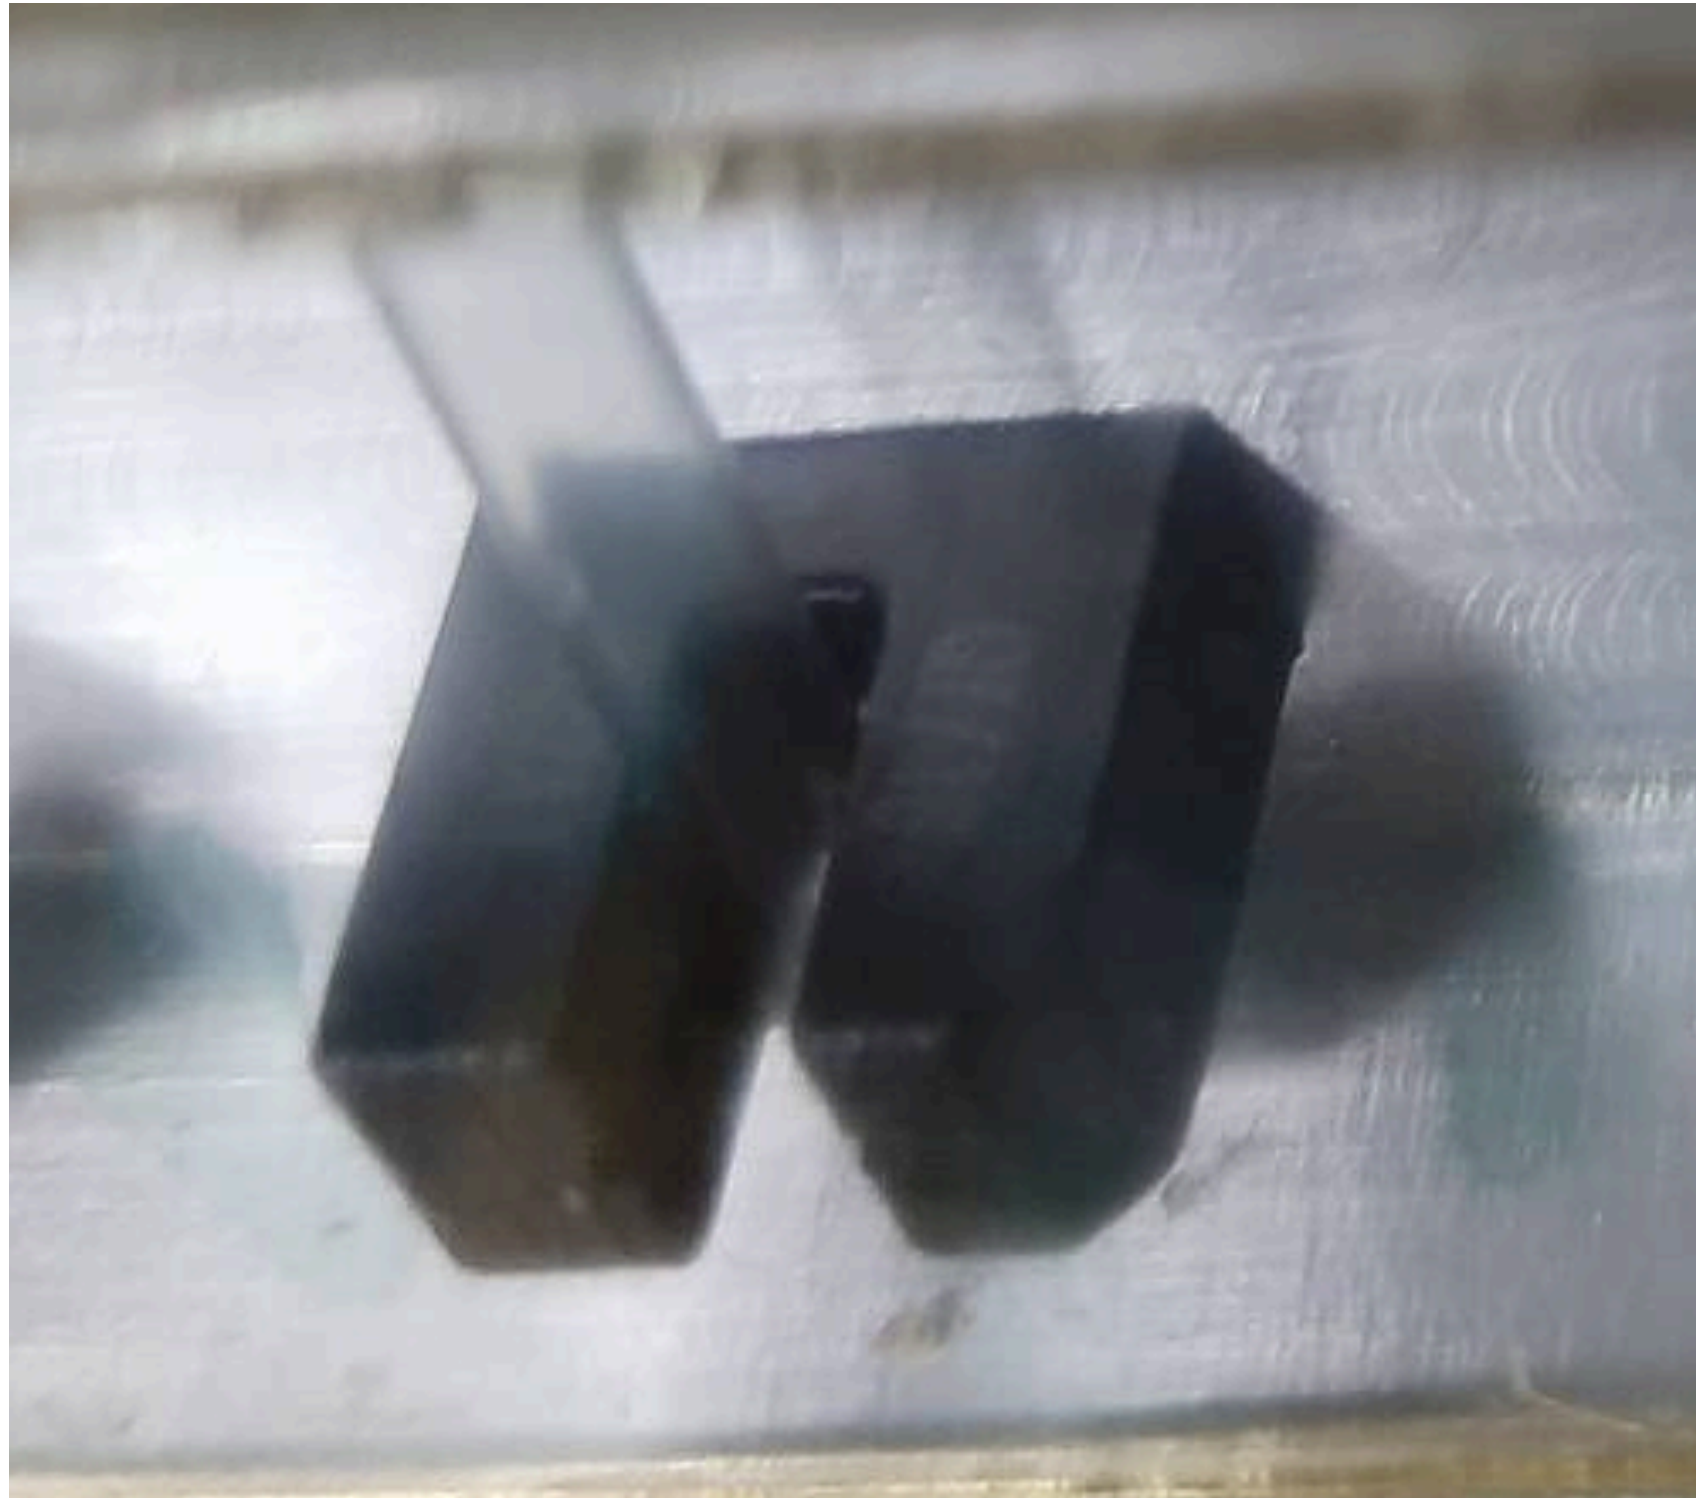
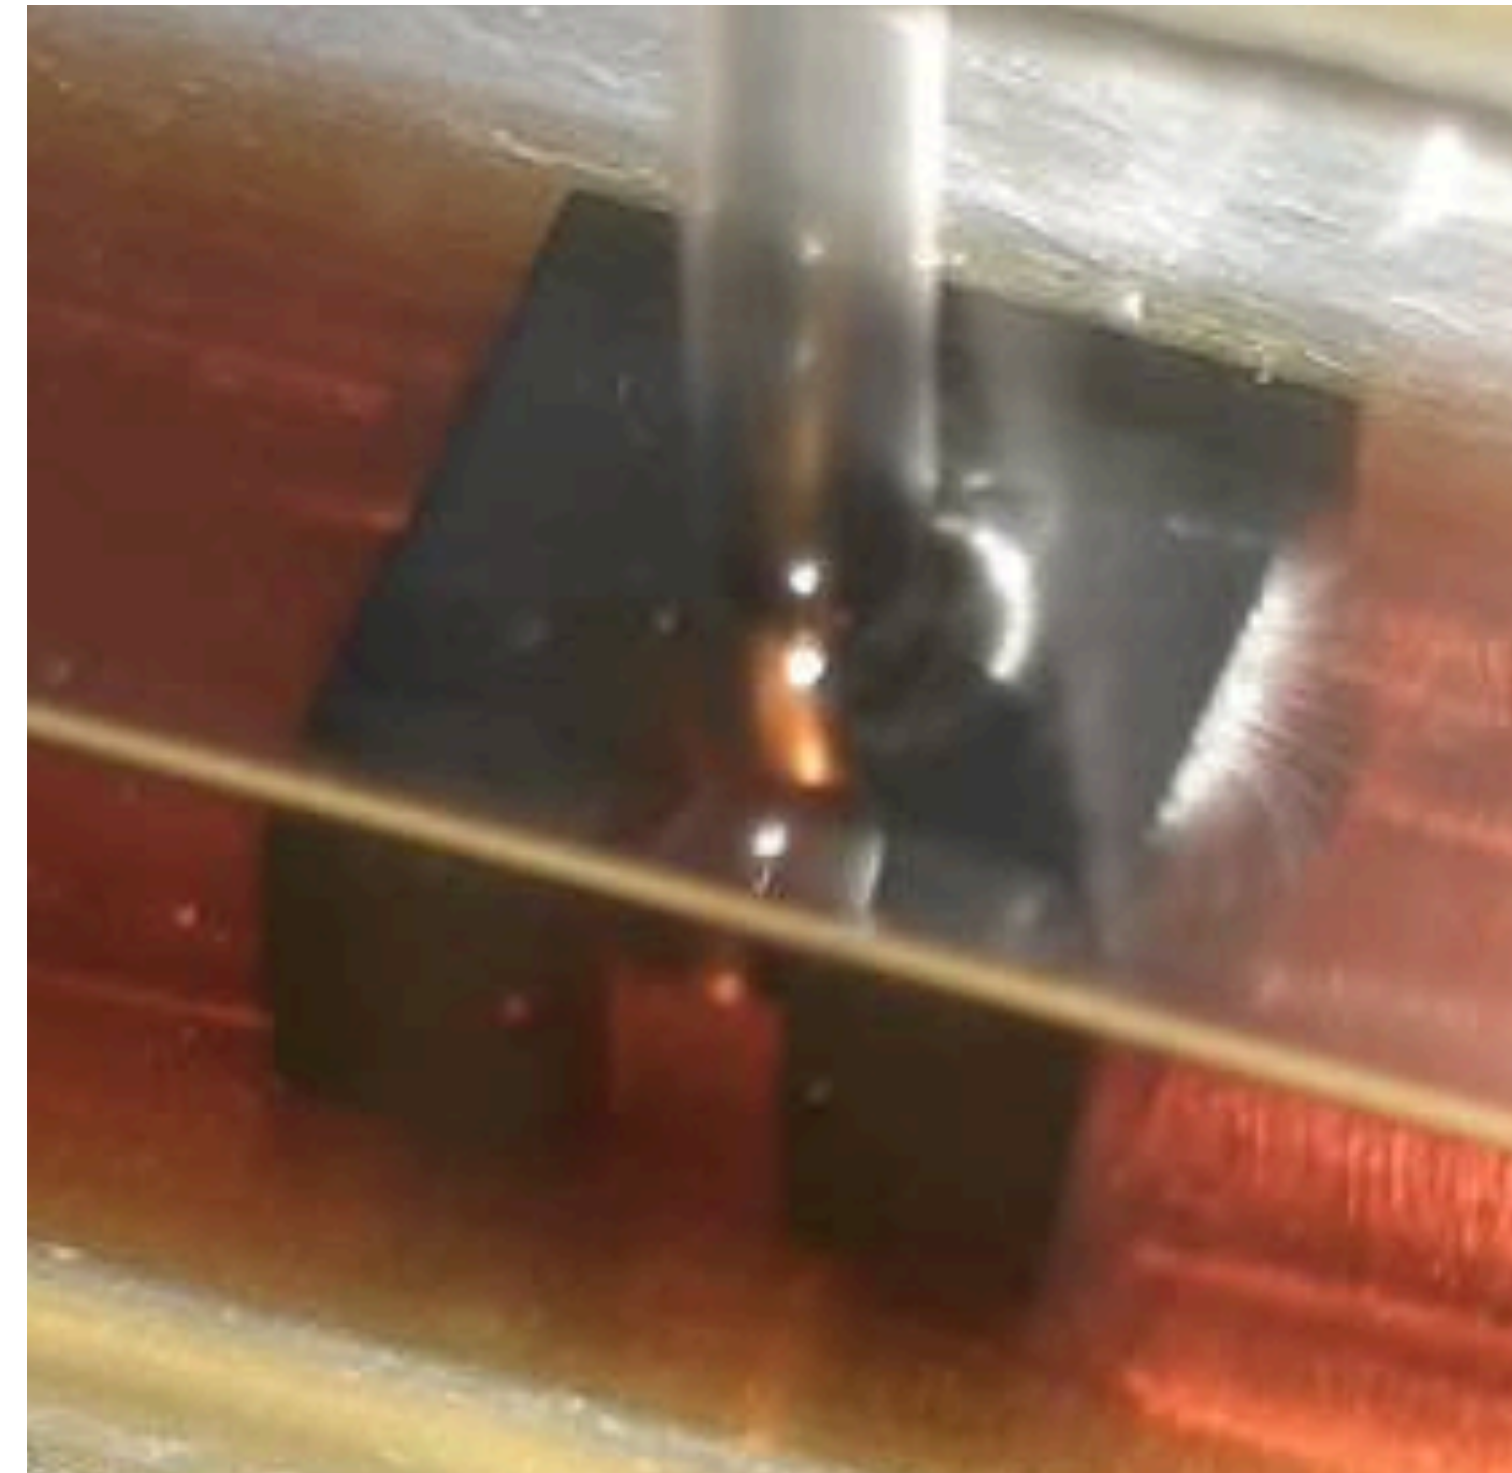
Gap in sensor support

- There seems to be a gap between the tubes and the LED sensor support structure
- Difficult to tell from the panels with oil
