# Debug of B2L

H. Nakazawa (NTU) 20241002@B2GM

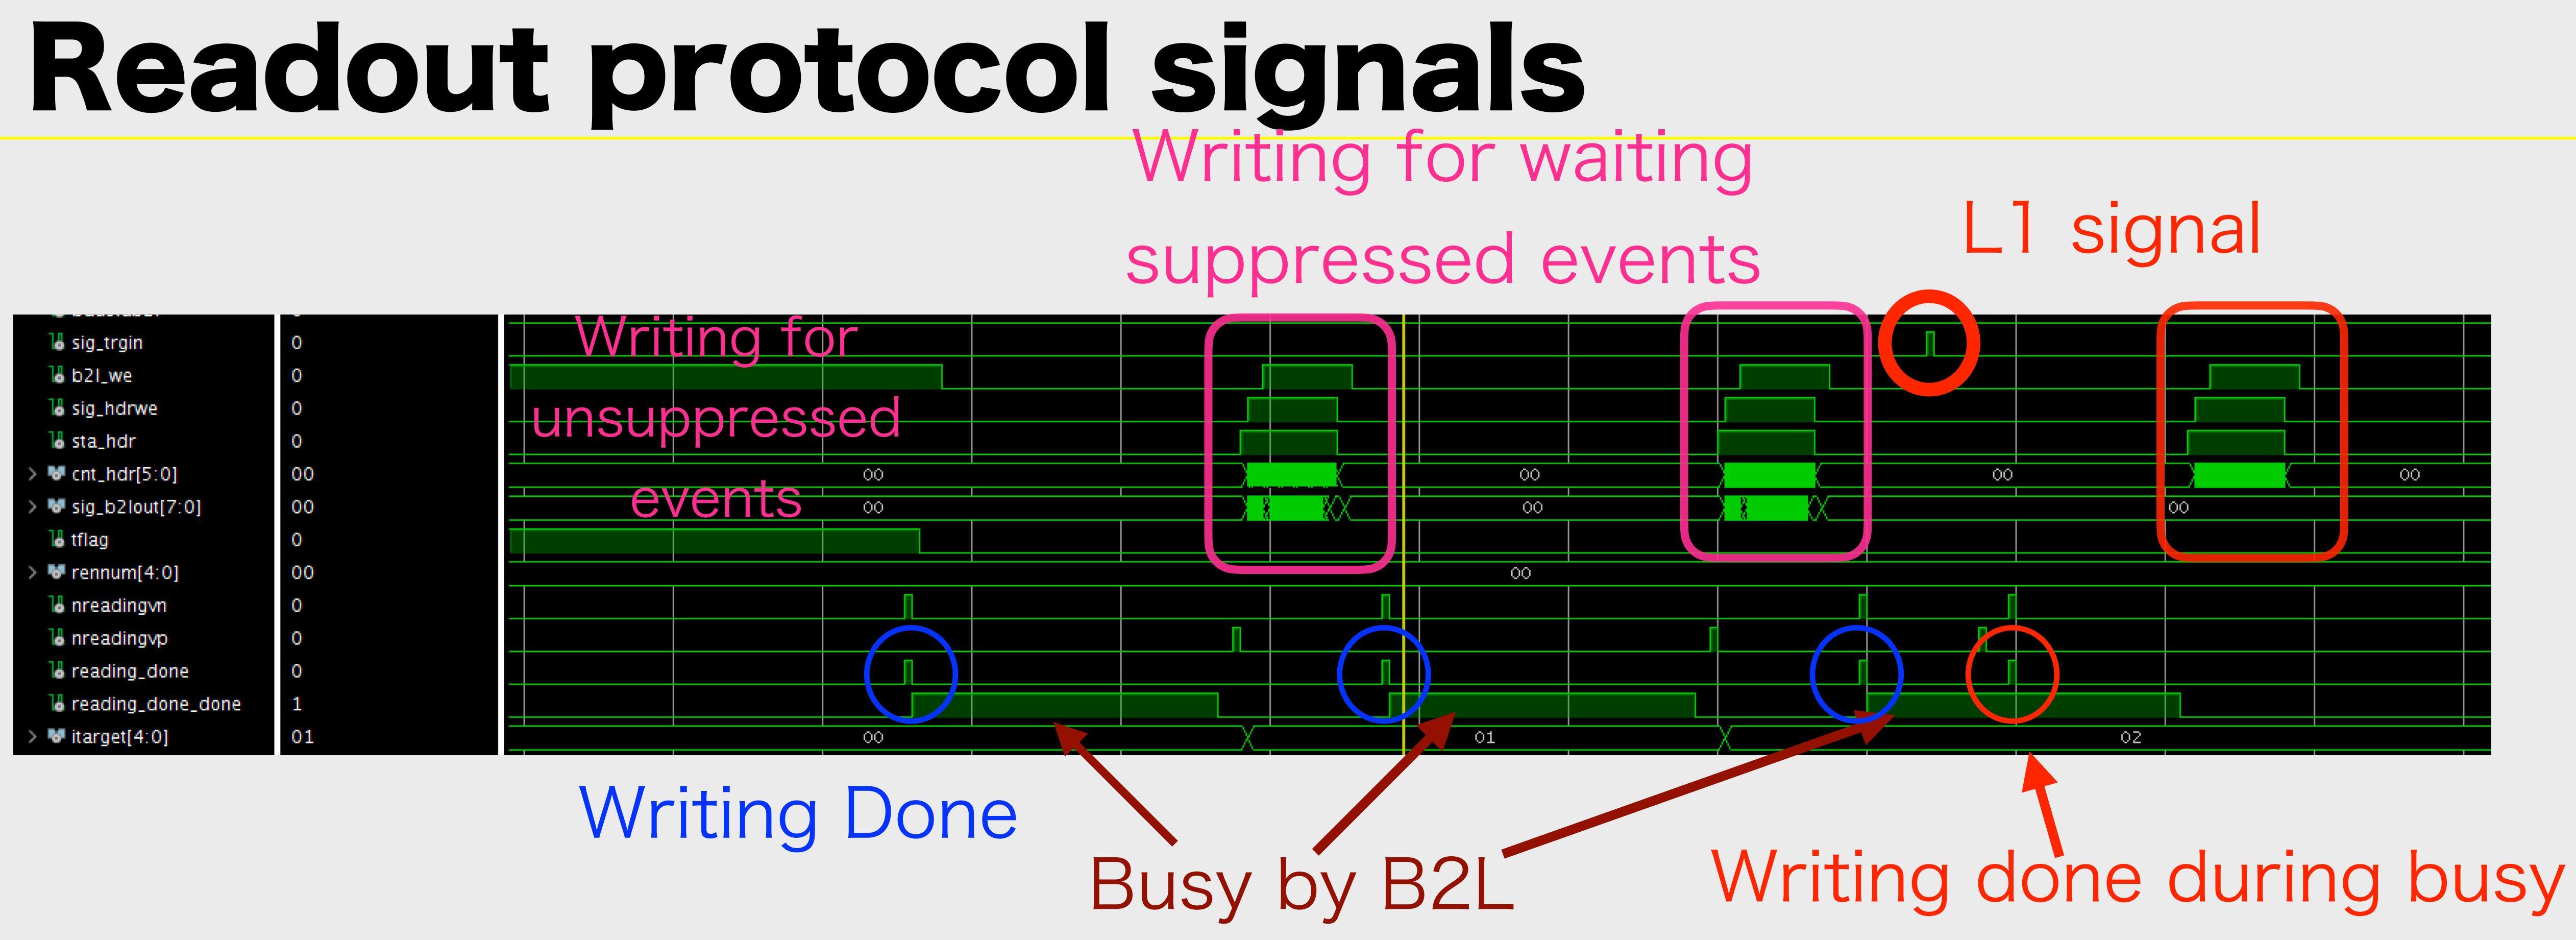
- the missing "start next writing if not busy" condition, the event buffer for the L1 is released.

• When a writing process is done, the next writing can start only after busy signal (150nsec) is negated. • But when the next L1 comes during busy signal for the last event of the waiting queue, because of

- Added on line to Library/libut4\_02/B2L/src/CB/cb\_top\_32MHz.vhd
- Corresponding file for gdl, cb\_top\_32MHz\_gdl.vhd, ok (the line has existed) ullet
- The same file for UT3 ok (the line has existed) •
- Maybe I used very old cb\_top\_32MHz.vhd when I started making UT4 version of B2L. •

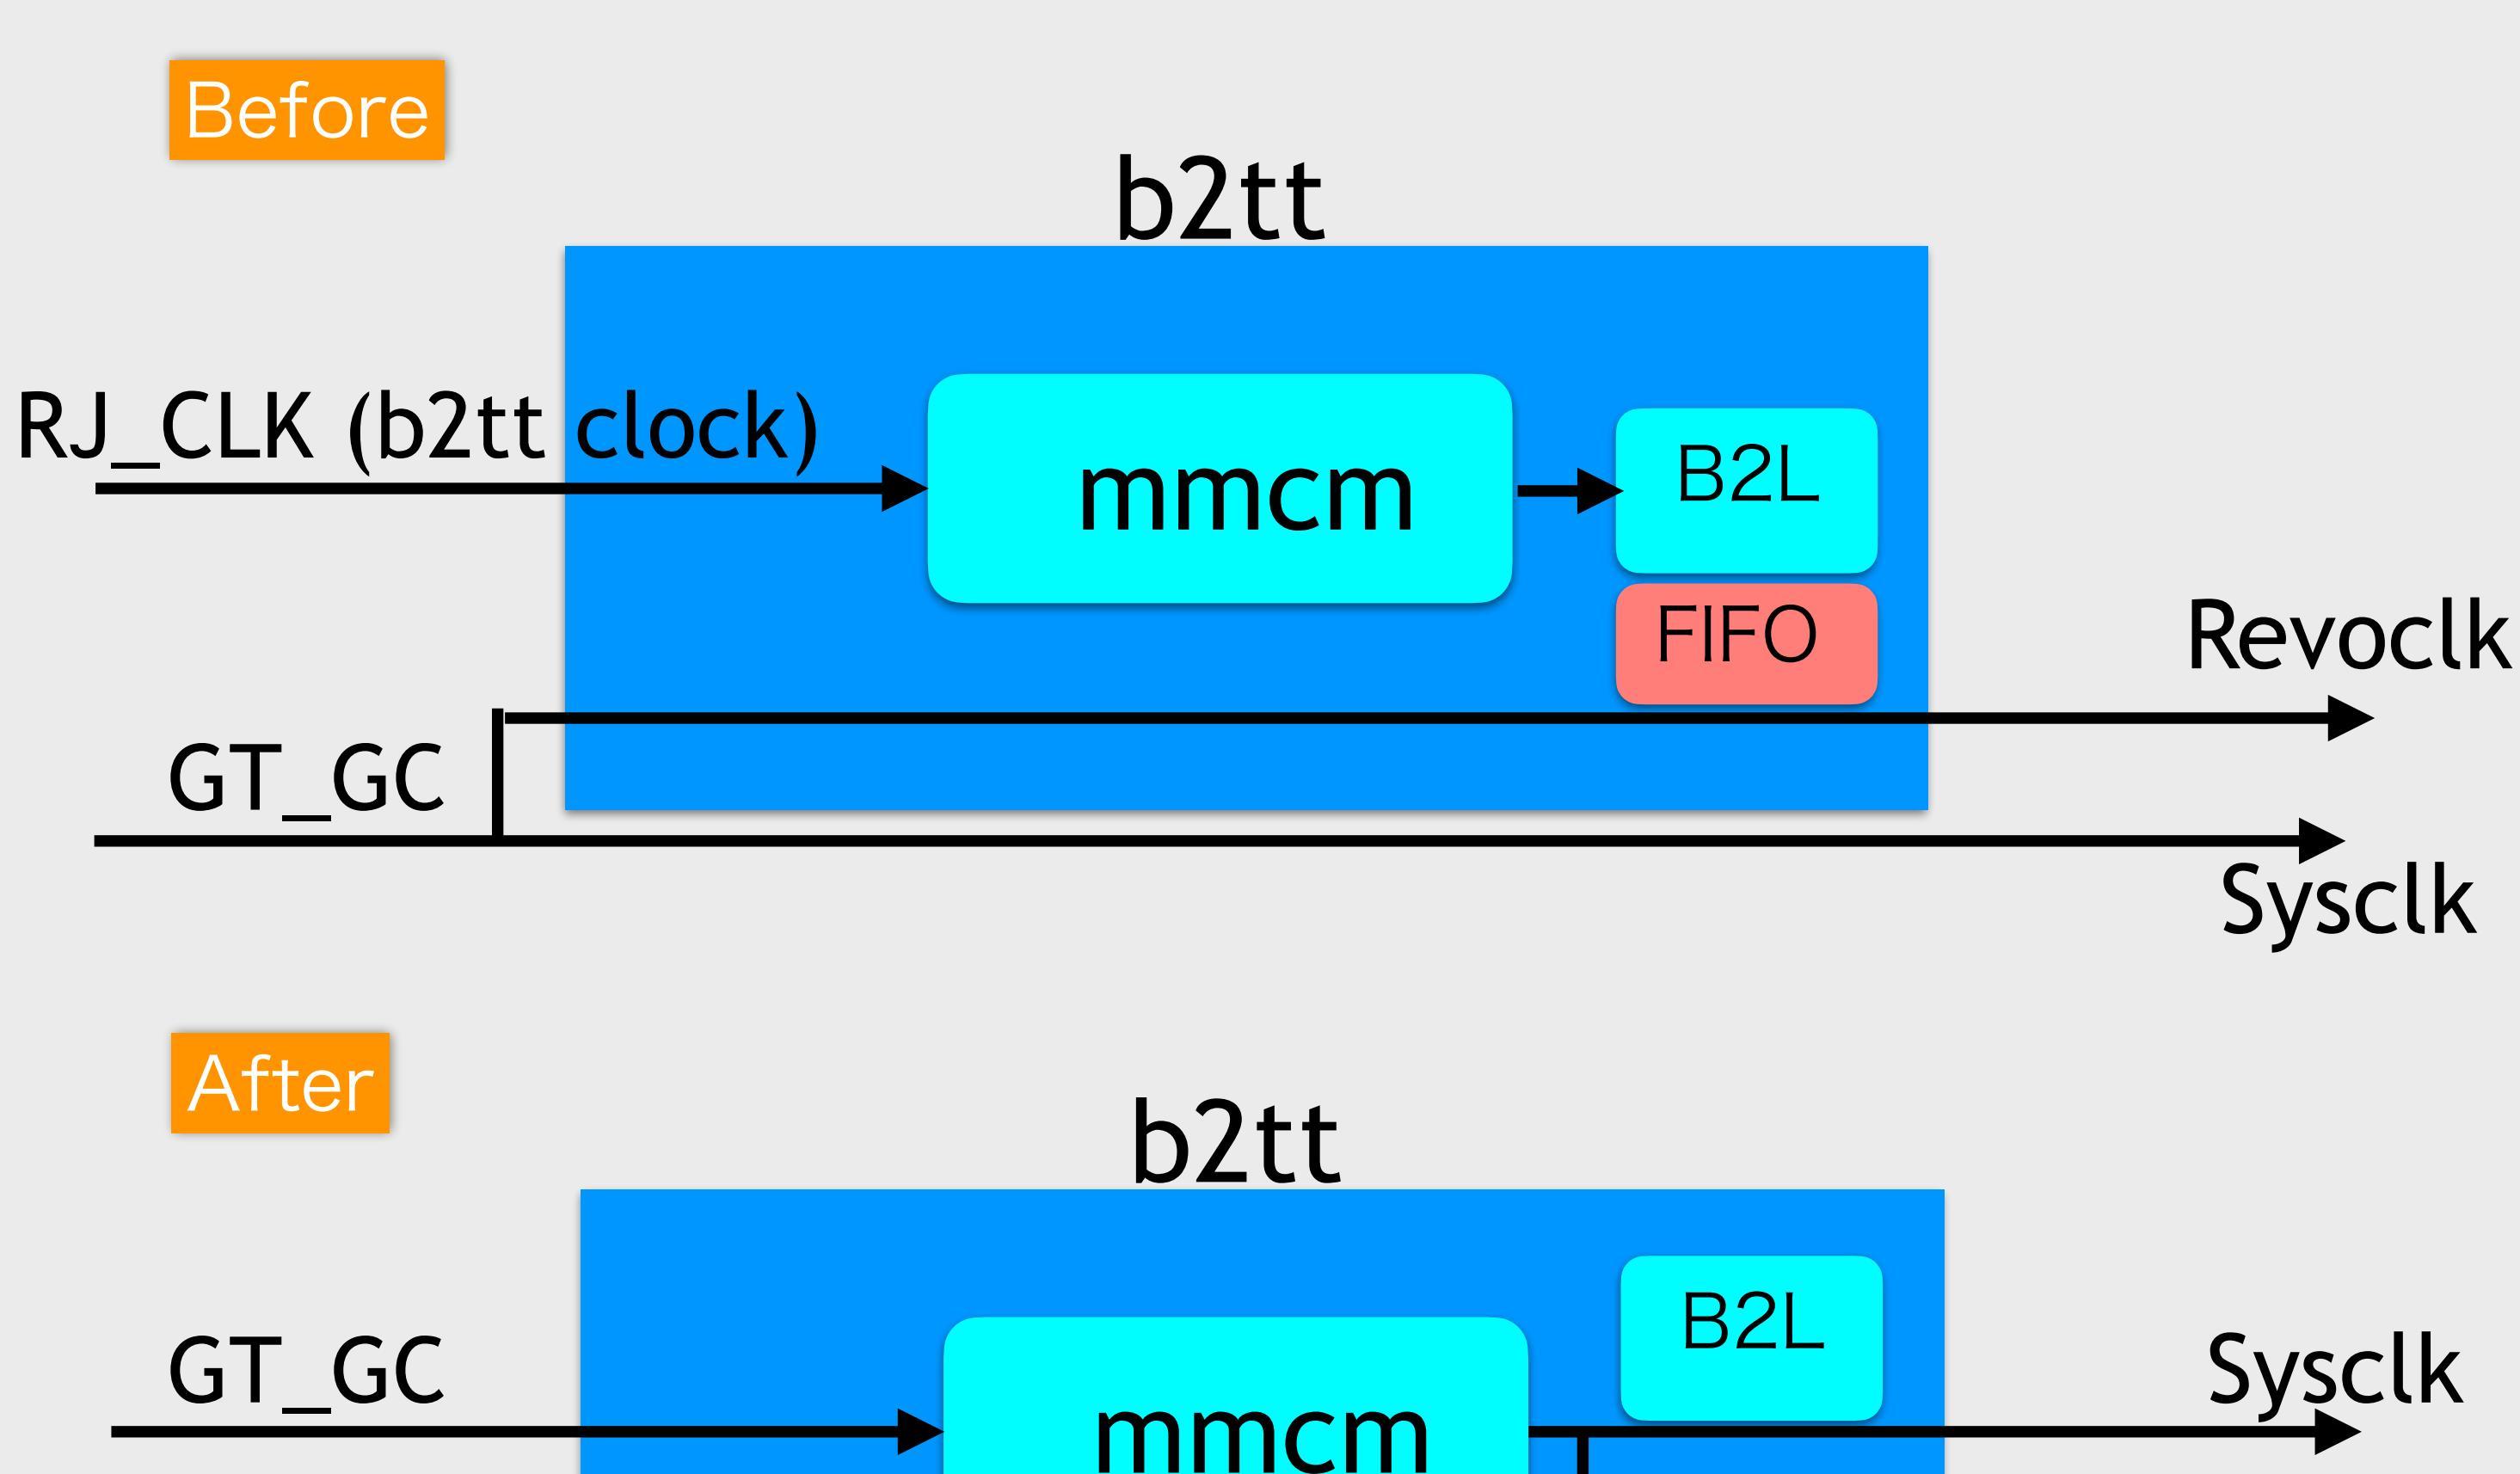
- For CDCTRG modules, different clock sources are used for sysclk and B2L

Unified clock source (GDL, ECLTRG) look stable

- TOP.vhd
  - Sysclk from b2l.clk127m
  - CLKGT?\_GC\_P/N to b2l.rj?clkp/n
- If you are using 254MHz reference clock for CLKGT\_GC, USE254IN=1 in Library/libut4\_02/B2L/src/b2tt/b2tt.vhd
