Cosmic ray run with PCIe40

S. Yamada (KEK)

Run summary of cosmic ray runs on June 9

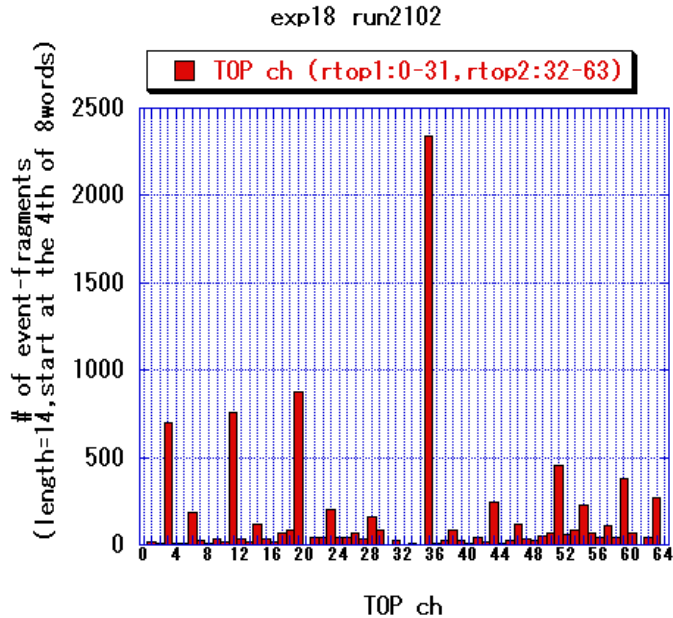
With ver.11.4 (Feb.23) : ff55 error

- Not sure if recorded data of the cosmic test contains the same pattern of an event without the error -> Need to check.
 - I checked four runs but KLM data had no event-fragment with the patter.
 - TOP data had many even-fragments of this patter even before the error occurred.

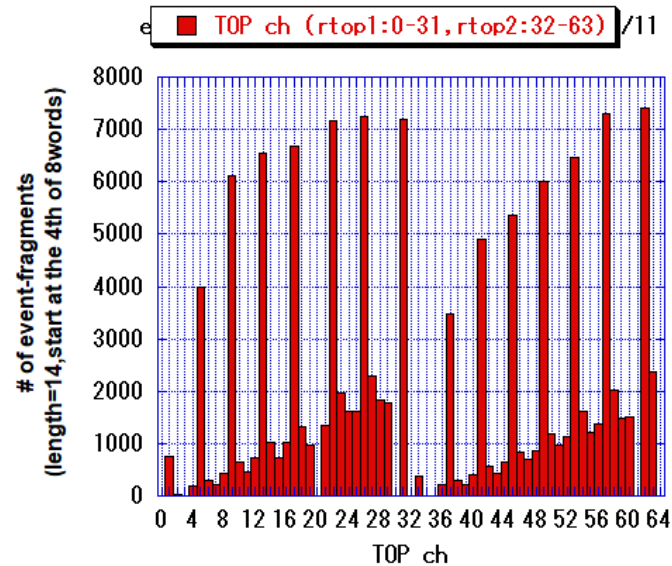
E2768c11d20 (Feb.7) : no erro

Many events without reduction of header and trailer are observed with Feb.7 version.

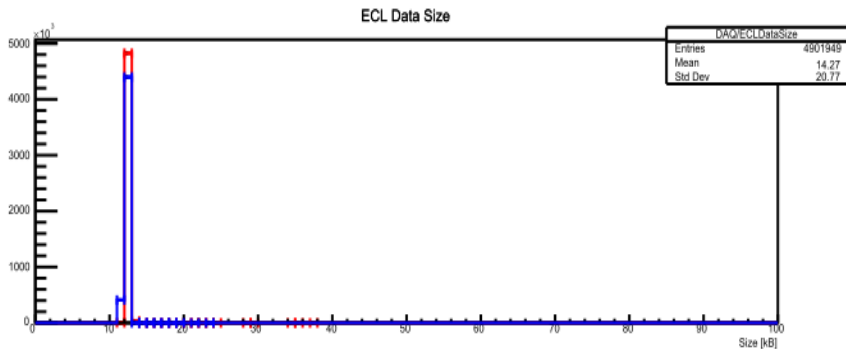
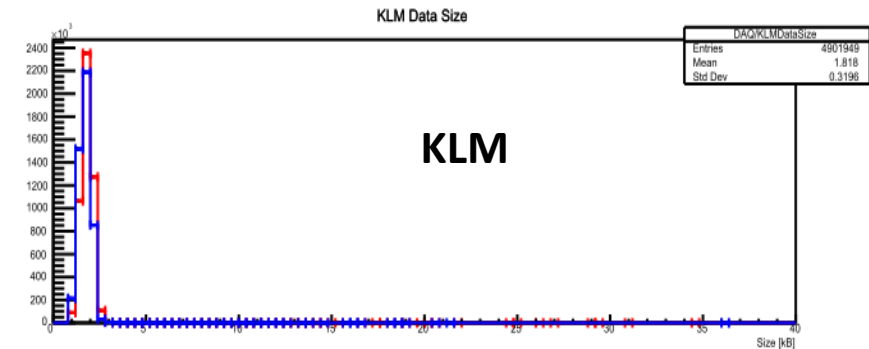
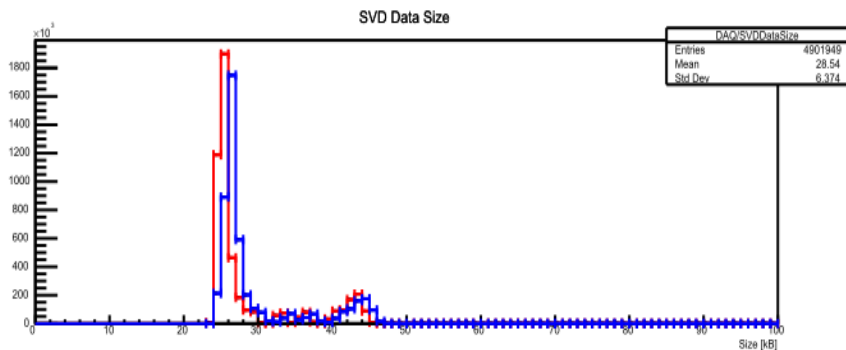
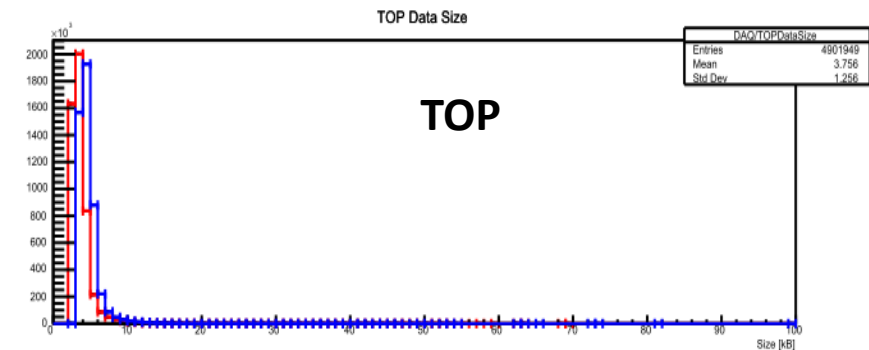
Red : run2114 : 05-02-10 (All : COPPER)
Blue : run2103 : BII-7732 (TOP+KLM :PCle40)

- Event size is different for SVD, KLM and TOP
- I was asked to unpack a same run with different basf2 version and see if the output is different.
