Investigation CDC b2llost / b2lerror via IBERT

Qi-Dong ZHOU (KEK)

DAQ TROUBLE BUSTERS SESSION TRG/DAQ Workshop 2019, Yonsei University, 26-29 Aug. 2019

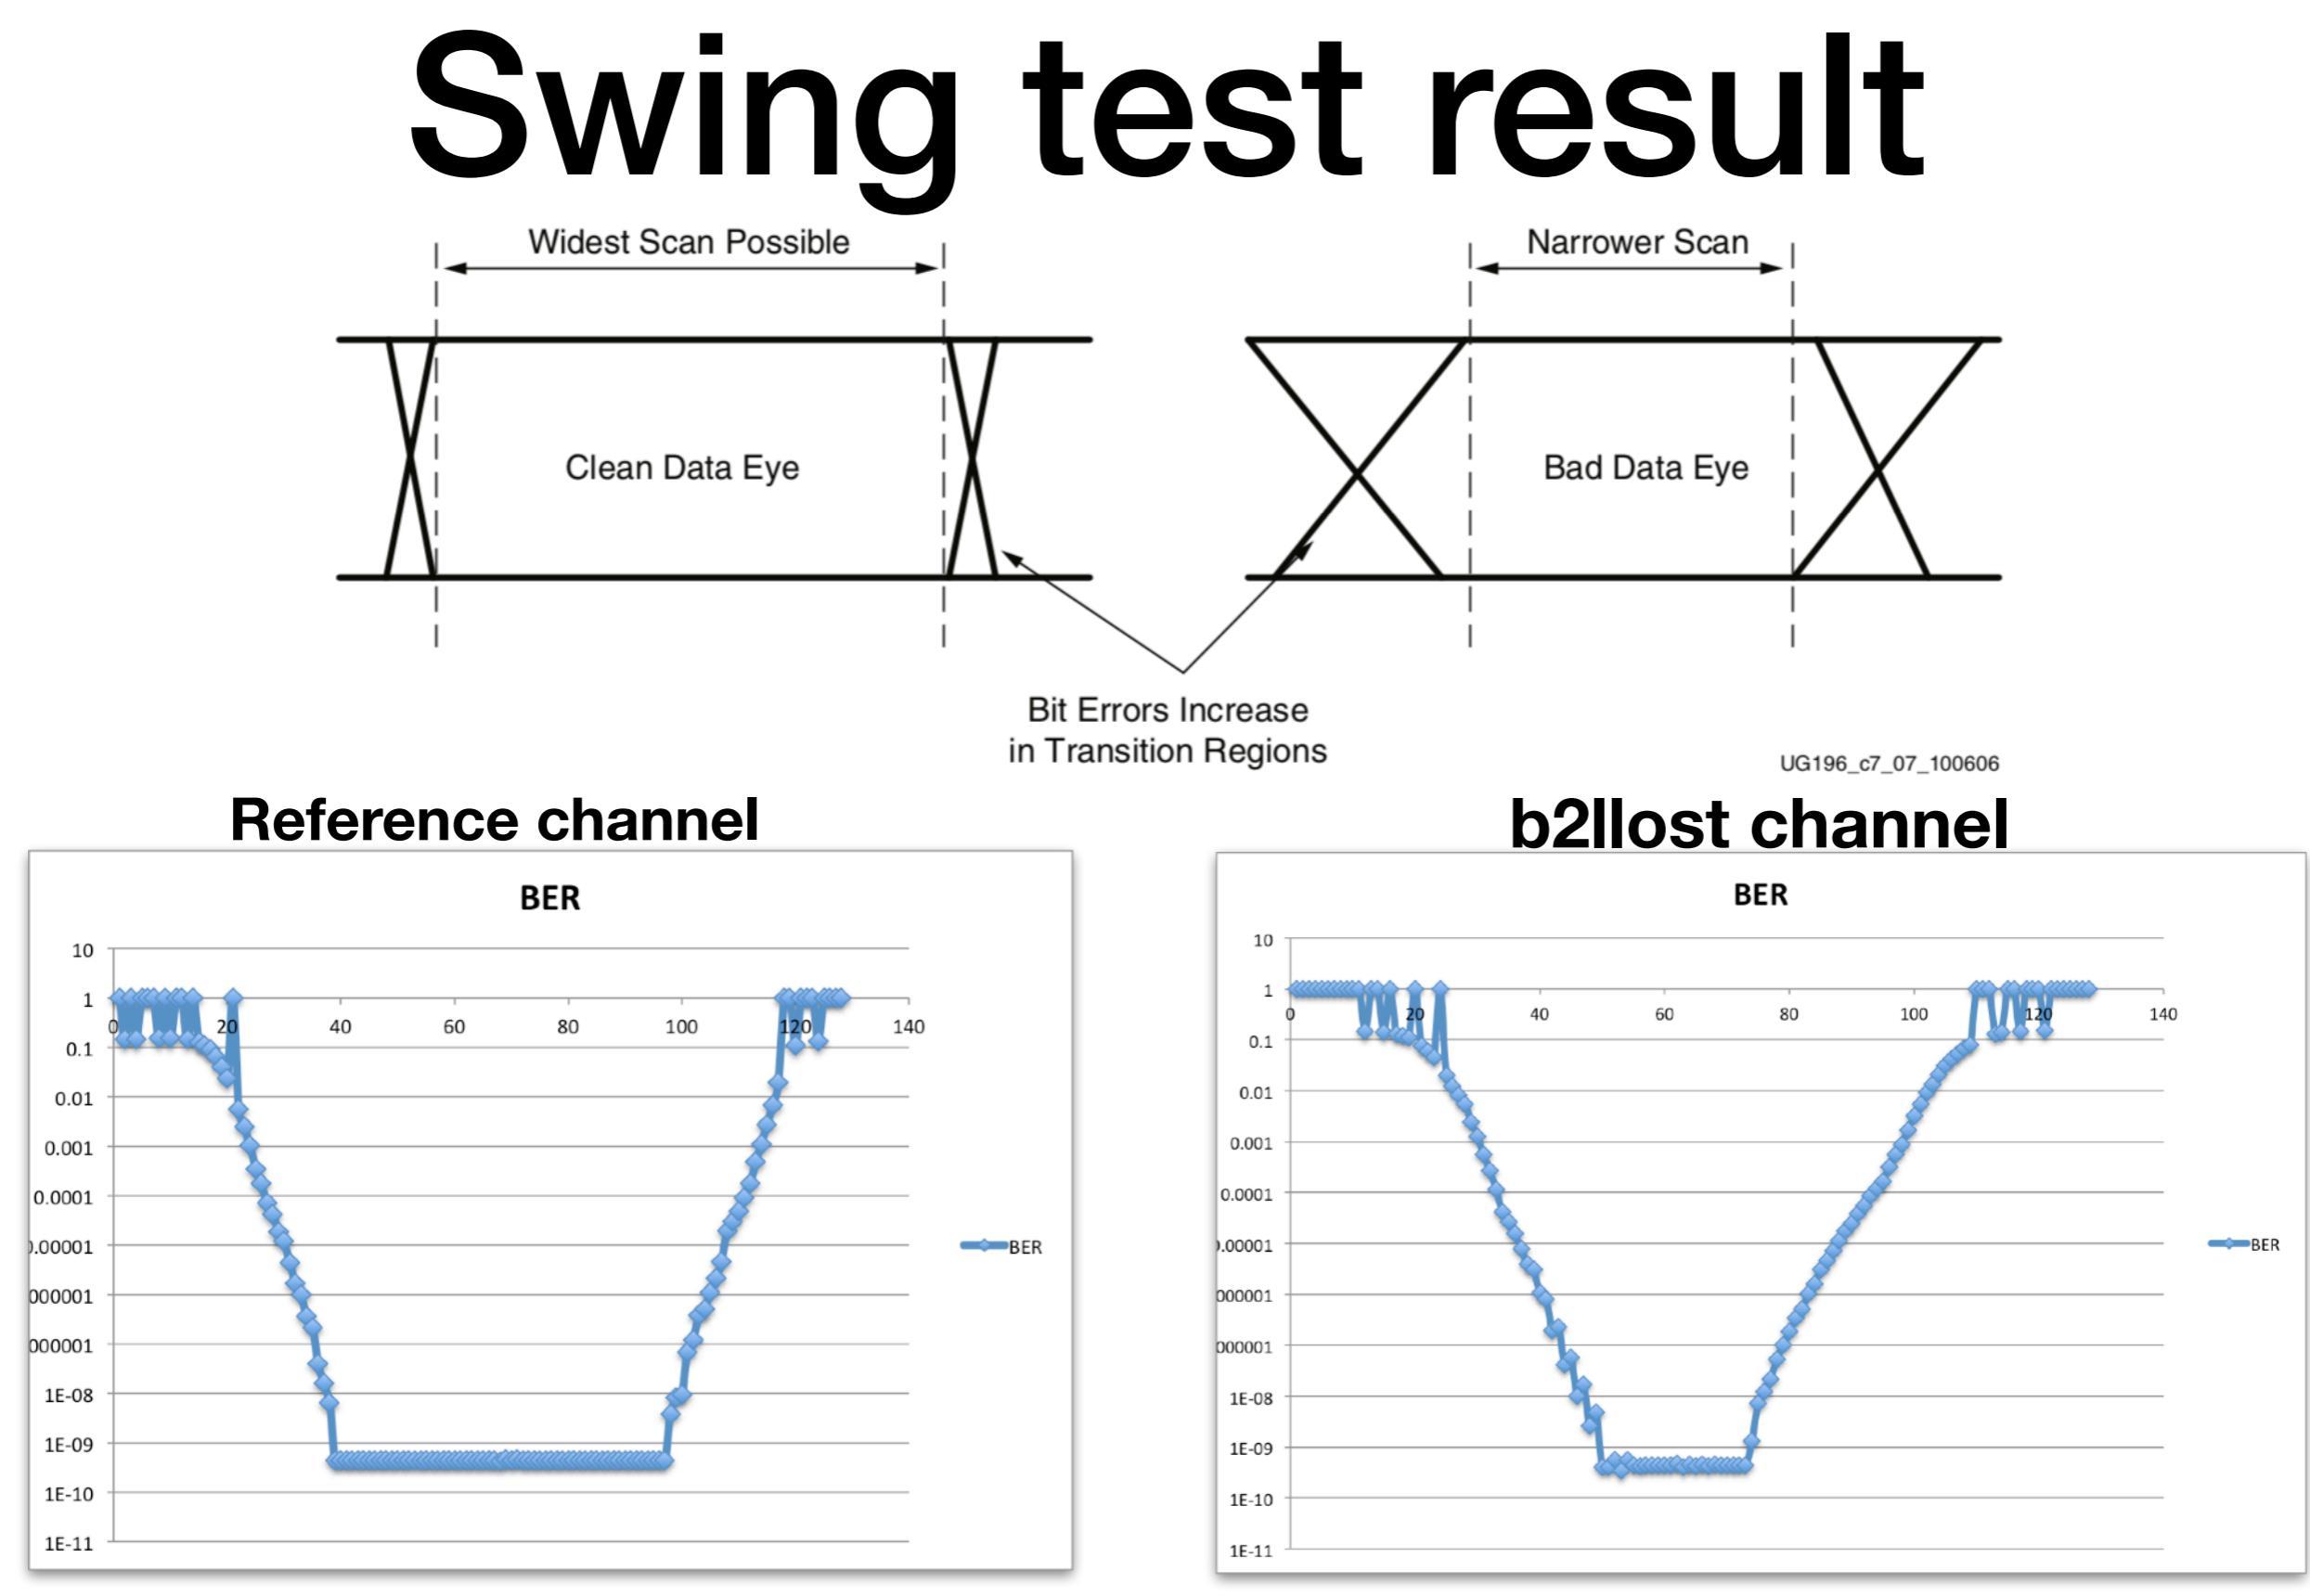
- The b2llost links show bad eye diagram, while the b2lerror links show normal eye diagram.
- By swapping the fiber on HSLB side, RX of fiber data transmission on the HSLB is working well.

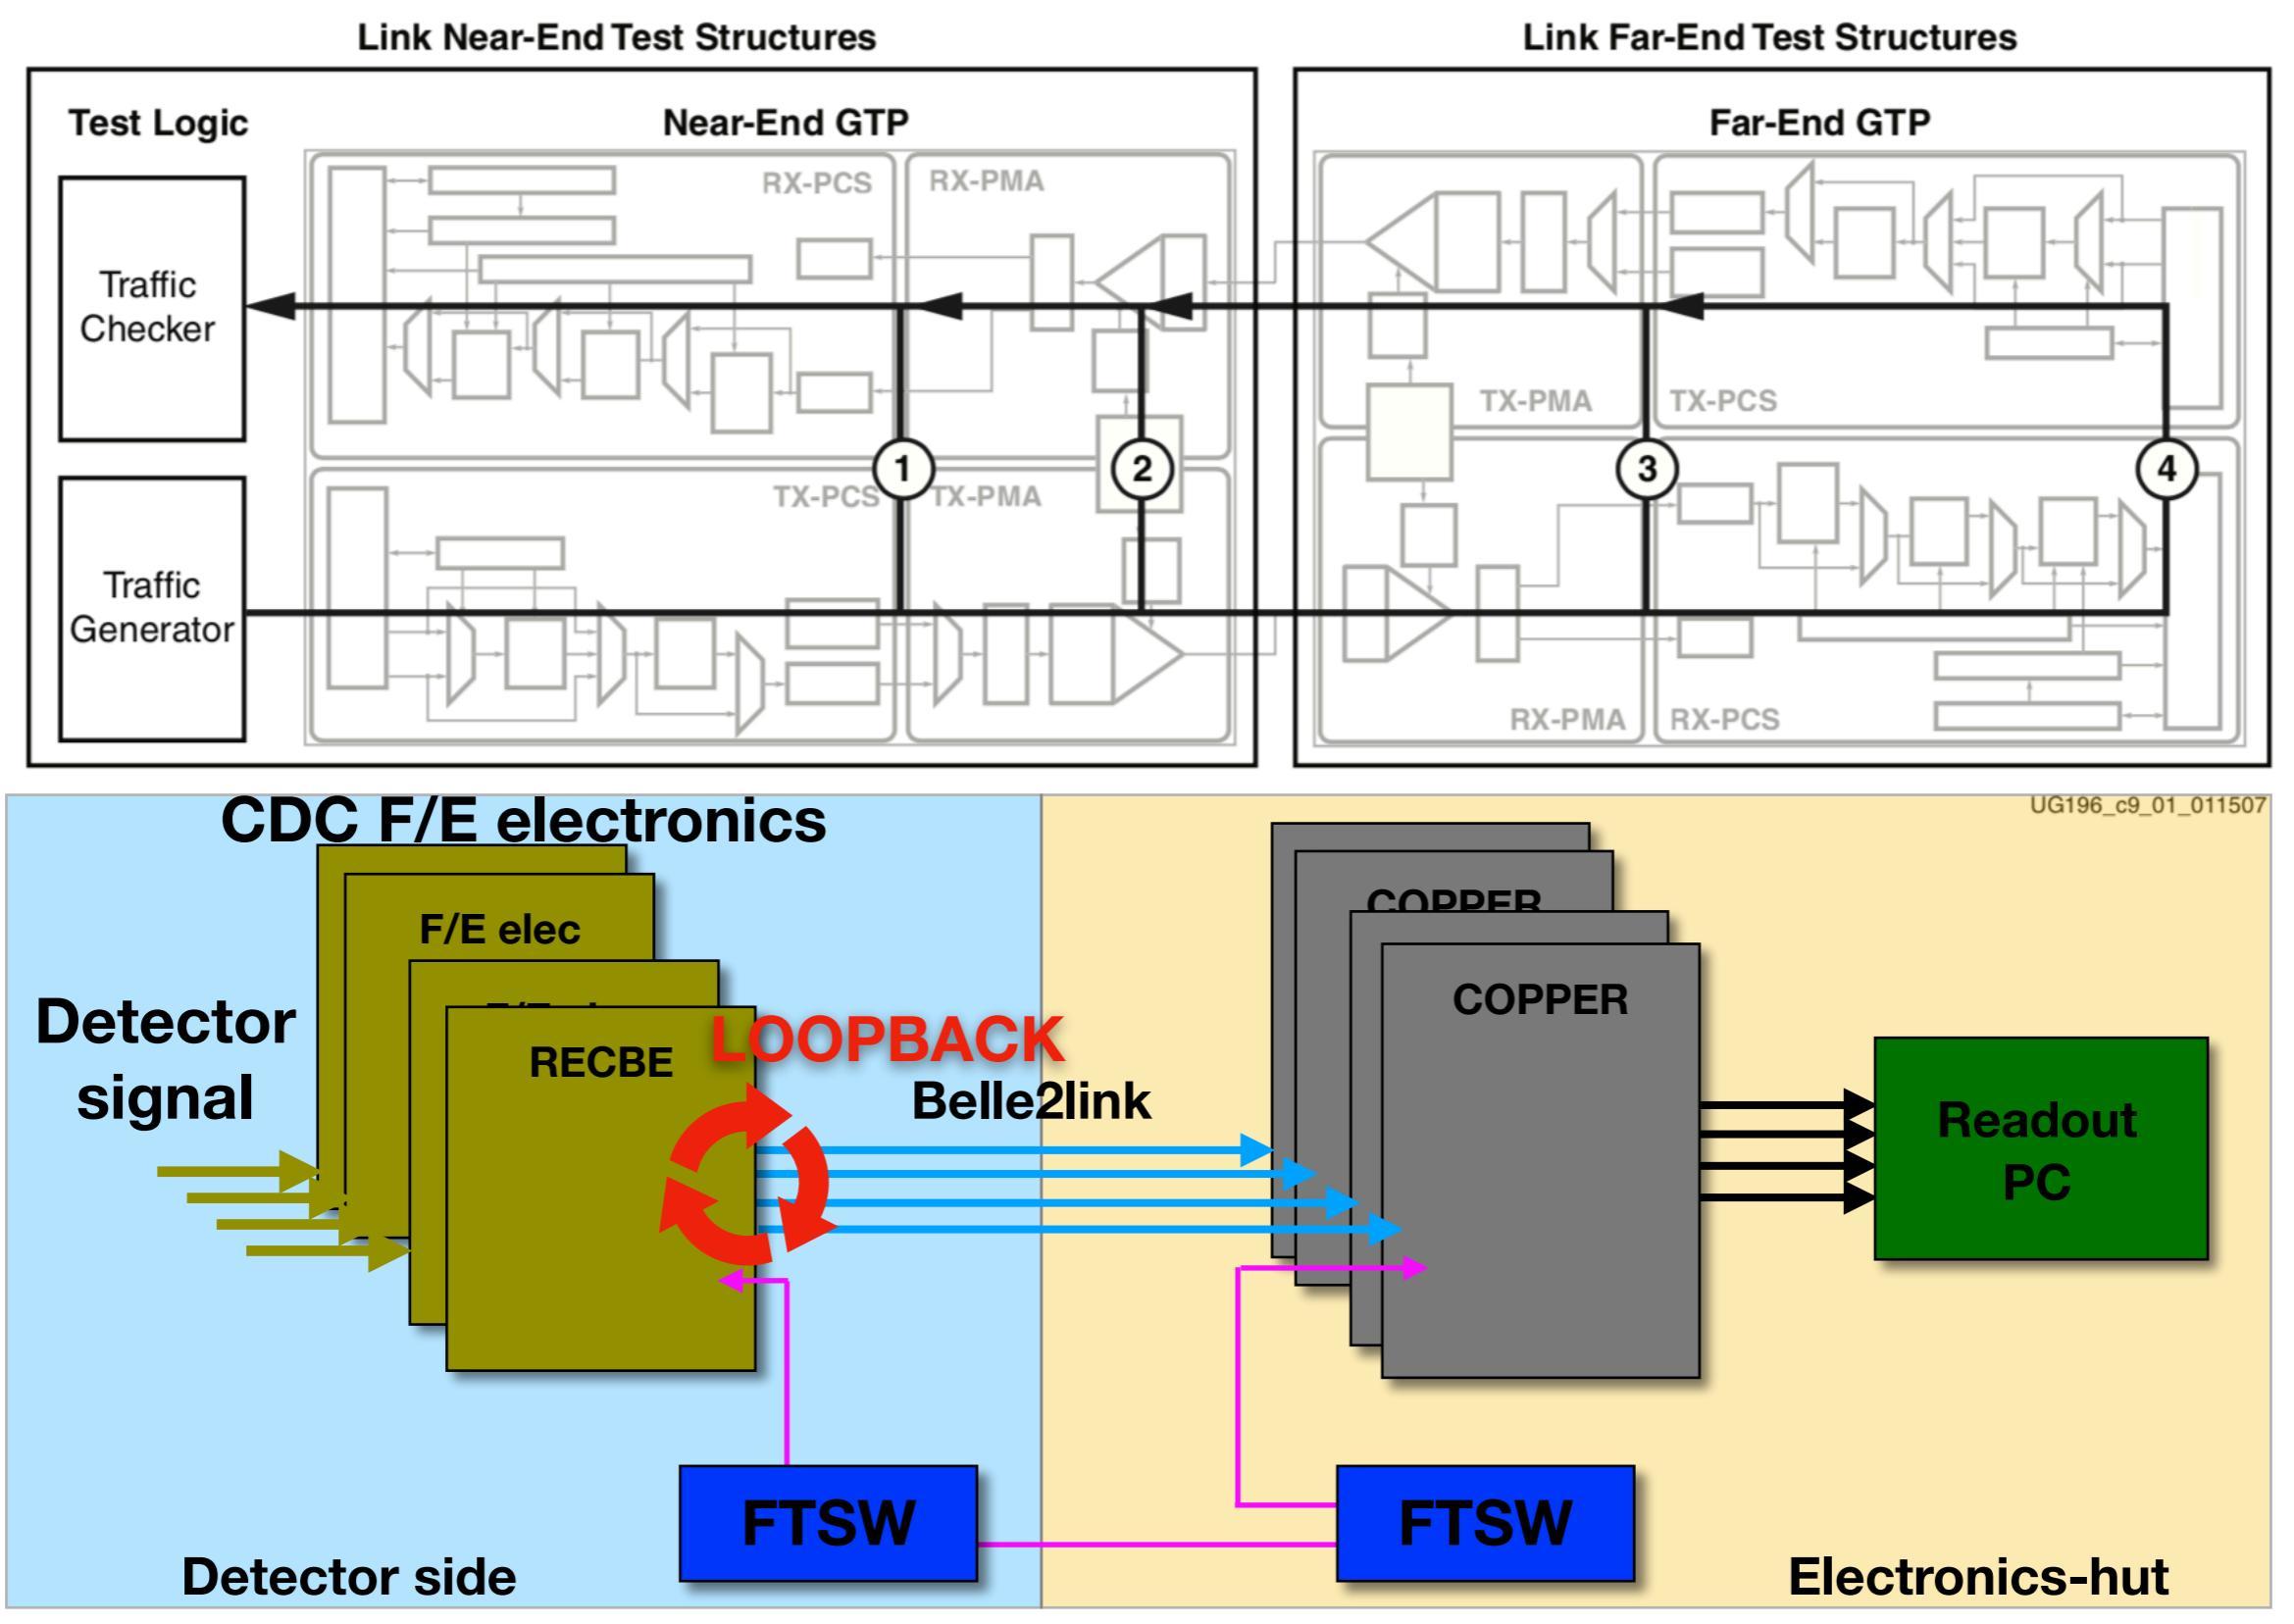
Specify the issue

Using loopback function at different can specify the problem is related to FPGA or optical fibre
