PXD Power Supply - Over Voltage Protection (OVP) Studies

Belle II Germany Meeting 2023

September 26, 2023

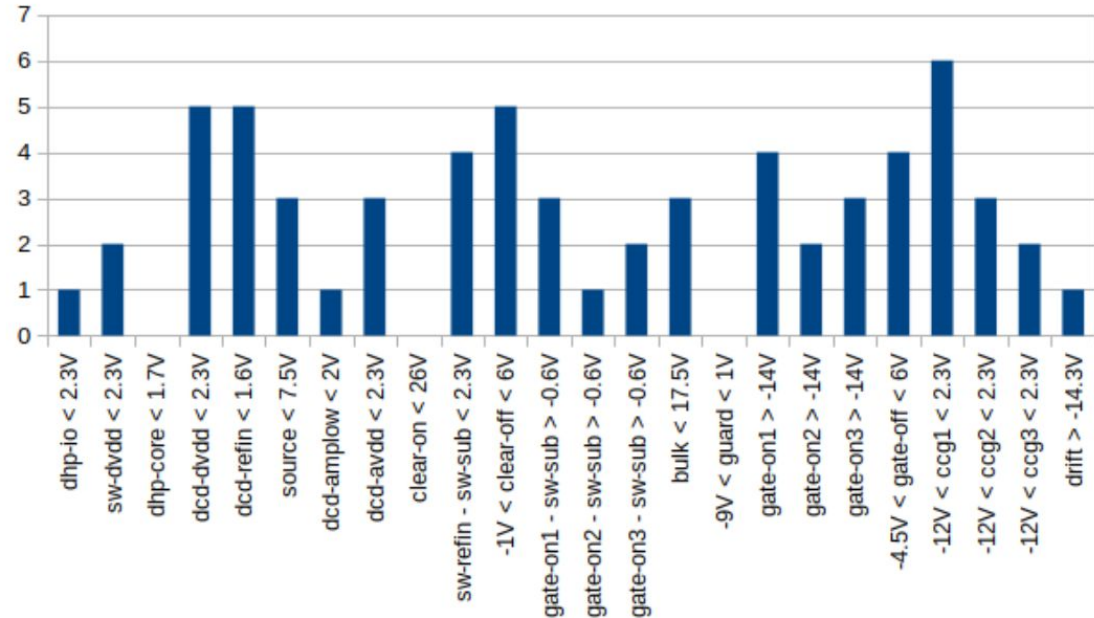
OVP/Trip by Channel in 2021abc

- OVP events (“**HV Trip**”) rate increased in spring 2021 (beam currents were increased)
- Rate approx. 0.5-1 per day
 - Rises with increasing luminosity
- Talks by Björn Spruck:
 - PXD HV “Trips” Issues By Over-Voltage-Protection ([link](#))
 - Update on PXD HV “Trips” Issues By Over-Voltage-Protection ([link](#))

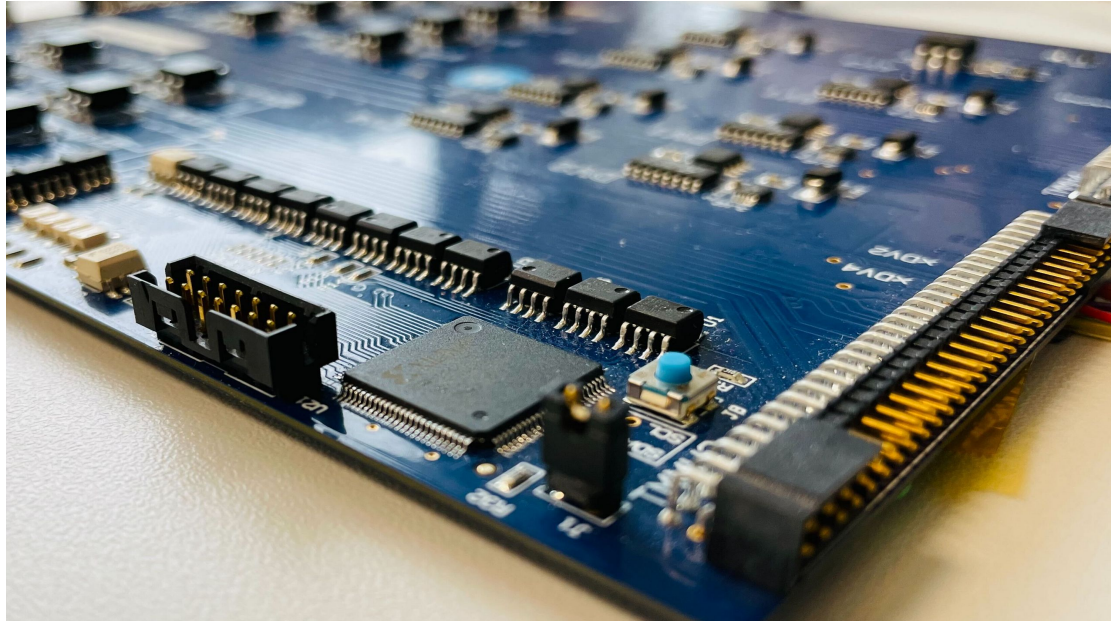
CPLD on the OVP board

- **Observation:** OVP events occur even when voltage regulators are switched off
- Effect of radiation on the logic can cause triggering of OVP events
- **Single Event Upsets (SEUs)** can trigger an OVP event
- Vulnerable to these events: Control logic implemented in the **Complex Programmable Logic Device (CPLD)**

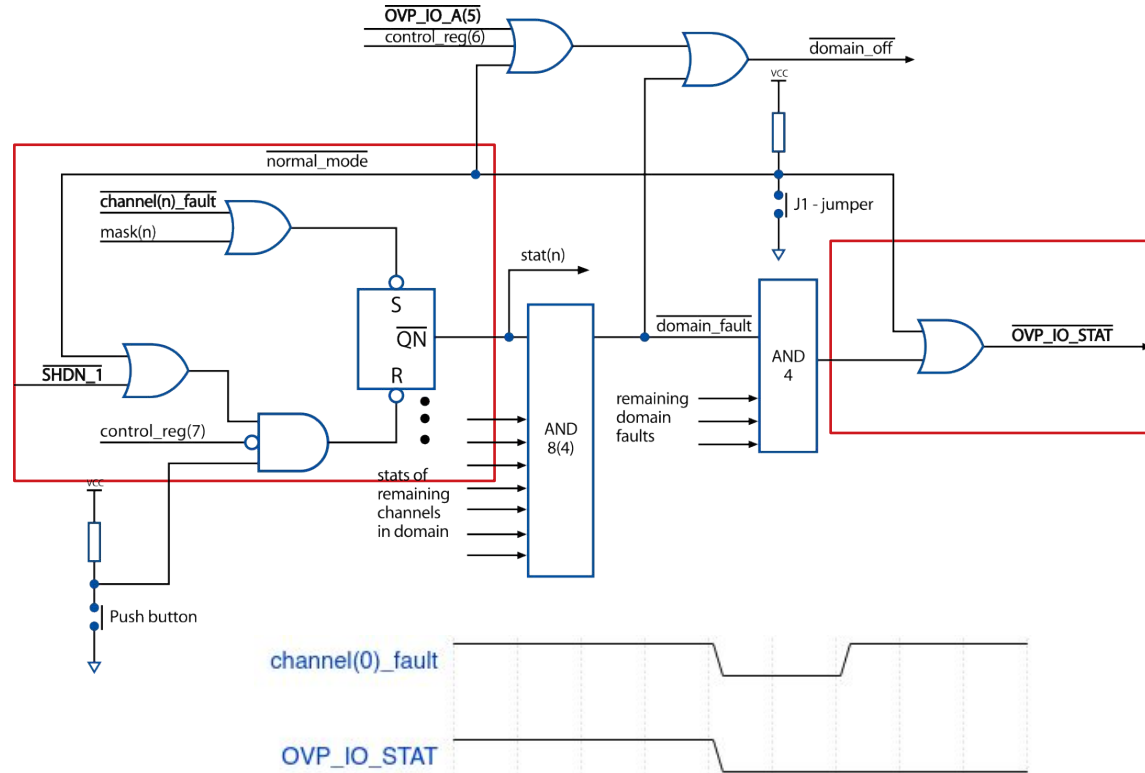
- Control logic in the CPLD:
 1. After detecting an error condition in a channel, **channel(n)_fault** is received
 2. The signal is fed into an asynchronous latch (set S)
 3. A general fault signal is sent: **OVP_IO_STAT**
 4. An “emergency off” is issued

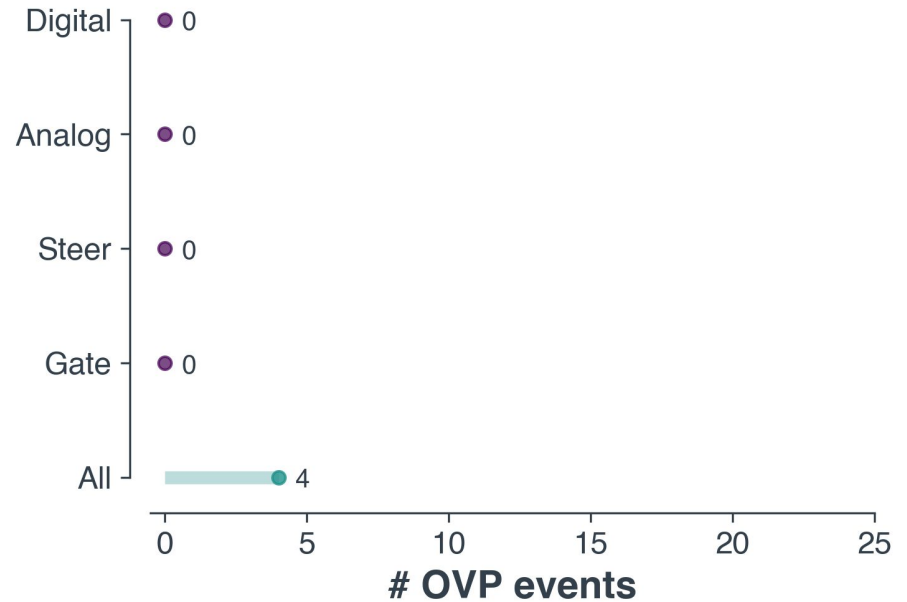
OVP new firmware - Neutron source

Note: Information about which channel triggered only implemented after this test

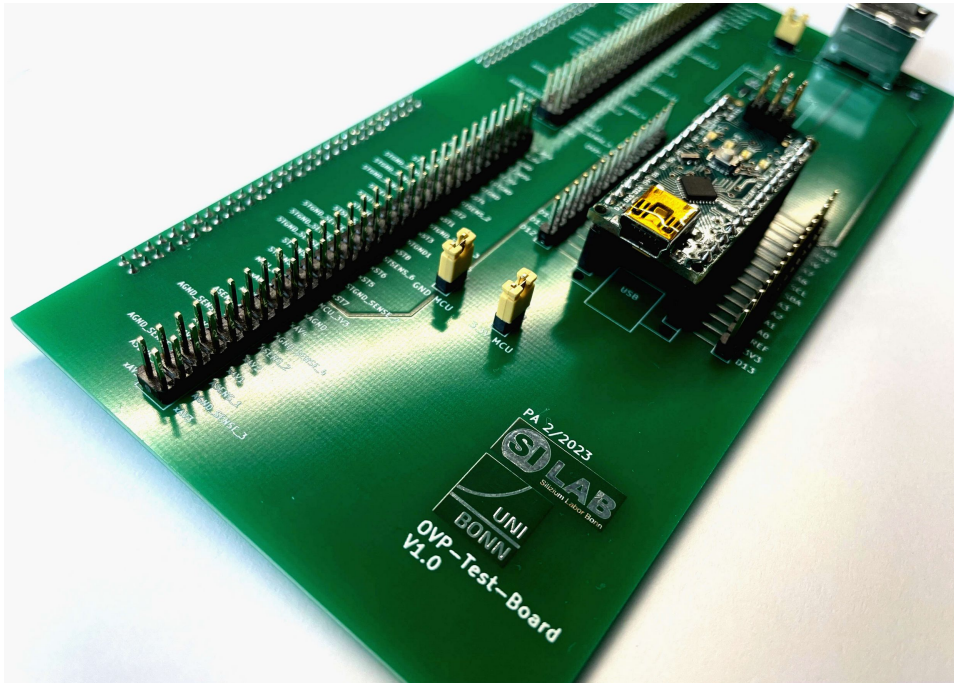
- Simulation and measurements show desired reduction of SEU triggered OVP events
 - Reduction by factor of 6
- Tests of the OVP board installed in the PXD-PS show the functionality of the new firmware
- Flashed new OVP firmware to all (but one) PSs at KEK
