# The New and Complete Belle II DEPFET Pixel Detector: Commissioning and Previous Operational Experience

Jannes Schmitz on behalf of the PXD collaboration

Belle II Germany Meeting

Bonn, September 9, 2025

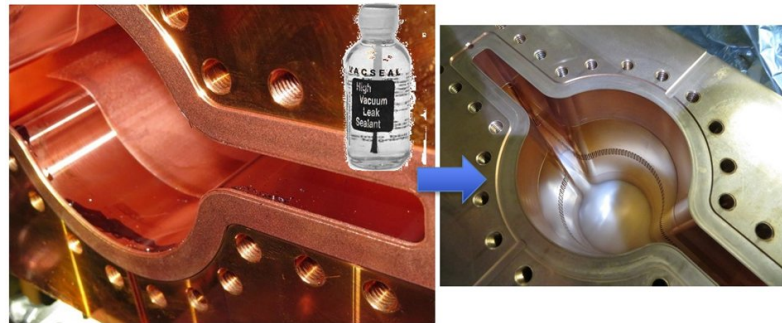
- One bellows chamber exchanged on 6<sup>th</sup> Nov. 2024
- Before (Oct 9<sup>th</sup> – Nov 6<sup>th</sup>) : 0.141 SBL / beam dose(1/Ah)
- After (Nov 6<sup>th</sup> – Dec 27<sup>th</sup>) : 0.043 SBL / beam dose (1/Ah)
- No SBLs with pressure burst in this section after replacement

Number of beam abort accompanied by pressure burst at D10\_L02

- One bellows chamber exchanged on 6<sup>th</sup> Nov. 2024
- Before (Oct 9<sup>th</sup> – Nov 6<sup>th</sup>) : 0.141 SBL / beam dose(1/Ah)
- After (Nov 6<sup>th</sup> – Dec 27<sup>th</sup>) : 0.043 SBL / beam dose (1/Ah)
- No SBLs with pressure burst in this section after replacement

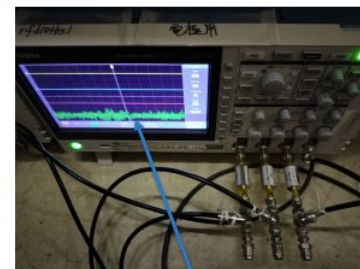
- New sensors, improved signal transmission  
→ Faster and earlier detection of SBLs
- Plan : Include signals into PXD interlock  
→ Lower threshold to put PXD into safe OFF state
- Candidate : Signal in clearing electrode
  - Signal detected close to area where pressure burst occurred
  - Strong correlation with SBLs
- Cable routing started (amplification and integration still TBD)
- To benefit from faster detection, we must minimize PXD shutdown delay

Monitor the signal from the feedthrough

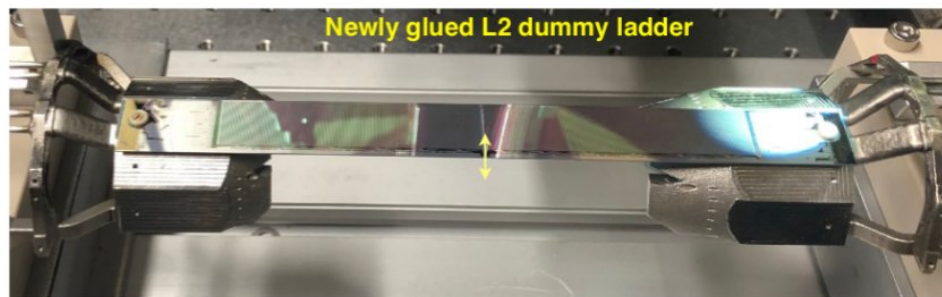
# LADDER BENDING STUDIES AT DESY

Thermal dummy L2 ladder bent with gradually increasing sagitta

- $\sim 4500$  cycles at  $\Delta 0.9$  mm
- $\sim 2500$  cycles at  $\Delta 1.1$  mm
- $>100$  cycles at 1.8 mm  
 $\rightarrow$  ladder developed two kinks

$\rightarrow$  Thermal dummy ladder mechanically different

$\rightarrow$  Both kinks at resistor lines

Repeat with recently glued L2 dummy ladder

L2 glue joint endurance test

After more than two months with more than 90k cycles with sagitta  $>1$ mm  $\rightarrow$  Ladder still intact

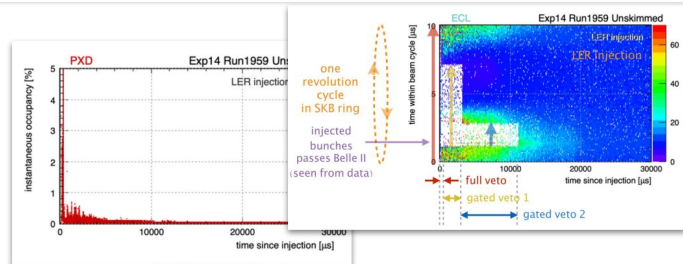
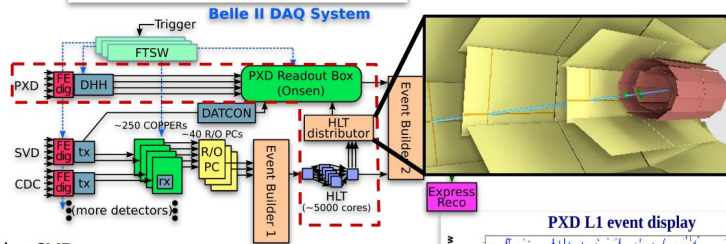
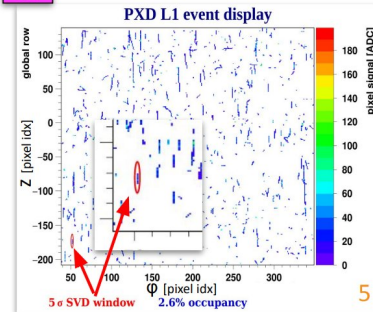
### Track reconstruction and PXD role

- (HLT) **track finding seeded in CDC** ( $p_T > 100$  MeV) or else **SVD**
- **PXD hits** used in offline track fit → **improved vertex resolution**
- Regions of Interest (**ROI**) filtering:
  - HLT: extrapolates tracks to ROIs on PXD for readout to reduce data rate  
not needed yet
- PXD layer one crucial for *impact parameter resolution*
- PXD layer two (will be) important to retain performance at *higher backgrounds*
