CDCTRG labeling work
2023/3/2
T.Koga

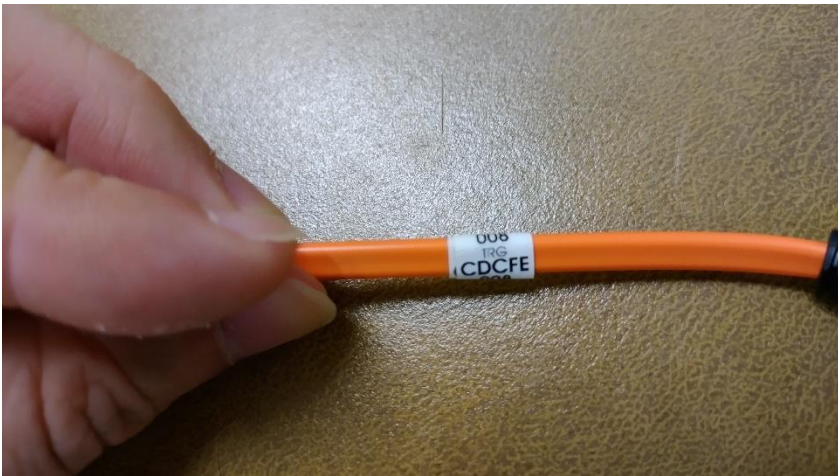
New label

- New labels are made with help of Nakao-san
- the same label used for FTSW<->CDCFE
- Totally $\sim 300(\# \text{CDCFE}) \times 2$ (Ehut and detector side)=**600** labels prepared

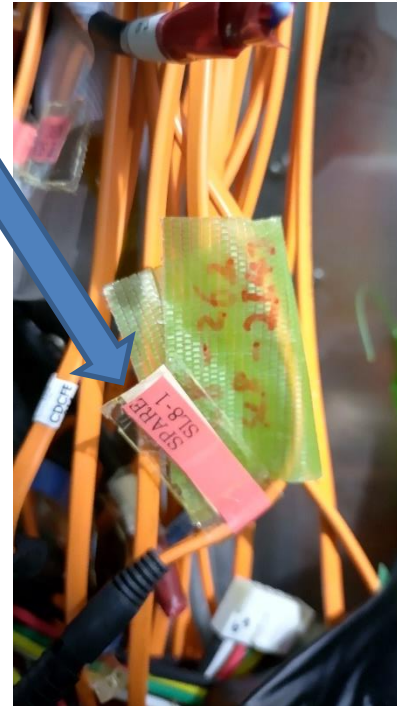
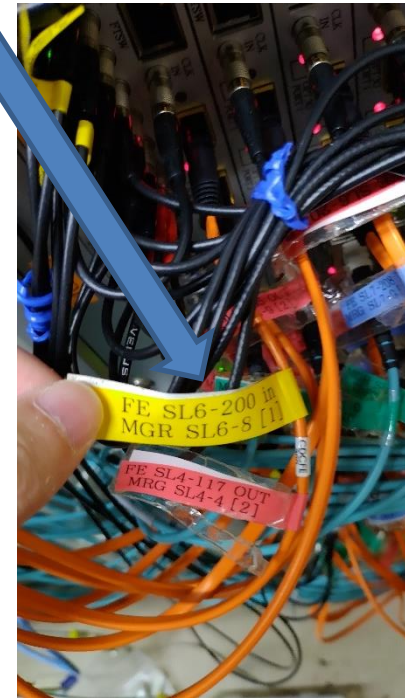
Channel mapping problem

- A few cables have no label or wrong label
- Sellotape label is broken
- exceptional label is sometimes used at Ehut but not at detector.
not consistent with original label.
- Many spare cables have been used

- Need to be careful for the channel mapping
- >Plan to do one-by-one channel mapping check with MGR.
(reboot MGR and check laser light at detector side)
