KLM Bubbler updates

return side bubbler flowrates

Michele, Noah, Sayan, Soeren; 18th October, 2023

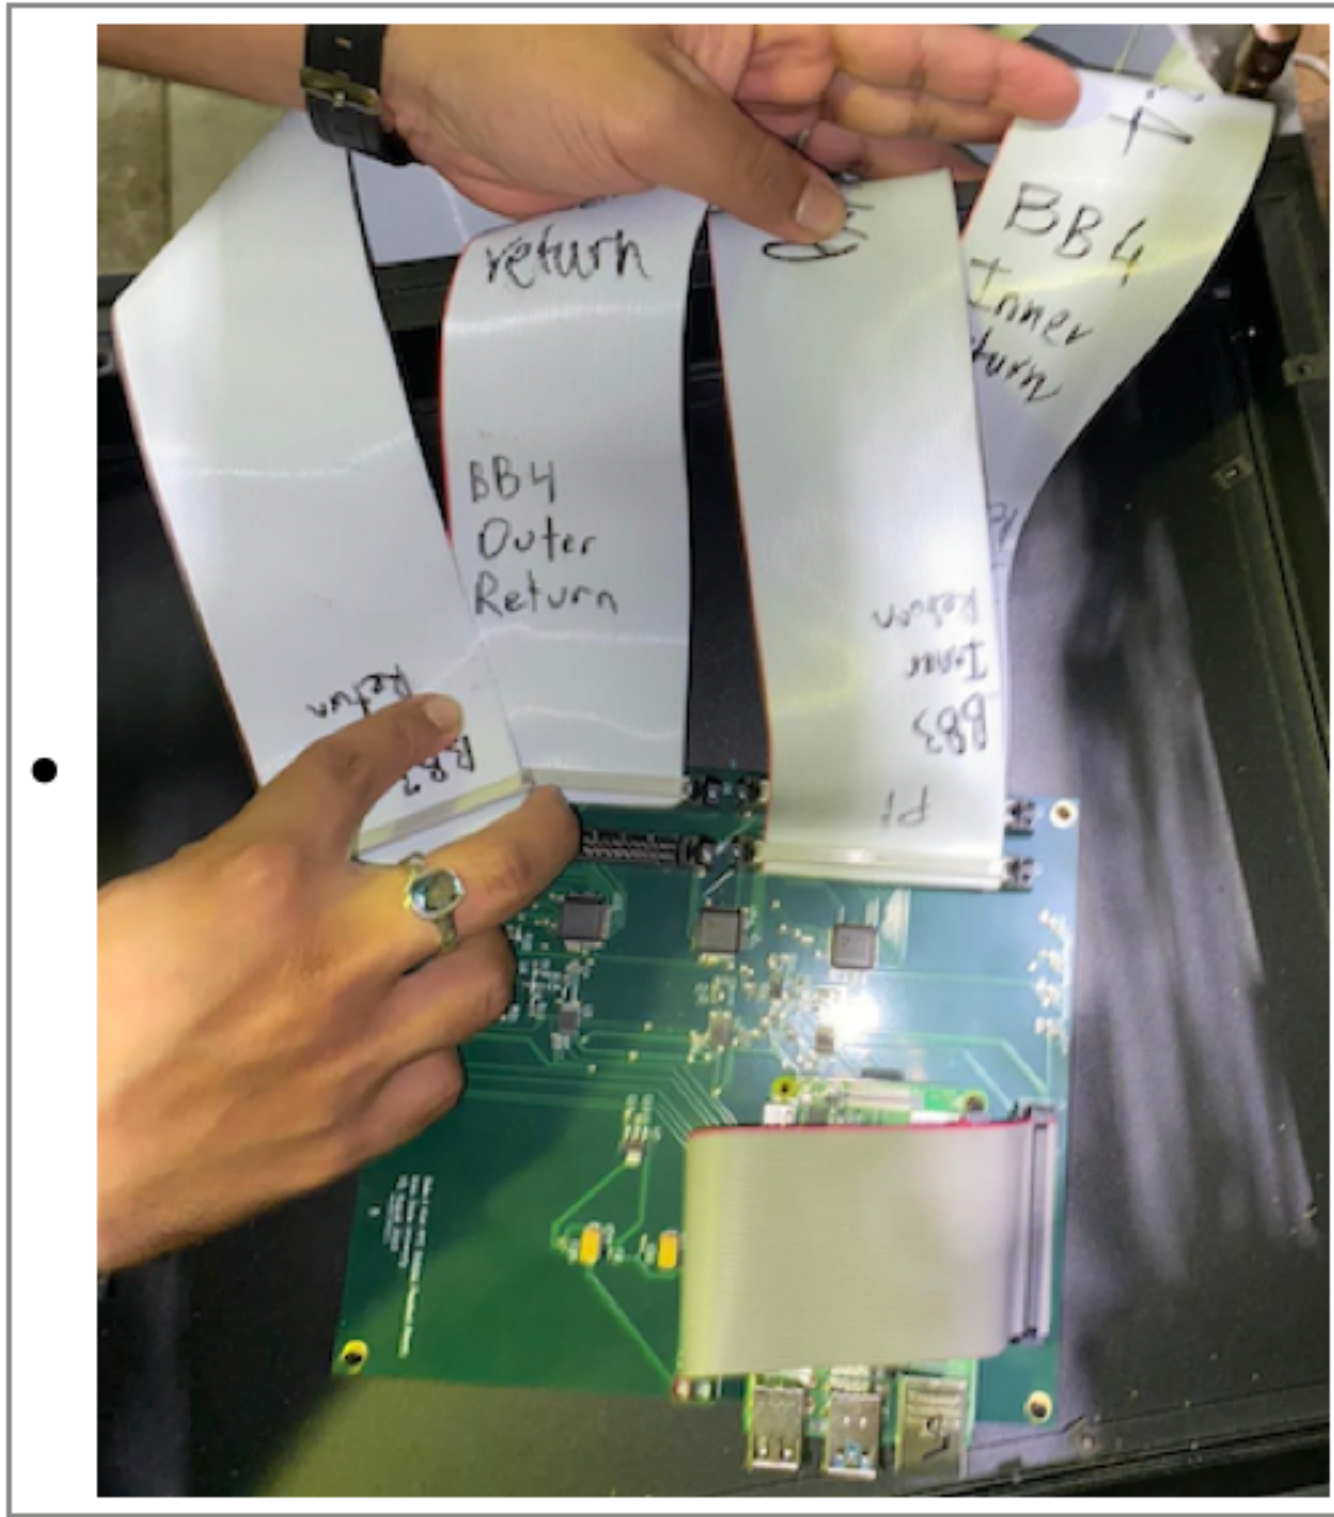
- Plots on indico
- Data from four channels connected to board 5
 - BB3, BB4 return side bubblers conected

0	BB3 Inner Return
1	BB4 Inner Return
3	BB3 outer return
4	BB4 outer return
