# Belle II operation issues and how they have been addressed

Giuliana Rizzo, Katsuro Nakamura  
18 December, 2025  
ARC-BPAC joint review

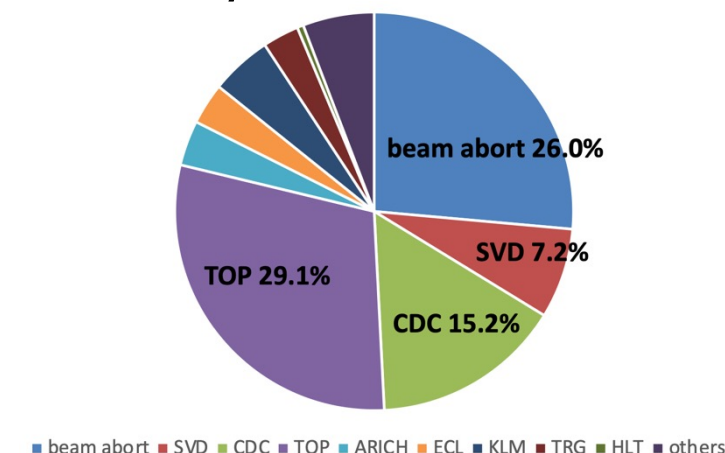
*DAQ stop reason in 2024c*

- Barrel PID (TOP): Frequent b2link errors (b2llost), SEU on Processing System (PS) in front-end
  - CDC: b2tt and b2link errors due to SEU on front-end FPGA
  - Silicon Strip detector (SVD): SEU on front-end ASIC (APV25)
- **Injection trigger-veto deadtime**
  - 5.3% deadtime in overall DAQ running time
  - Larger deadtime under worse injection conditions: injection quality is essential for efficient data taking.
- **Overall data taking efficiency = (DAQ run time – deadtime)/(physics collision time) was 85%, while our target is 90%.**

**Improving these issues was the top priority mission during the 2025 shutdown period.**

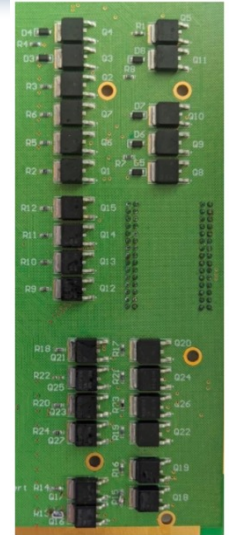
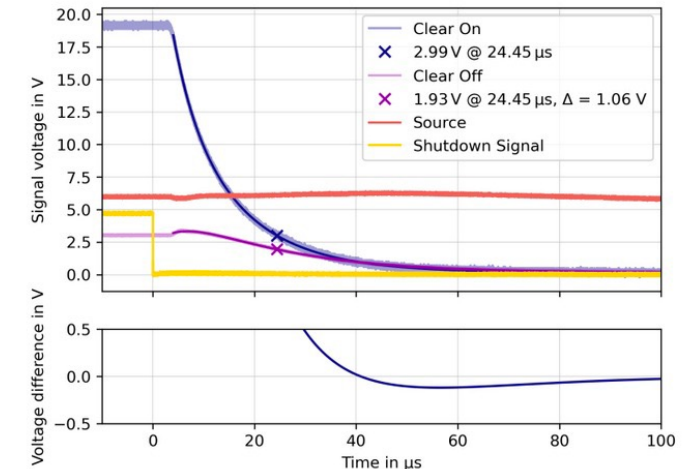
Voltages on module at the fast shutdown

- More details about precursor signal development will be shown by Nakayama-san.
- Developed an active discharge board that rapidly discharges capacitors on power lines through resistors by switching MOSFETs.

- Requires careful optimization of resistor values to realize both safe and rapid shutdown.
- In high-intensity e-beam test at MAMI, we confirmed that the new shutdown function saves the PXD if it receives the signals about 30  $\mu\text{s}$  BEFORE the radiation hit on the PXD.

- Parts procurement is ongoing to start the mass production of the boards, which will be ready in March-April at earliest.

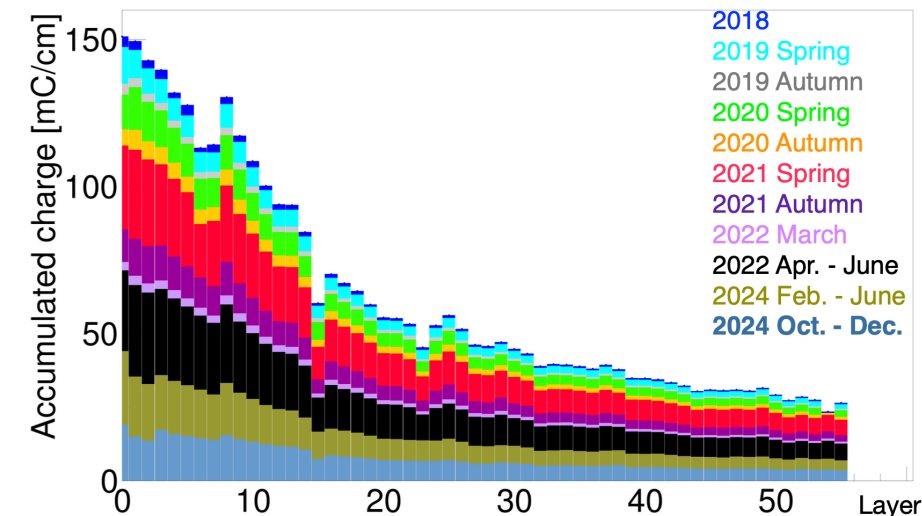
- Integrated charge in CDC reached 150 mC/cm in 2024c.
- 600uA/layer current (expected at  $L=1 \times 10^{35} \text{cm}^{-2} \text{s}^{-1}$ ) corresponds to about 700 mC/cm per year at the innermost layer, assuming 6 months of full CDC operation per year.
- Gain degradation speed for the Belle I CDC was estimated to be about 6% per 1C/cm accumulated charge, but we need to estimate that for the Belle II CDC conditions.

- An initial irradiation at an electron beam in Tohoku University was conducted in November
  - About 350 mC/cm was accumulated. Possible aging effect is now being evaluated.
- New test in spring 2026 to increase accumulated charge.
- Now exploring additional test also at Gif++ at CERN with the DRD1 collaboration for faster charge accumulation.

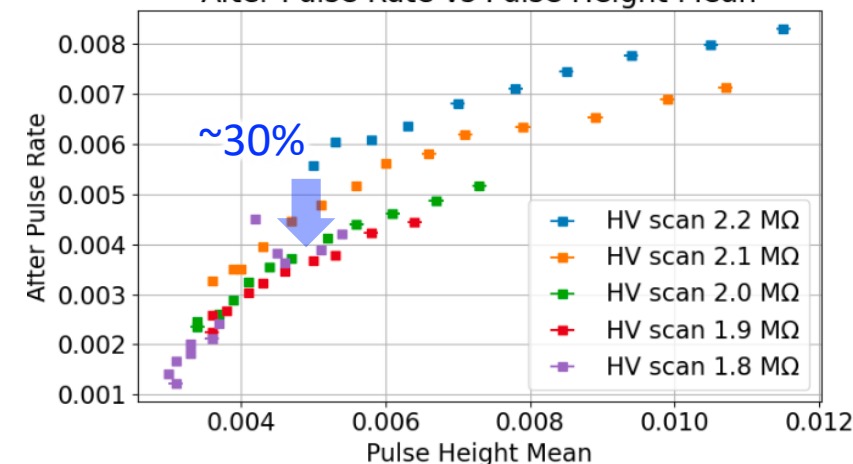
## After Pulse Rate vs Pulse Height Mean

- Adjust the gain in the 1st and 2nd MCP layers and reduce outgas and ions from the 1st layer that go back to Photocathode to mitigate the QE degradation.
- Measuring the gain and after-pulse rate with changed resistors to find optimal resistor values
  - About 30% reduction in after-pulse rate.
- Next steps are to measure QE drop and check the performance in 1.5T in a few months.
