Ladder Bending Tests

BPAC Concerns & Recommendations

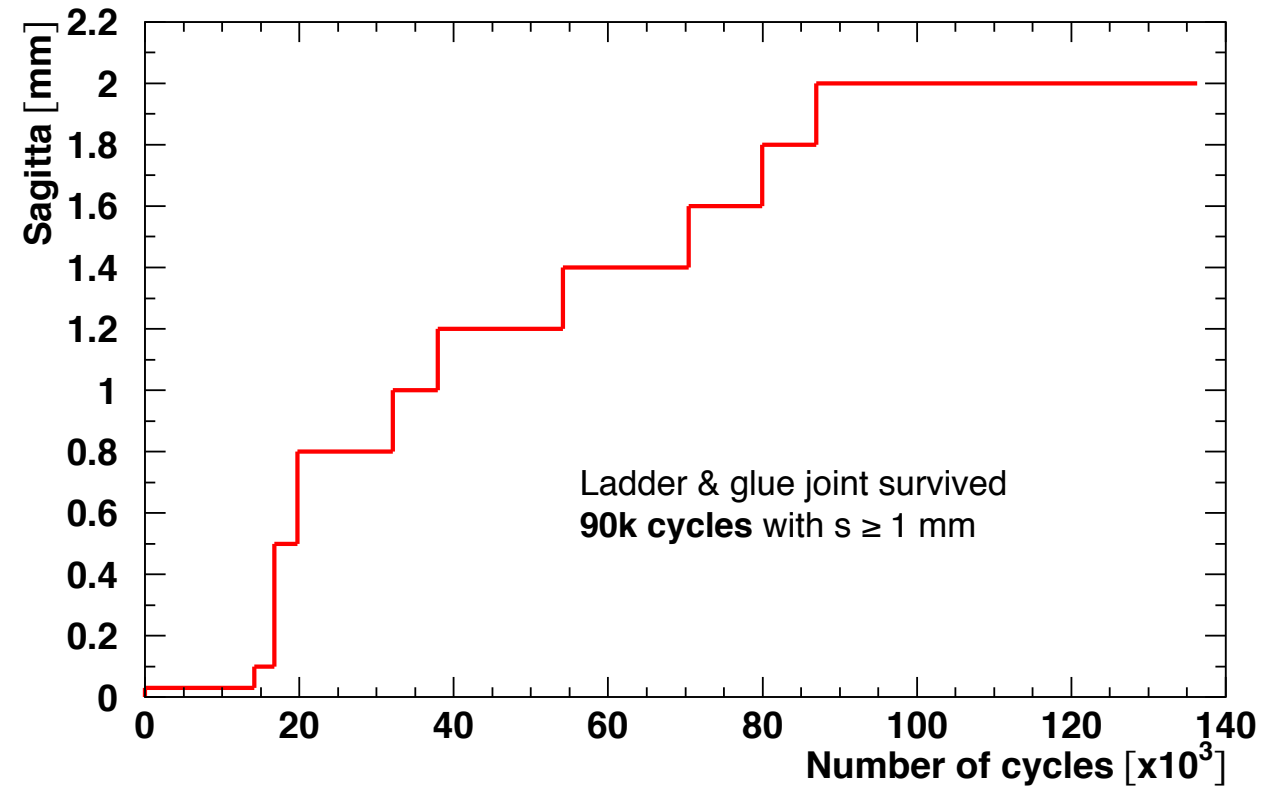
L2 glue joint endurance test with thick ladder

Mchanical Stress Tests of L2 Dummy Ladders at DESY

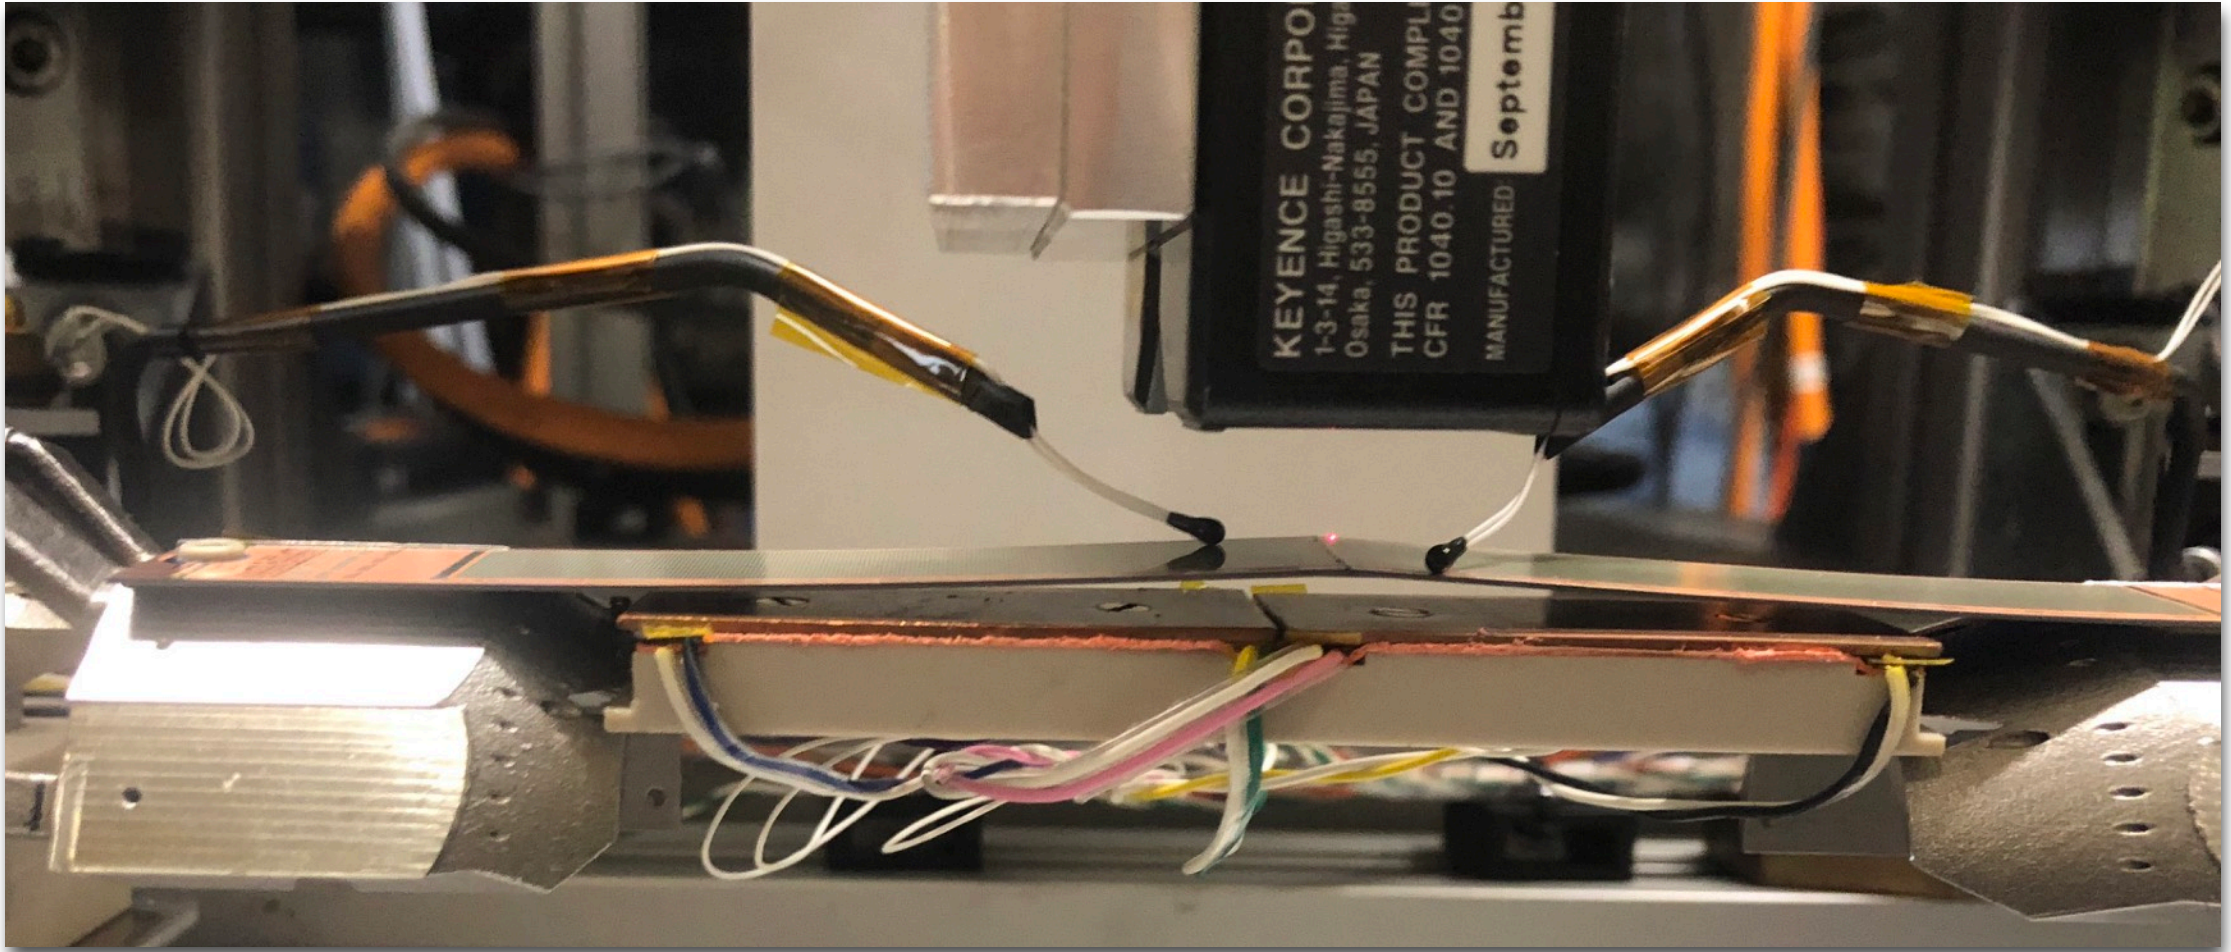
Modified Stress Test Setup

- L2 Ladder fixed at both ends and pre-bent
- Ladder heated in stages from below by radiant heater
- Simultaneous measurement of sensor temperature, bending and force

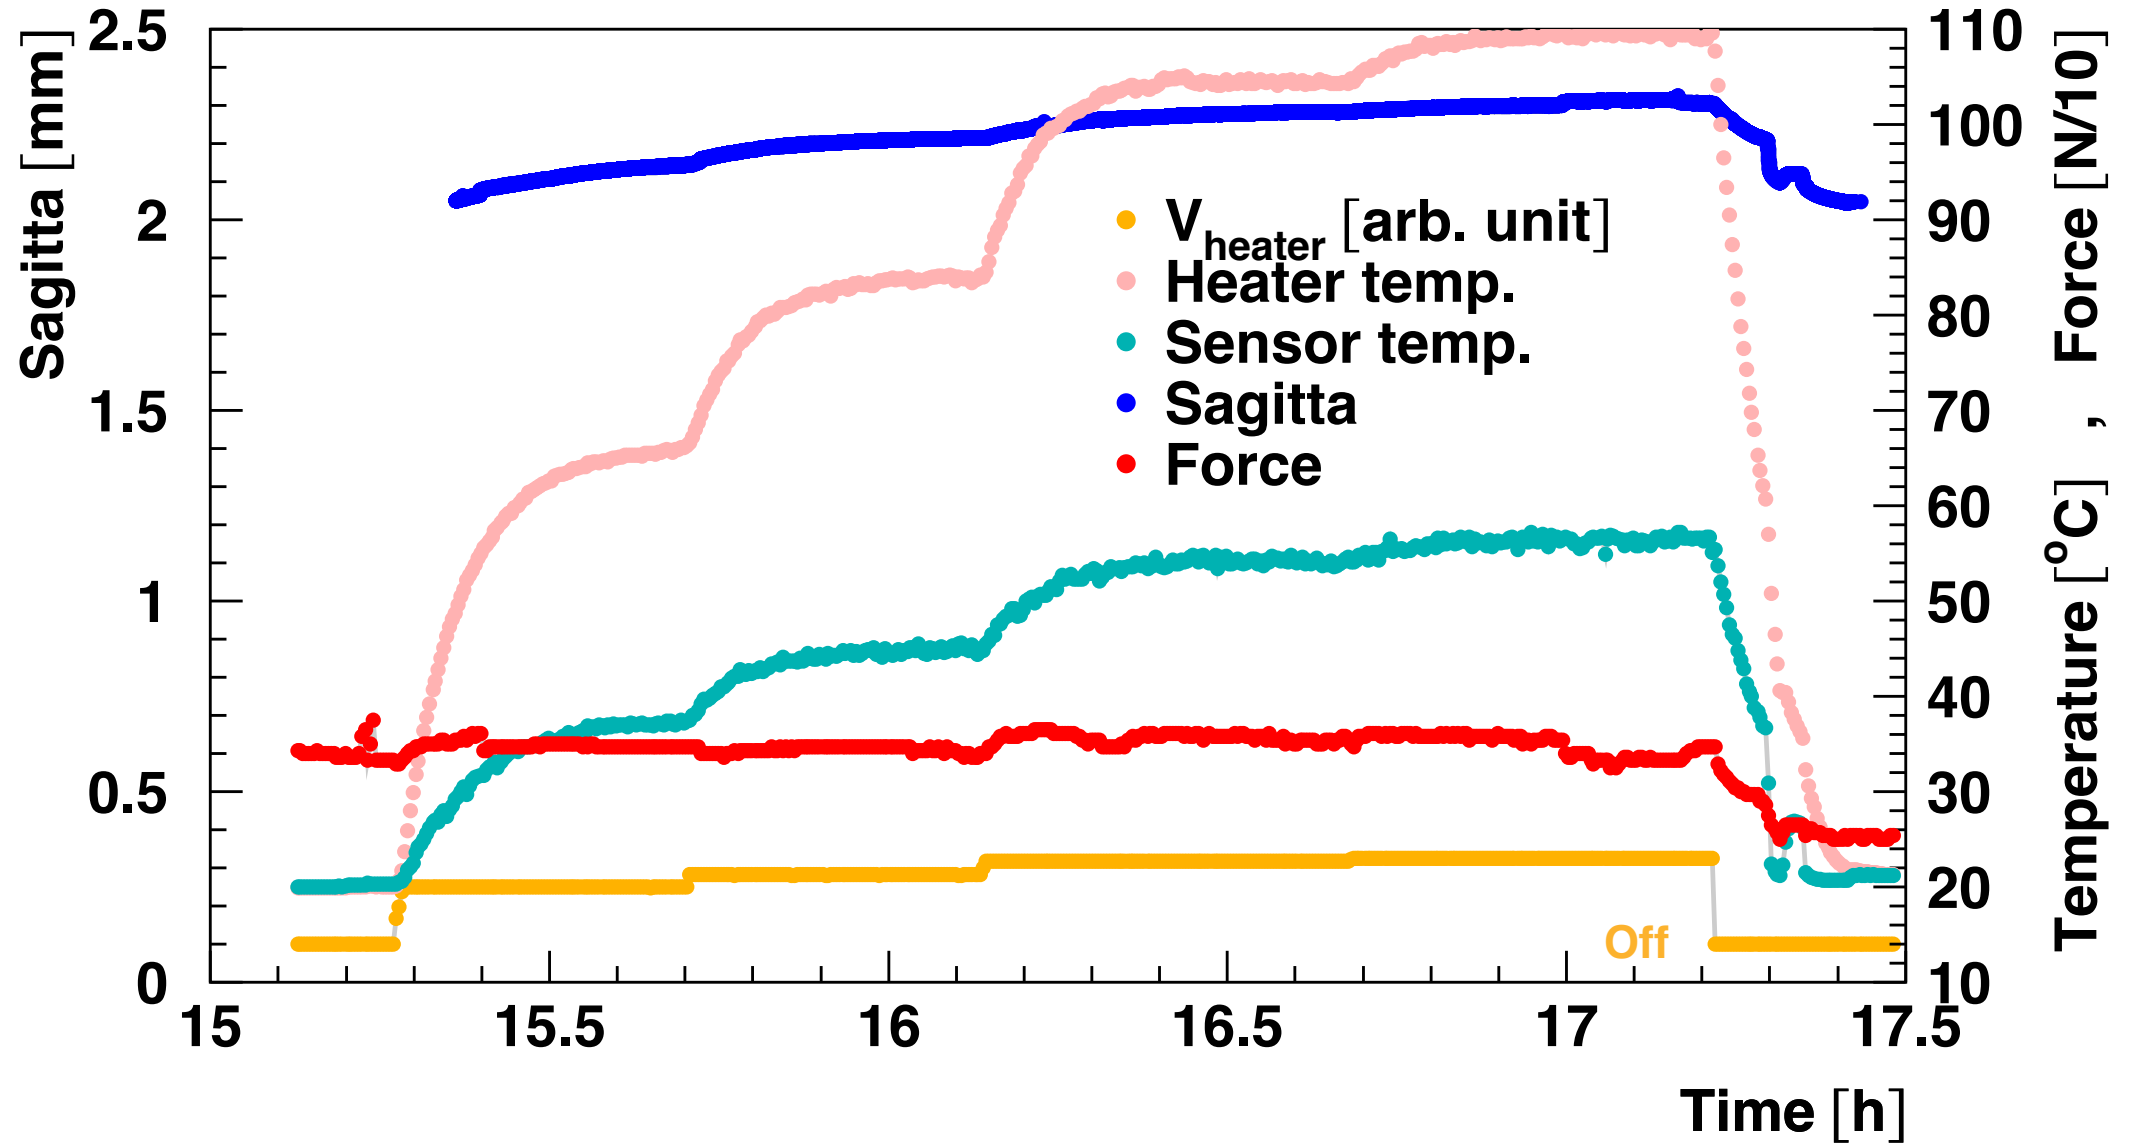
2nd LK79 Heating Test

- Ceramic stiffeners remain in place after second heating cycle
- Bend remains but modules are mechanically intact and still firmly connected at room temperature

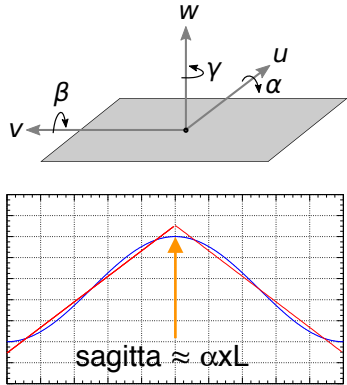
Ladder Bending Studies with Field-off Cosmics

- Most bent ladders 2.7 and 2.8 also have large β and γ values
- Suspect that gliding impossible as these ladders are not optimally mounted on SCBs
- Reminder: Unlike other half-shell, this one not disassembled at DESY
