CAT7 cable problem

Mikihiko Nakao (KEK)

2021.6.11

DAQ meeting

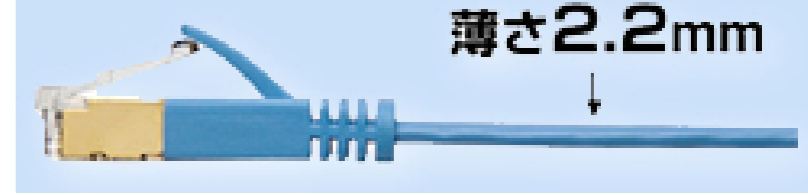
KB-FL7 — problematic product

● SUNWA-SUPPLY KB-FL7

- Flat CAT7 cable, 2.2mm thick
- My first choice, heavily used in many places, including DESY VXD test
- Clock jitter and various specs were tested before choosing this
- Later, another flat CAT7, SUNWA-SUPPLY KB-FLU7, 1.9mm thick, is more widely adopted

- There was a suspicious signal shape when I was testing a spare FTSW in B2
- I decided to measure the cable resistance in a systematic way
- **I found large resistance in all of the KB-FL7 cables that I tested (!)**
