PXD2 Pre-Commissioning

Anselm Baur (DESY)

Belle II Germany Meeting, Munich, Sept. 20th 2022

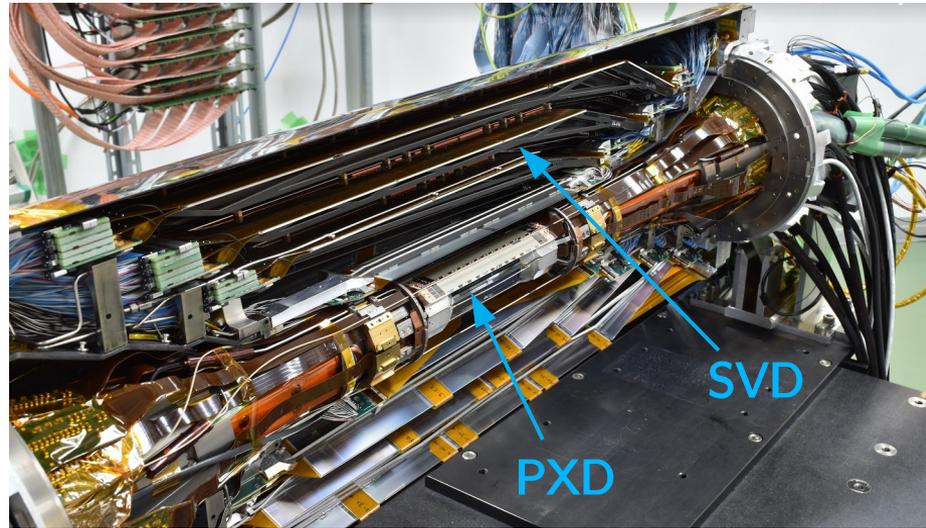
Exp: 26; Run: 1968 (latest physics run before LS)

- Suffered from high instantaneous radiation doses
 - ~ 150 dead gates, 1 unstable switcher region
- Pedestal aging already visible (pedestal currents drifting apart)
- Regions with lower efficiencies appear → pedestal compression, DCD gain

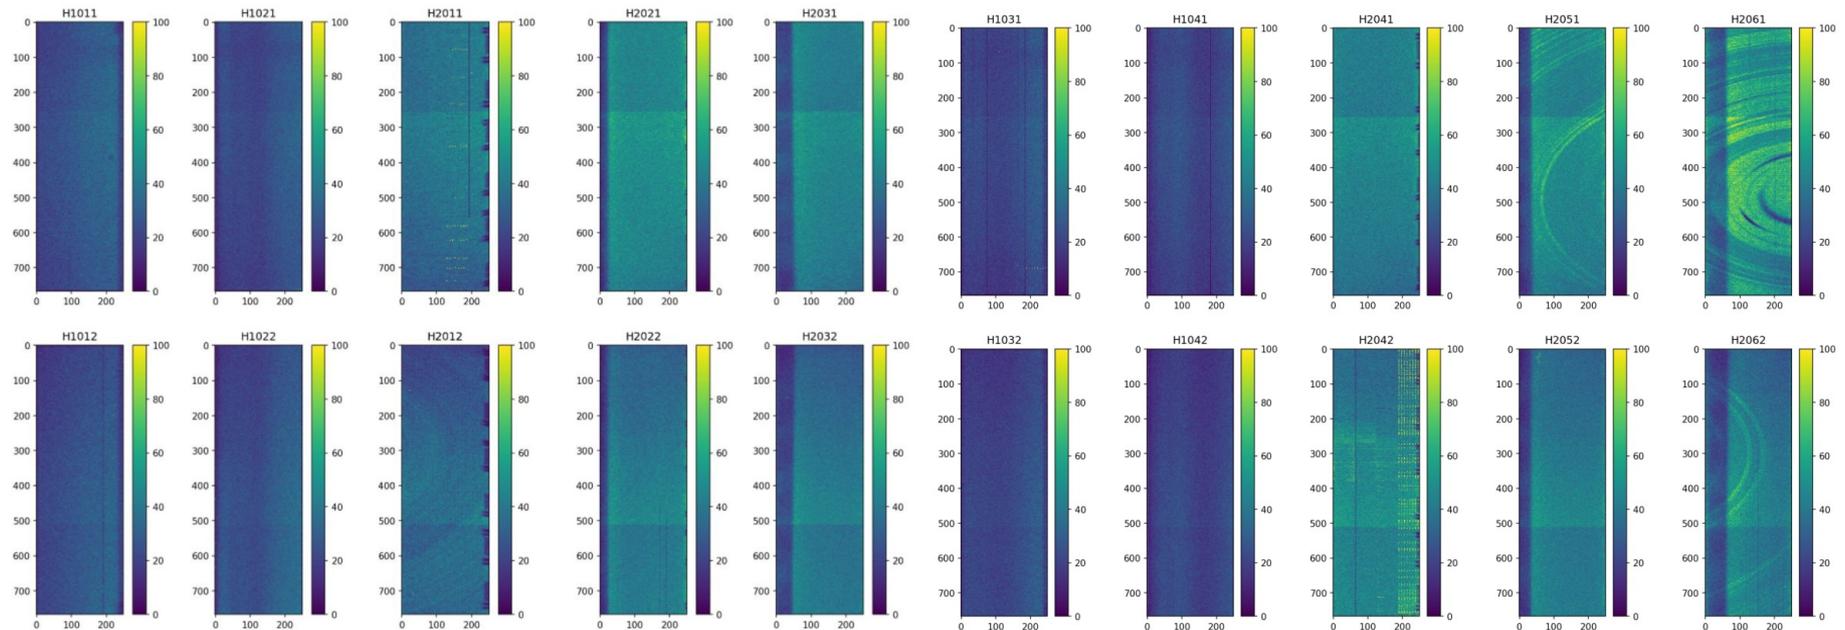
Sr90 hitmaps (re-measure hit efficiencies, tune working point)

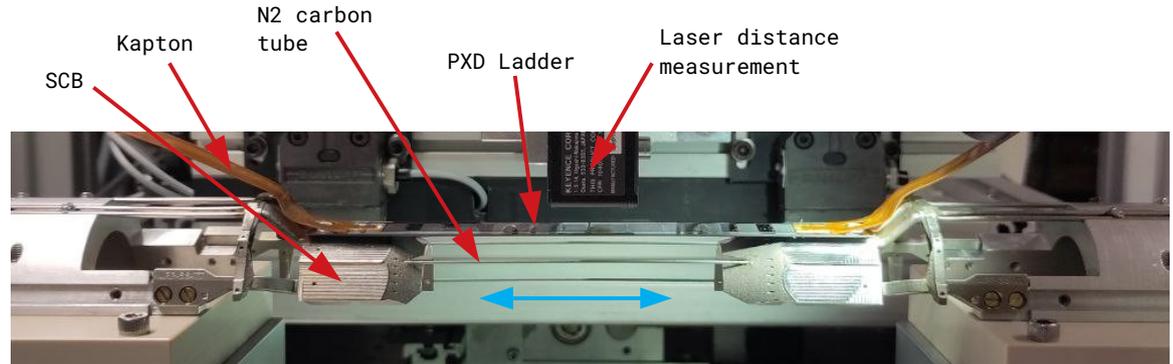
- **2 broken inner ladders** L1a, L1b
- **Kink height** of ~1.5 mm
 - Equivalent thermal expansion of Si at ~140 K (this we did not have)
 - Ladder were still under tension, relaxed when releasing screws
- **Outer ladders not affected**
- **Unclear if L1a and L1b still functional**

Possible Causes (Combination?):

- S.th. **prevented SCB from gliding** under thermal/mechanical stress
- Ladder **tightening torque** too high → **no module gliding**
- Explanation of large kink, an **asymmetric** process must have **periodically** enhanced stress → **accumulated bending**
- Influence of massive **Al beam pipe mockup**
(Al ~10 times higher thermal expansion than Si)
- **Glue loses strength** at ~60 °C under stress (tests at MPP)
- Incident: once **CO2 cooling broke down** in forward SCB
(ASIC temperatures up to 80-90 °C for a few seconds)

- 2nd HS **pre-commissioning on hold**
- **Mechanical tests** ongoing/in preparation:
 - screw tightening torque → ladder gliding
 - SCB mechanical gliding
 - thermal conduction depending on tightening torque
 - influence Al dummy beam pipe
- **Consultation** of retired expert from MPP (PXD mechanical design)

Repair 1st Half-Shell:

- **2 good** L1 ladders for replacement
- **1 more** L1 ladder can be **glued** from good modules
- **Risk analysis**
