PXD Power Supply - Over Voltage Protection (OVP) Studies

Belle II Germany Meeting 2023

September 26, 2023

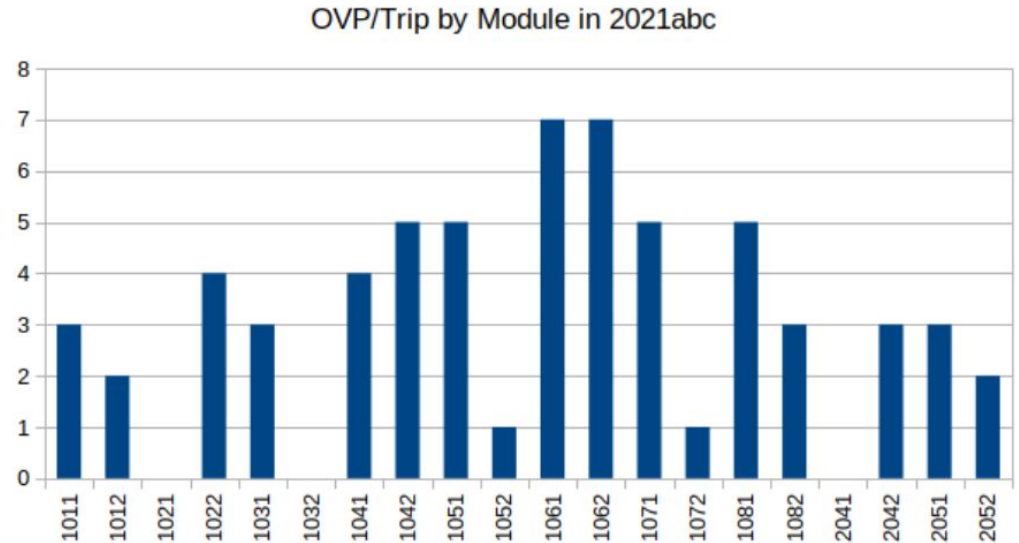
- OVP events (“*HV Trip*”) rate increased in spring 2021 (beam currents were increased)
- Rate approx. 0.5-1 per day
 - Rises with increasing luminosity
- Talks by Björn Spruck:
 - PXD HV “Trips” Issues By Over-Voltage-Protection ([link](#))
 - Update on PXD HV “Trips” Issues By Over-Voltage-Protection ([link](#))

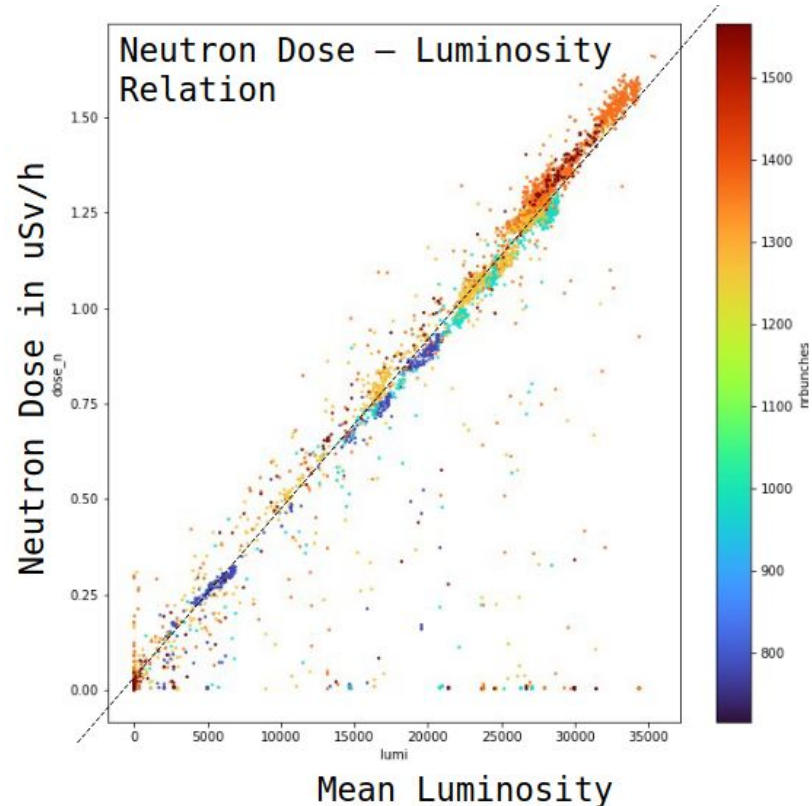
- OVP events (“*HV Trip*”) rate increased in spring 2021 (beam currents were increased)
- Rate approx. 0.5-1 per day
 - Rises with increasing luminosity
- Talks by Björn Spruck:
 - PXD HV “Trips” Issues By Over-Voltage-Protection ([link](#))
 - Update on PXD HV “Trips” Issues By Over-Voltage-Protection ([link](#))

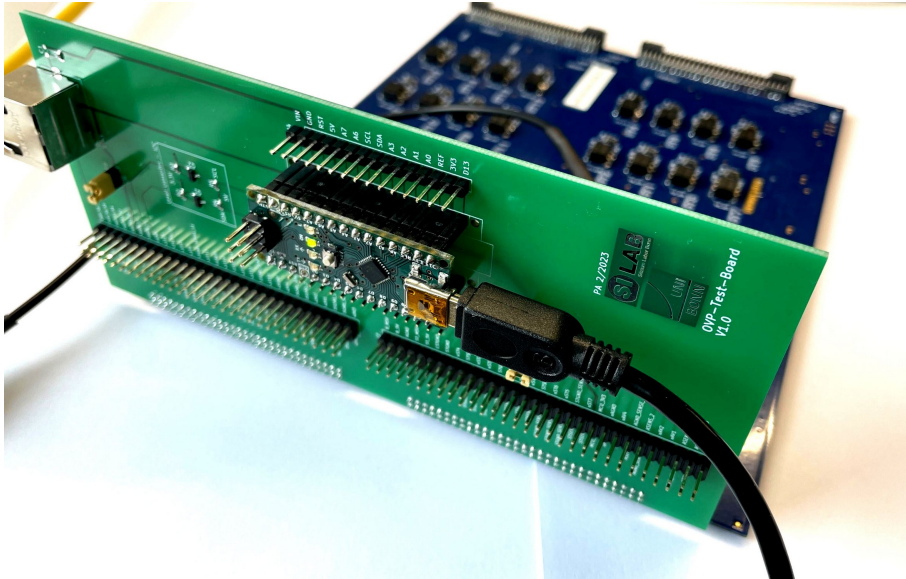
- Injecting short pulses to *channel_fault*

OVP testing - 1000 pulses

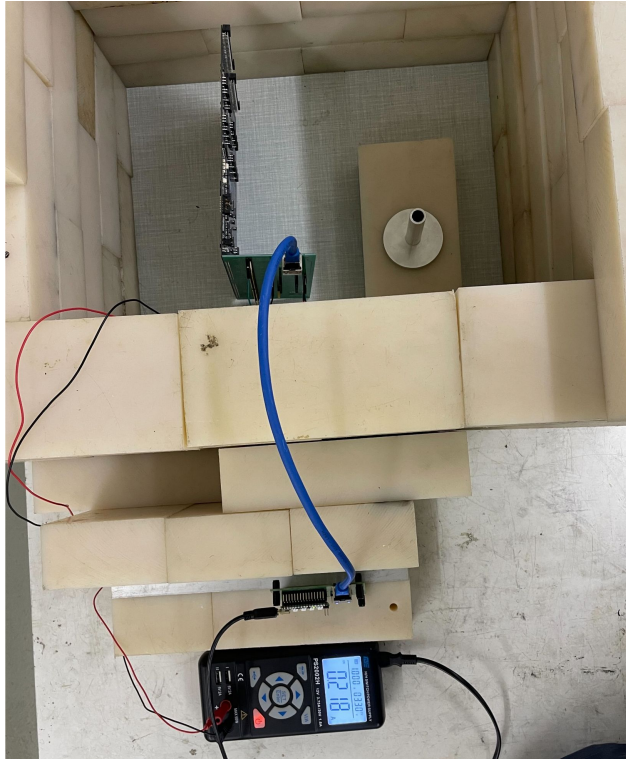
OVP new firmware - Neutron source

Note: Information about which channel triggered only implemented after this test
