# KLM-DAQ Performance, Issues, & Progress

**Chris Ketter**  
**26 August 2019**

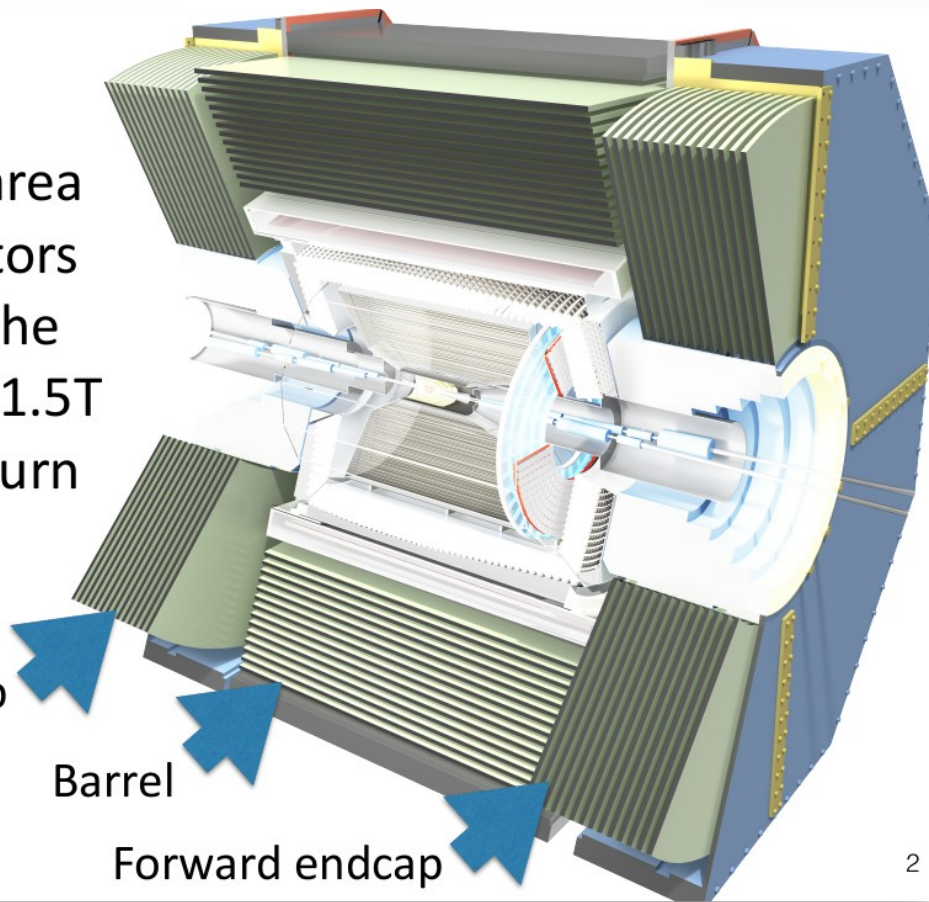
# Reminder – KLM Detector

consists of large-area thin planar detectors interleaved with the iron plates of the 1.5T solenoid's flux return yoke.

Backward endcap

Barrel

Forward endcap

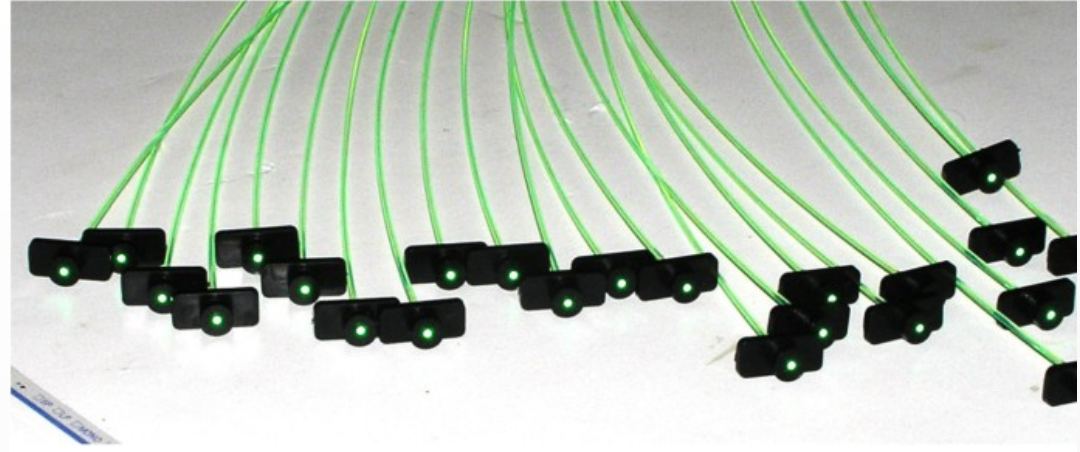
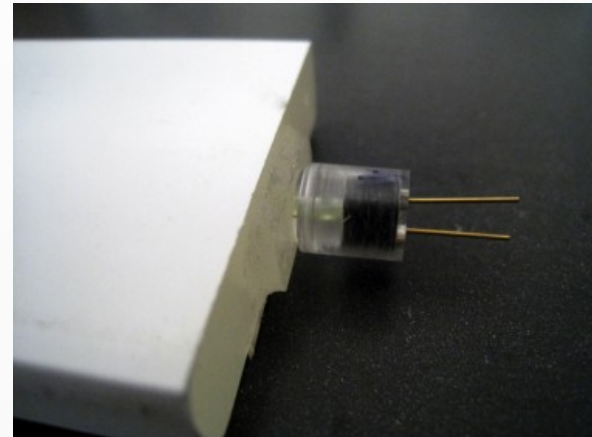
# Scintillator Upgrade

- Inner two barrel layers and entire endcaps replaced with plastic scintillators in Belle II
- TiO<sub>2</sub>-coated PVT plastic scintillators with wavelength-shifting fibers
- Hamamatsu S10362-13-050c MPPCs

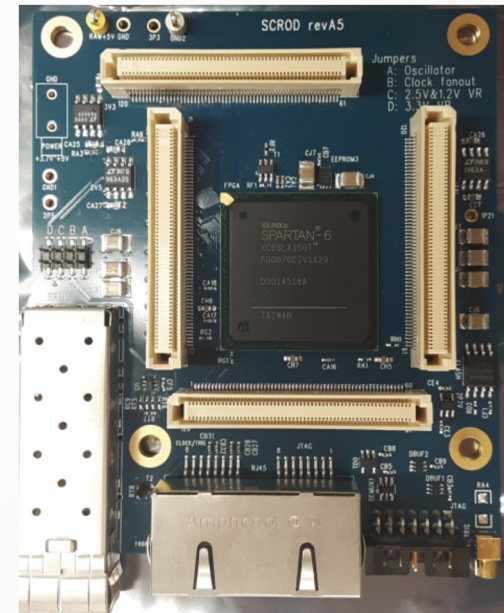
## KLM SCROD

- Time-stamping scintillator trigger primitives with 4 ns clock period for KLM trigger
- Time-stamping scintillator DAQ packets with 8 ns clock period
- High rate test with dummy packets (4 hits per module)
  - Trigger up to 50 kHz Poisson w/ 200 ns holdoff
  - Bottle neck was readout PCs
- KLM regularly joins global DAQ stress tests with 10 kHz Poisson / cosmic trigger and has not had any issues
  - SCROD firmware in “daq” mode, so mostly empty packets
- Latency of  $\sim 200$  ns between receipt of global trigger and sending DAQ packets

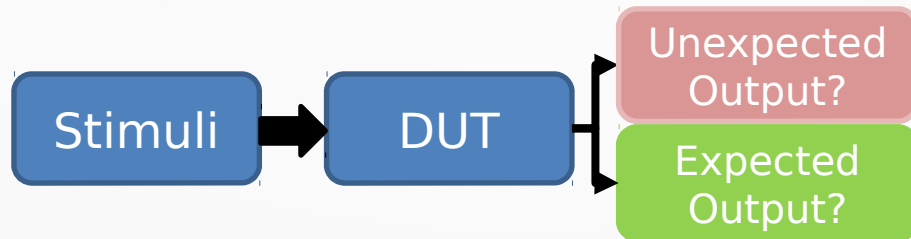
# Firmware Verification

- Group from PNNL (Lynn Wood, Eric Becker, Mitch Mannino) performing pseudo-random verification on Data Concentrator and SCROD firmwares
  - Lynn is refining the combined Data Concentrator / RPC Front End / SCROD simulation
  - Eric & Mitch are writing the test harnesses for pseudo-random verification
- Verification is a continuous process as the Belle II will run for years and odd inputs will eventually occur during measurements!

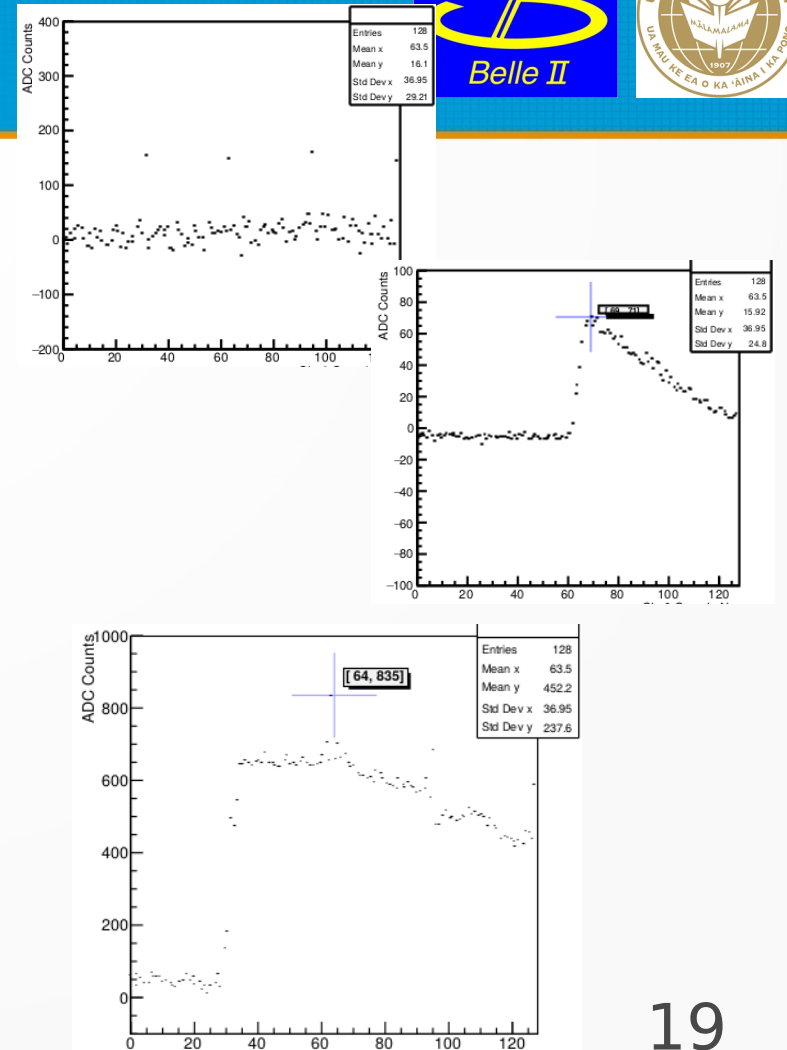
# Waveform Readout

- TARGETX reads out all 15 channels simultaneously
- Needed to disambiguate multi-hits
- Can improve leading edge timing to  $\sim 1\text{ns}$
- Subtract pedestals for best results
- Known issue of preamp saturation has to be dealt with

- Logical path forward, in terms of ease of implementation:
  1. Implement waveform readout with pedestal-less threshold checking for multi-hit disambiguation.
    - Sets up required framework for waveform readout with more complex feature extraction later.
    - Without pedestals timing is not likely to be very good, but can see if it improves relative to current 8 ns.
  2. Implement pedestal subtraction to achieve ~1 ns leading edge timing.
  3. Add amplitude information.
- Schedule:
  - Target item 1 ready for fall running, item 2 as "stretch goal."
  - Schedule for item 3 to be assessed as work continues.
    - Recall that we have a saturation issue on preamps that may limit our ability to measure amplitudes.

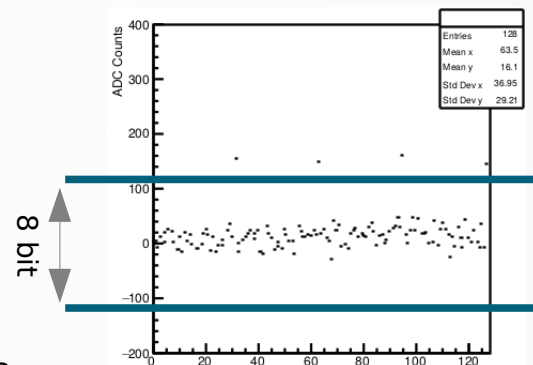
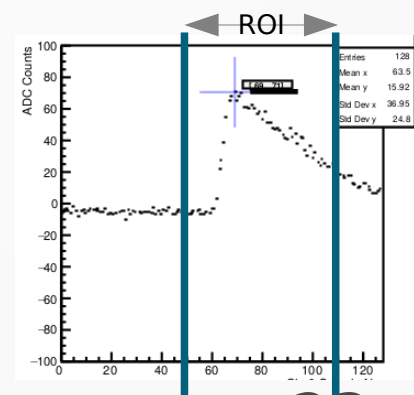
# Pedestal Bottleneck

- Pedestals stored on Cypress CY62177EV30 CMOS static ram
  - Configured as 4M × 8 static RAM (SRAM) (22 bit address space, 8 bit values)
- 55 ns read time yields 10.6 us time per hit if using same ROI as older firmware:

- Strategies being implemented for improvement:
  - 8 bit peds: 10 us → 7 us
    - Requires optimization of mean values to make it work at all
    - Requires outlier detection in feature extraction in case even one sample rolls over the MSB

- Readout smaller ROI (eg. 32 or 64 samples): 10 us → 2.5 - 5 us
    - Utilize 4-bit time-stamping in conjunction with sample-select lines to dynamically select ROI

$$4 \text{ win} * \left( \frac{32 \text{ sa}}{\text{win}} \right) * \left( \frac{3 \text{ read}}{2 \text{ sa}} \right) * \left( \frac{7 * 7.87 \text{ ns}}{\text{read}} \right) = 10.6 \text{ us}$$

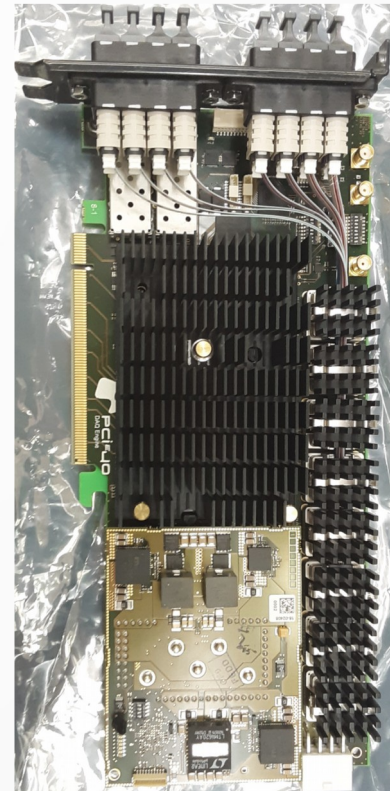
# DAQ Upgrade

- Already have one PCIe40 card from LAL in Hawaii
- Oscar Hartbrich helping to procure server for using the PCIe40
- Will be able to test with KLM (and TOP) on testbenches in Hawaii
- New post-doc Harsh Purwar joining Hawaii group very soon to work on DAQ upgrade
  - He overlapped with Oskar recently in LAL and received some basic training on operation of the PCIe40

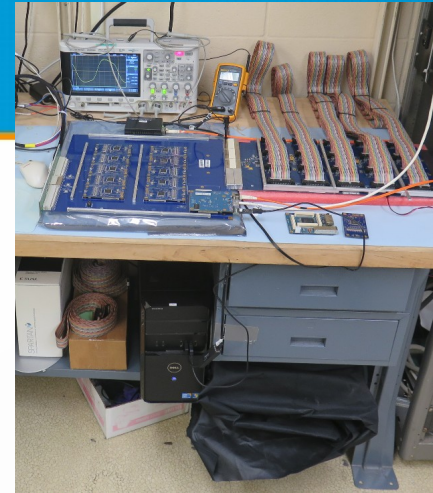
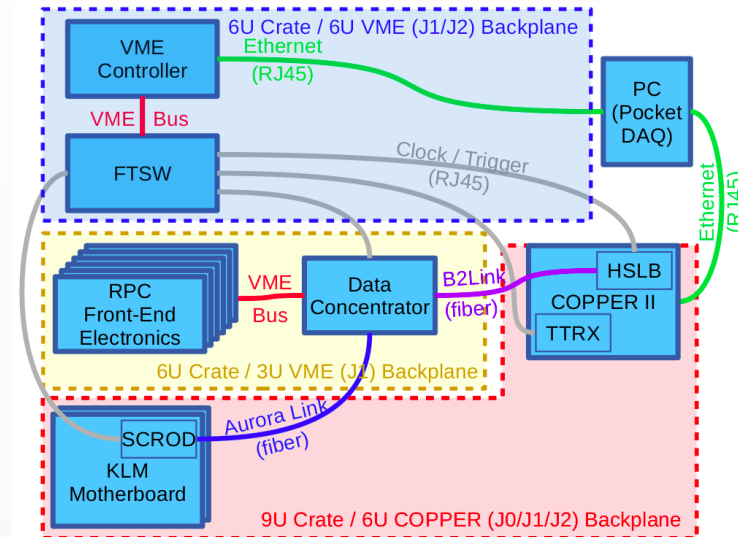
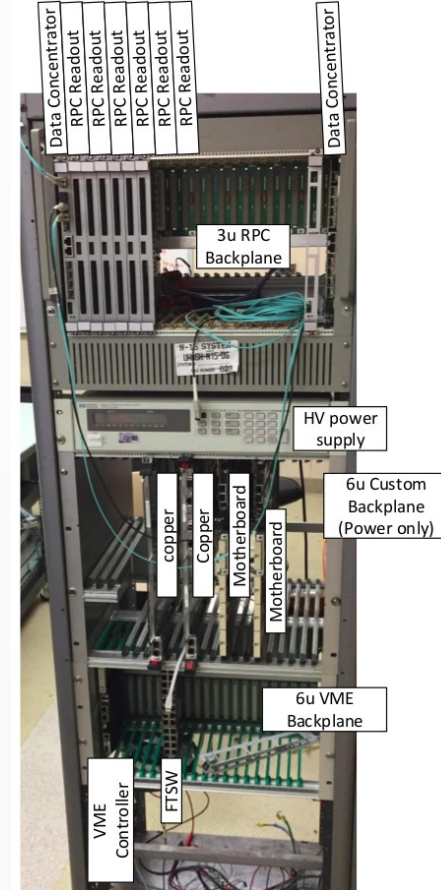
# KLM Testbench

- Commissioned fall '18
- DAQ equivalent to Belle II KLM (other than PocketDAQ)
- Instrumented with:
  - Scintillator readout  
1-layer eq. w/ MPPCs
  - RPC readout  
6-layer eq. w/ 1 DC  
(no test signals available)
- Has proven instrumental in debugging new scint. firmware releases and testing of control & calibration software
