DHH Status

Belle 2 DAQ Workshop

Seoul August 26-29, 2019

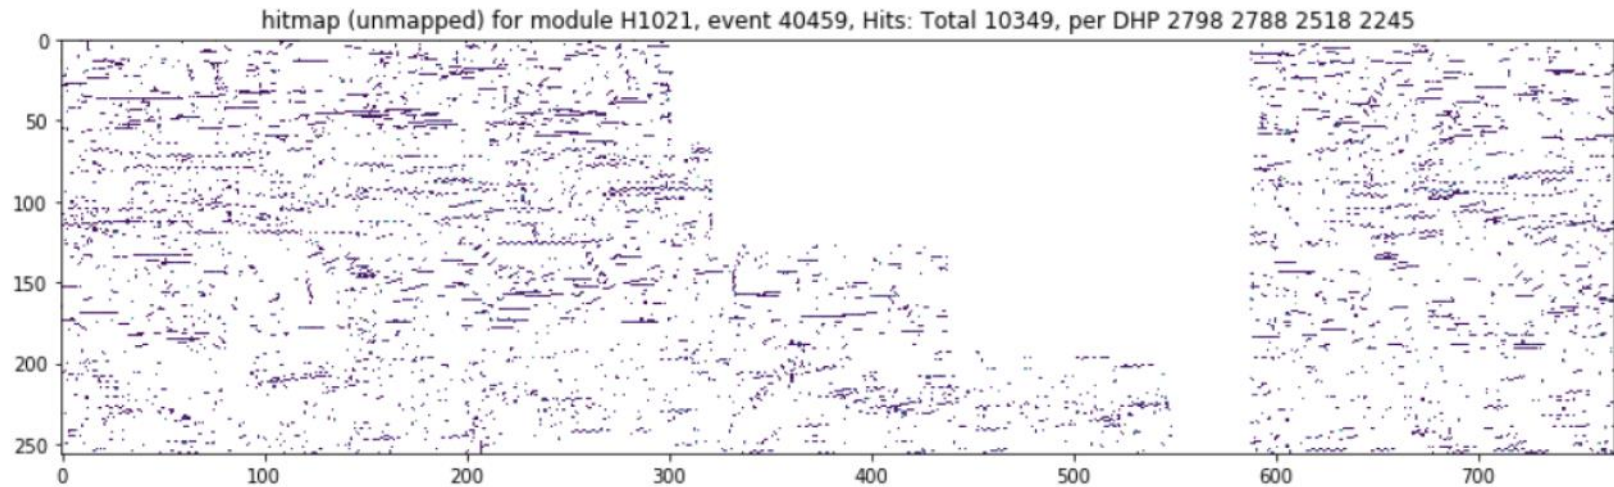
Full feature version 30kHz capable deployed on May 12

- Data truncation when DHP frame size exceeds 2000 words or more than 3.3% occupancy
 - ✓ 1616 pixels/DHP frame => not less than 3.3% occupancy

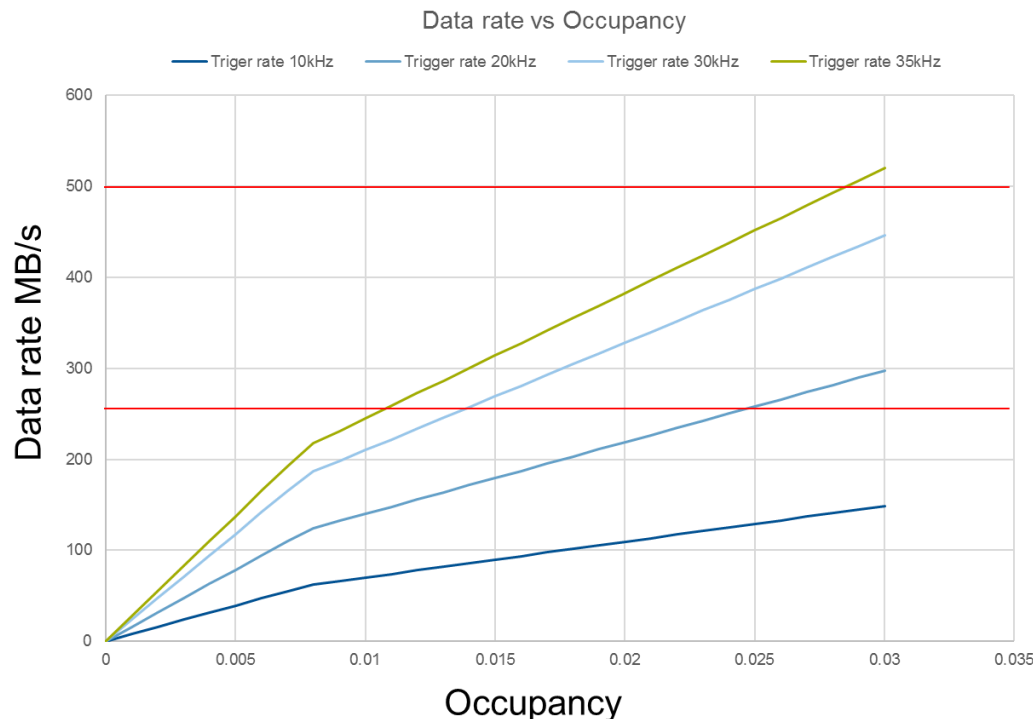
- High trigger rate capable => Trigger throttling
 - ✓ trigger rate is limited by bandwidth of DHE=>DHC or DHC=>ONSEN data links
 - ✓ DHE firmware limits : @10kHz no limit, @20kHz 2.5% occupancy, @30kHz 1.4% occupancy
 - ✓ Current PXD averaged occupancy below 0.1%

Possible link speed improvement
DHE=>DHC link 500 MB/s

Current limit
DHE=>DHC link 250 MB/s

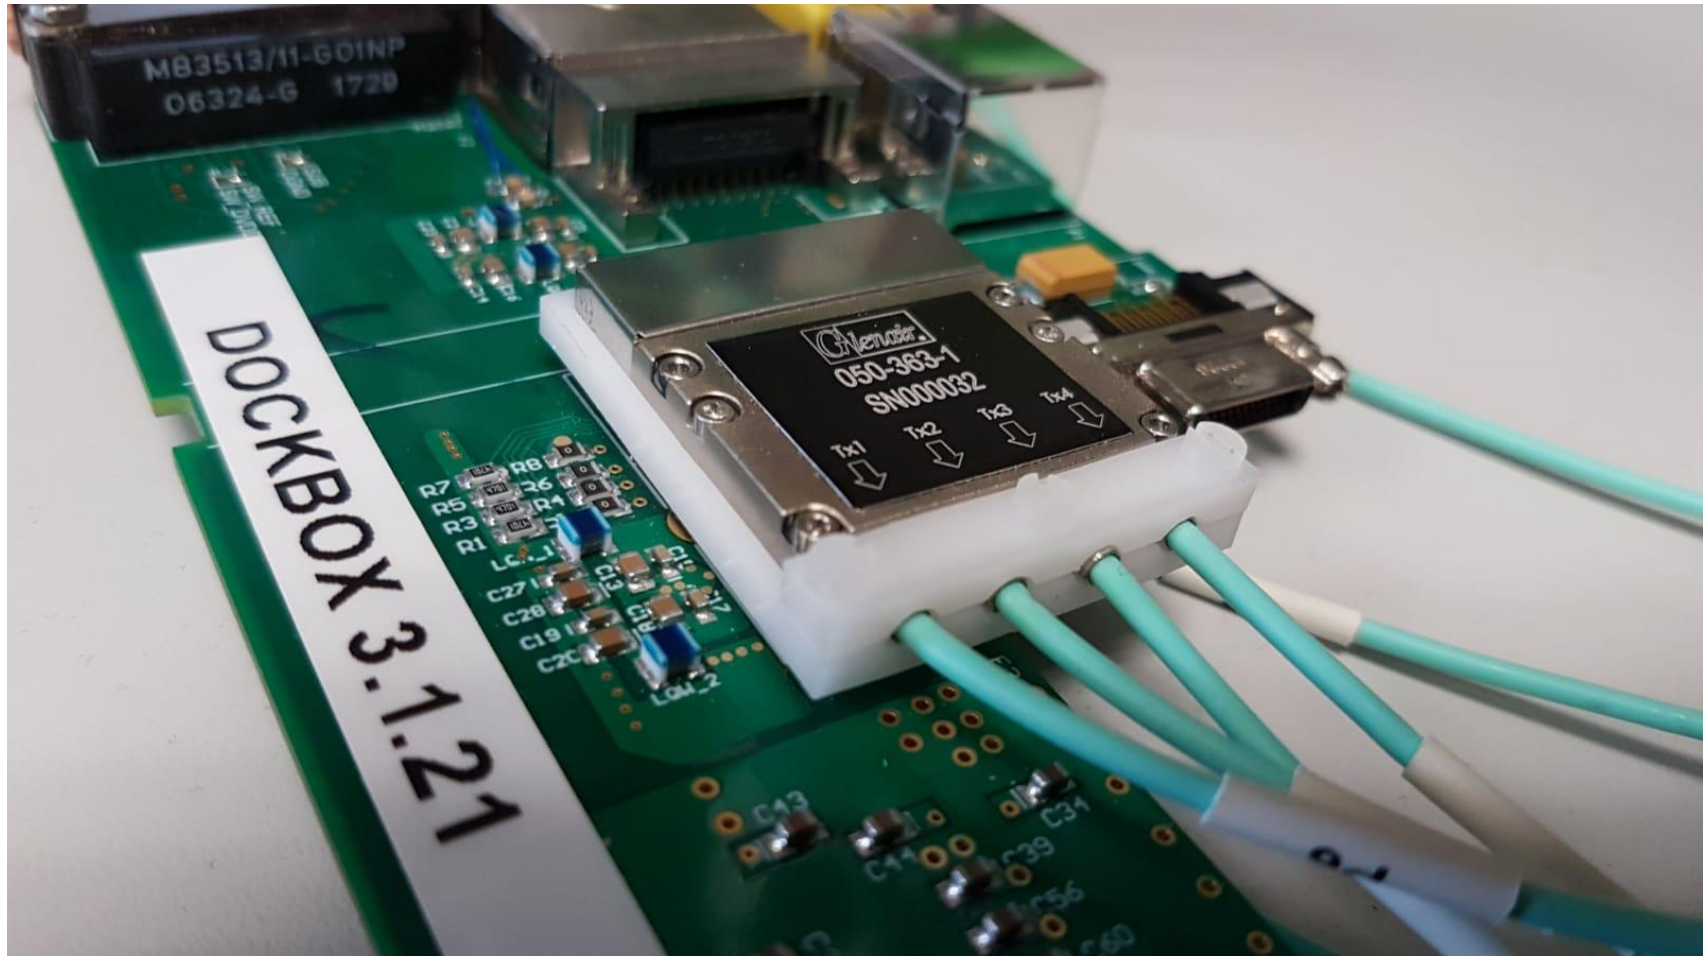
Clamps to Fix Optical Connectors - Done

- Dead link was caused by broken transmitter
 - ✓ Dock box PCB was exchanged
 - ✓ Broken transmitter will be sent to Glenair for diagnostics
 - ✓ Transmitter shall sustain radiation dose above 250 kRad
 - ✓ No information about actual radiation dose yet
- Other links with reduced light yield were recovered by pushing optical connector
 - ✓ We assume it was a single failure unrelated to radiation
 - ✓ Clamps were installed to prevent lose connectors

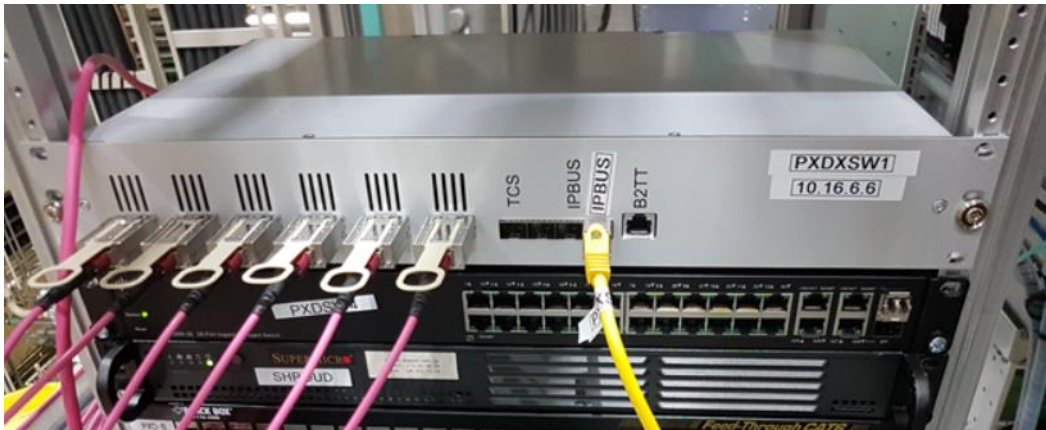
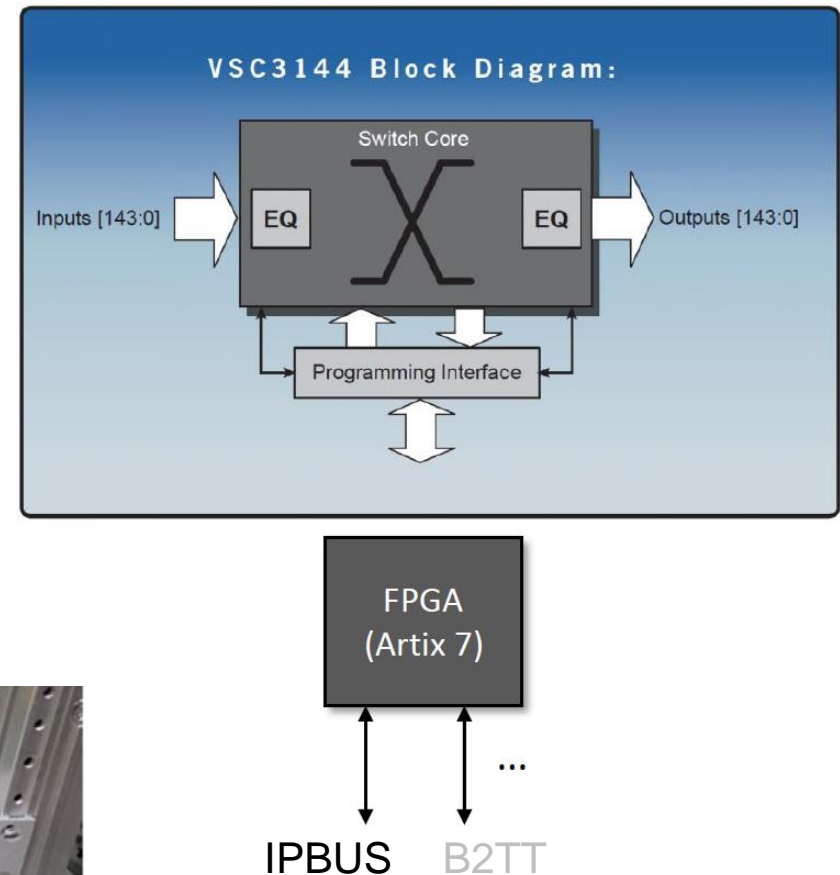
Cross-Point Switch

- IC VSC3144
- 144x144 non blocking cross-point switch
- 45x45 mm²
- Up to 6.5 Gbps/port, 1072 BGAwww
- Analogue circuits, no restriction on phase, frequencies, signal pattern
- Programmed on port-by-port basis
- Configuration programmed via IPBUS

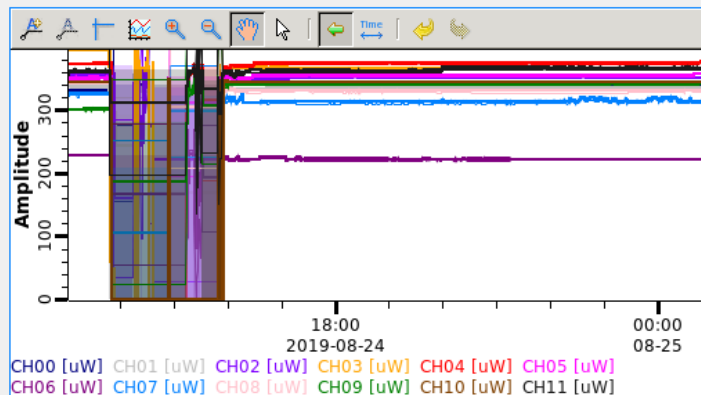
CXP01

- Cross-point switch fully integrated in EPICS
- Configuration stored in DB
- Optical receivers provide additional information
 - ✓ Light ON
 - ✓ Signal presence
 - ✓ Light power

Link 00	344 uW	
Link 01	336 uW	
Link 02	351 uW	
Link 03	367 uW	
Link 04	378 uW	
Link 05	358 uW	
Link 06	221 uW	
Link 07	311 uW	
Link 08	332 uW	
Link 09	344 uW	
Link 10	344 uW	
Link 11	365 uW
