PXD Status

DAQ, ONSSEN (ROI and HLT Feedback),
SlowControl (RC, HVC) & Monitoring

PXD Workshop and 23rd International Workshop on DEPFET
Detectors and Applications

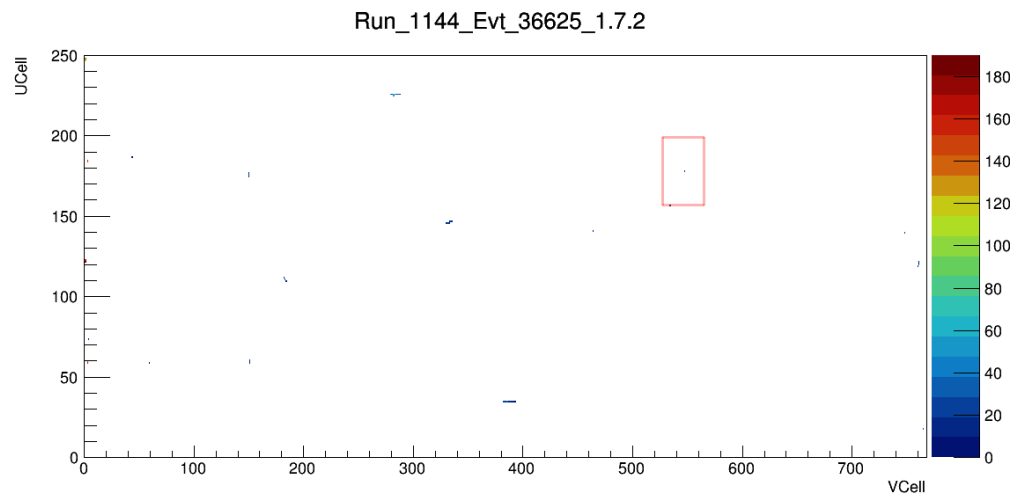
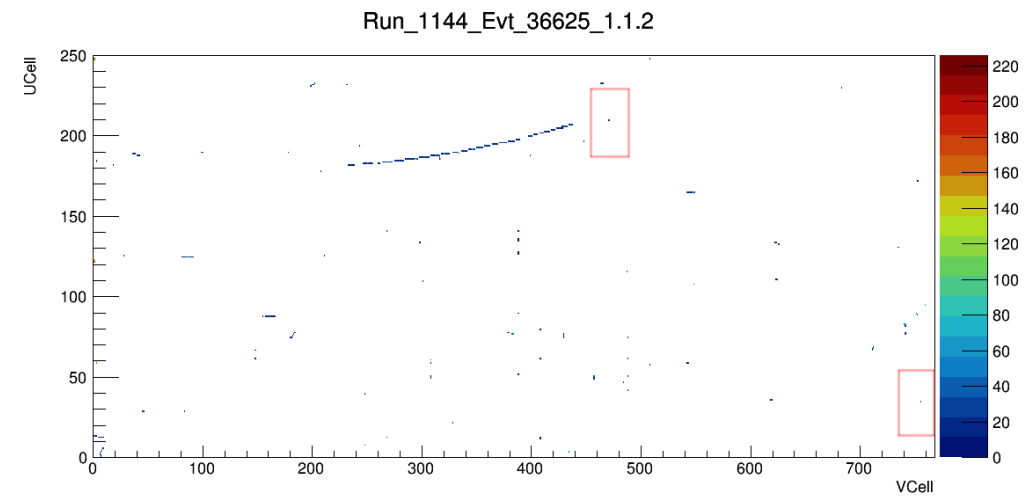
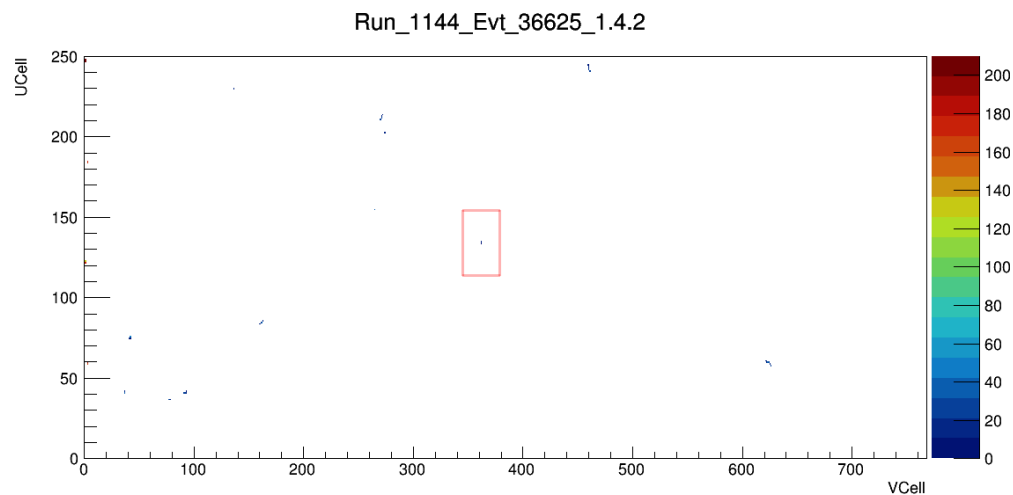
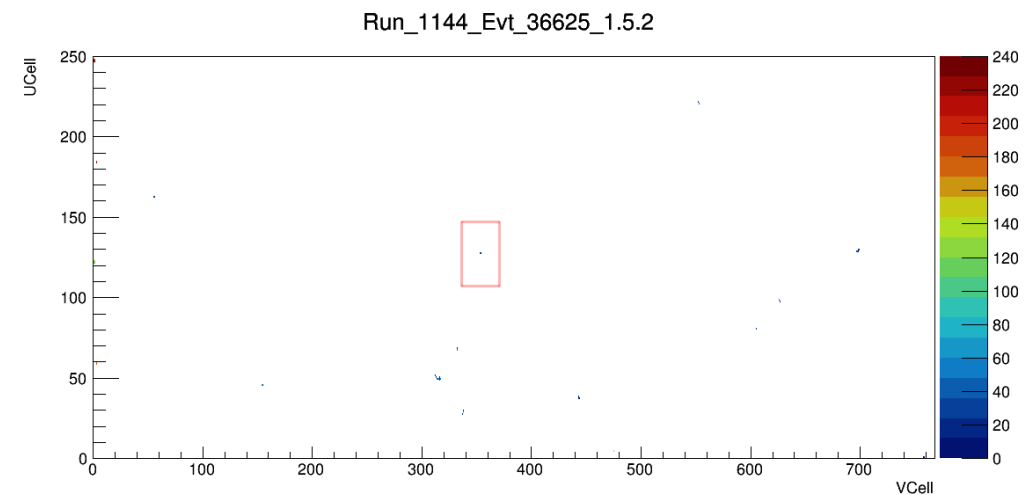
ROI Selection OFF, HLT ROIs Overlayed

Randomly chosen good event

Cluster seem to be centered in ROI → extrapolation on HLT seem to have good quality

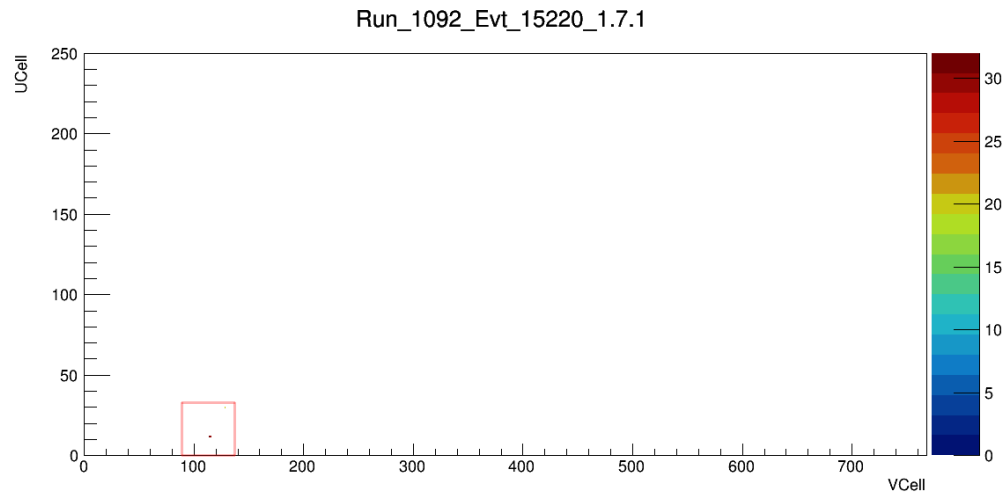
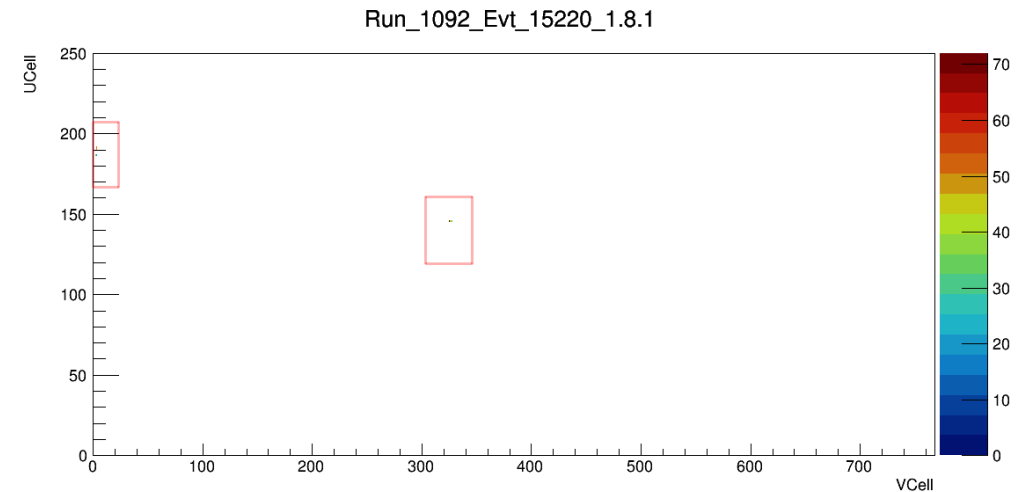
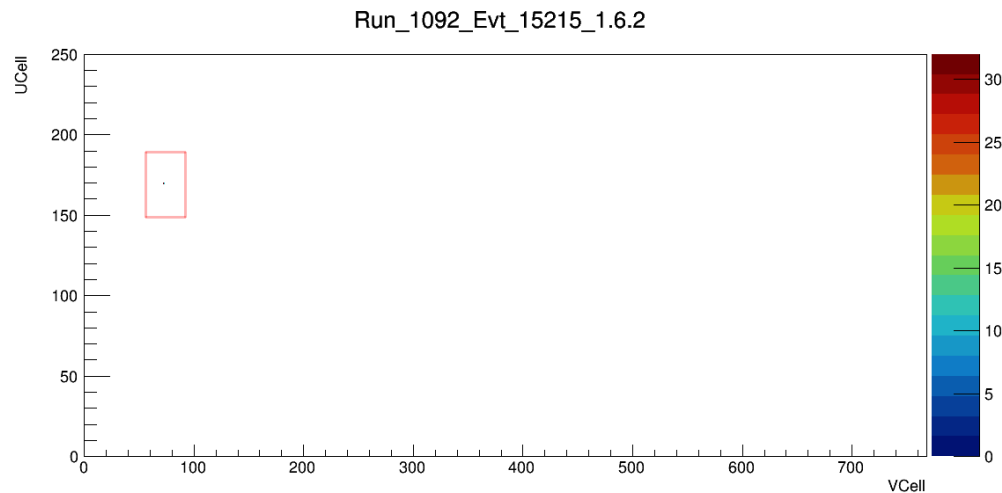
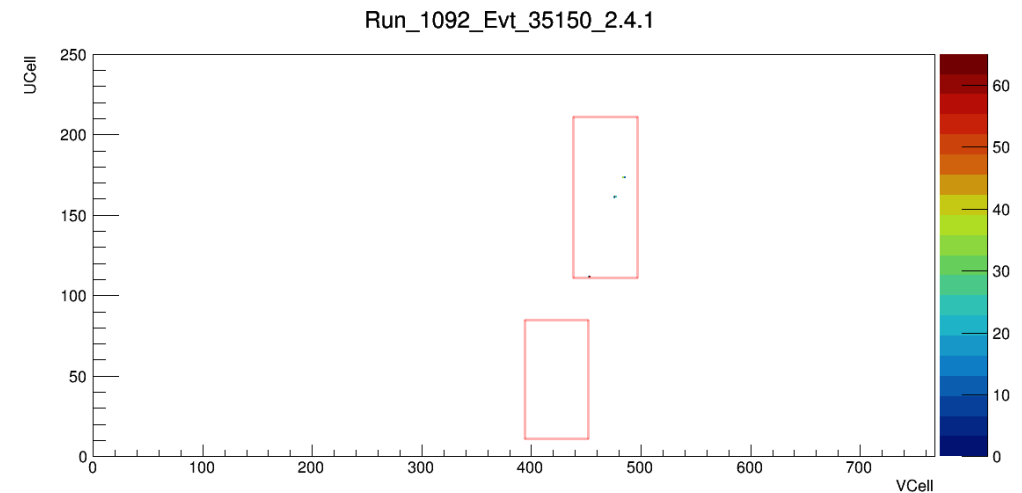
Randomly chosen good events

Cluster seem to be centered in ROI → extrapolation on HLT seem to have good quality
But: DHE Order problem, half of the modules have not data after selection
Selection worked as expected → verified in pixel-by-pixel check against BonnDAQ data

- ROI processing was turned on as a test for several runs. As expected, data for modules which were out-of-order is empty (→ no ROIs)
 - Offline check against BonnDAQ data for other modules:
 - → everything is selected as it should
- ROI selection needs ascending module ID in data and trigger for matching
 - Not fulfilled in beginning of phase 3
 - Cables within connectors in dock box and on DHH RTM could not be swapped.
 - ROI selection could only be verified for half of the modules (→ B2GM talk)
- Reordering of inputs from PXD Module → DHE → DHC
 - Optical switch has been installed in summer shutdown
 - Full ROI scheme still need testing
- Quality of ROIs (=Tracking Quality & Size) t.b.d.
 - Efficiency for low pT

- ... and so for all other modules (see backup slides)
- No hits OUTSIDE of ROIs
- No extra hits inside ROIs
- No hit is missing inside ROI
- → **everything is selected as it should**
- (but only few events 91244 within one run checked)

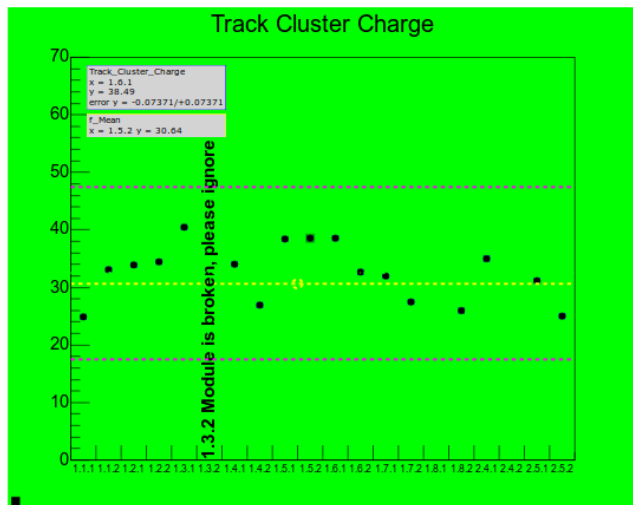
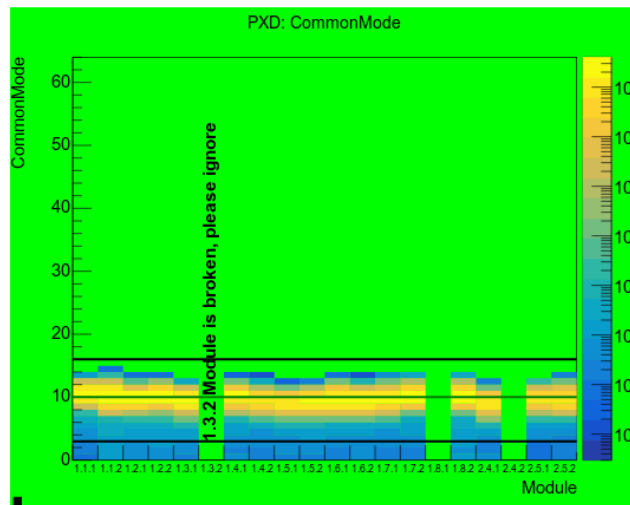
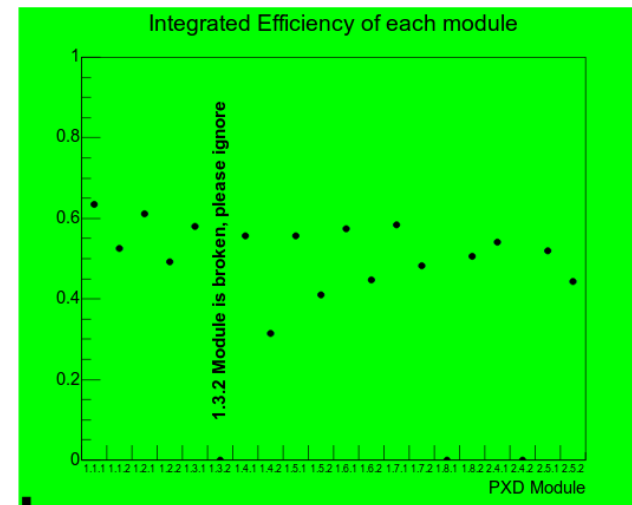
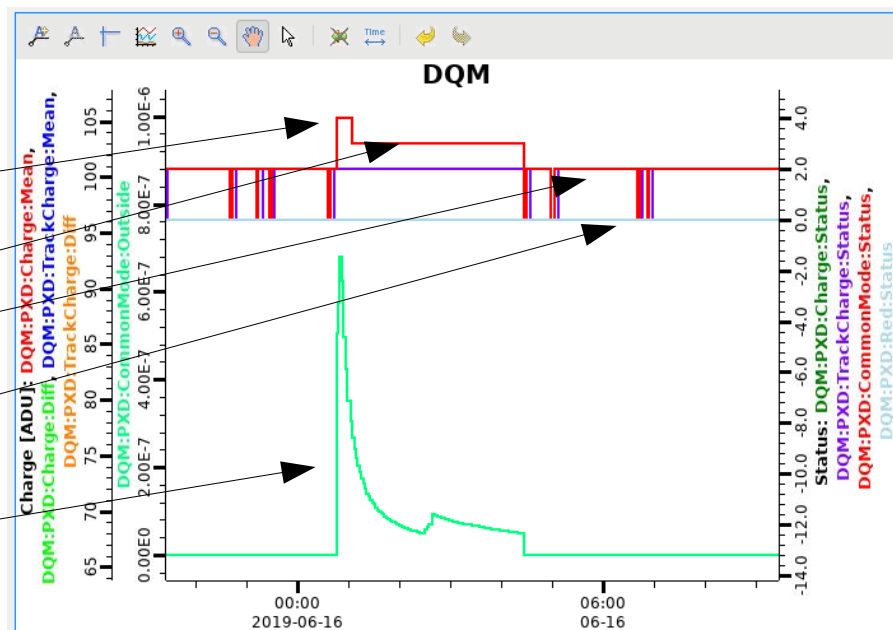
Histogram Status exported to EPICS & archived

RED = CHECK!!!
YELLOW = check
GREEN = OK
GREY = empty
Value the decision
is taken from

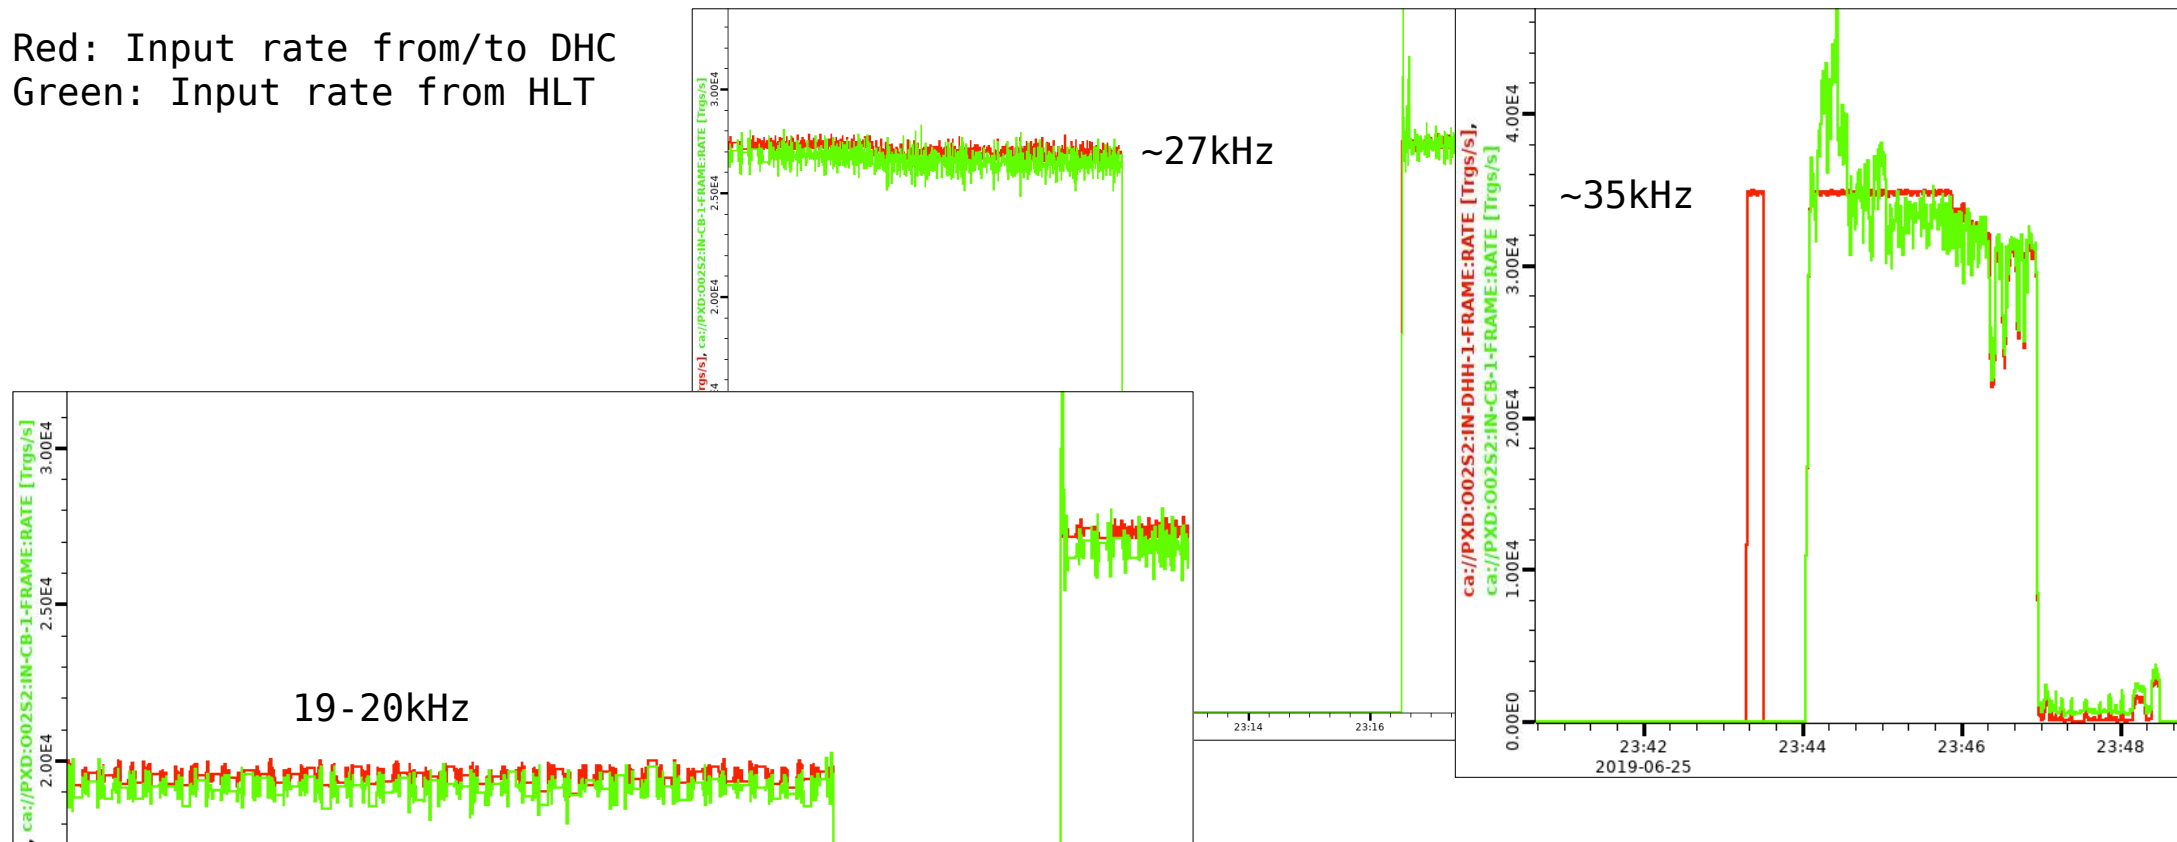
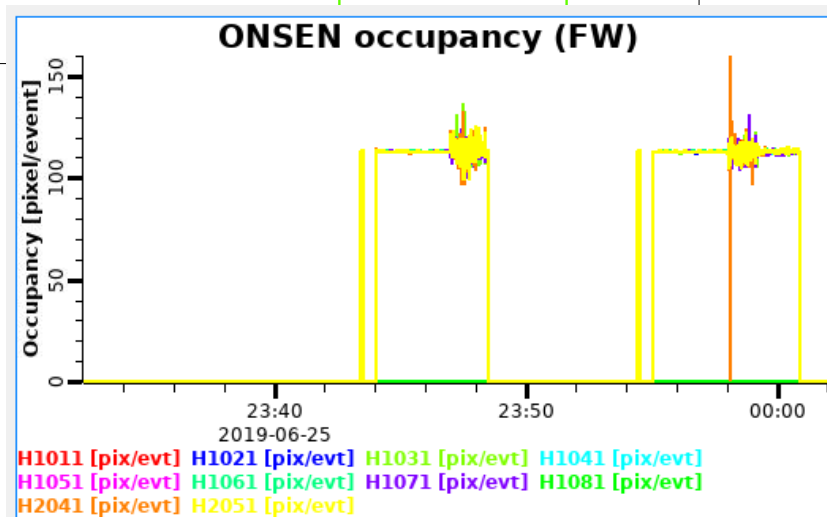
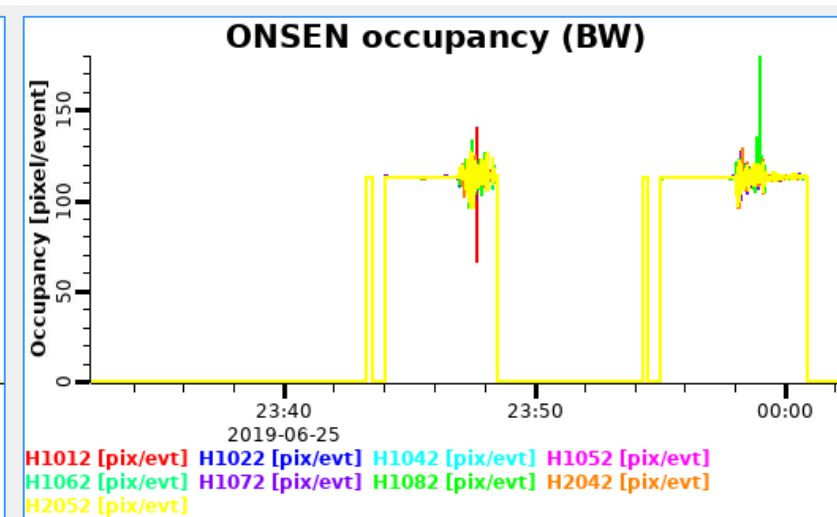
Red: Input rate from/to DHC
Green: Input rate from HLT

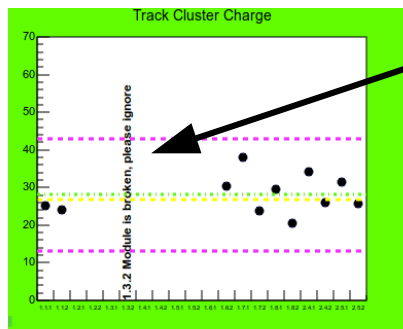
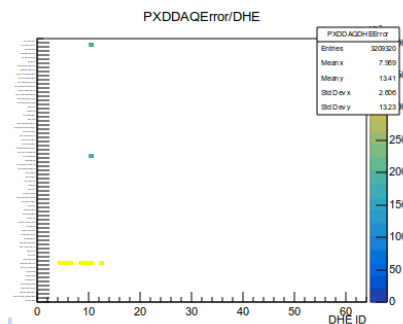
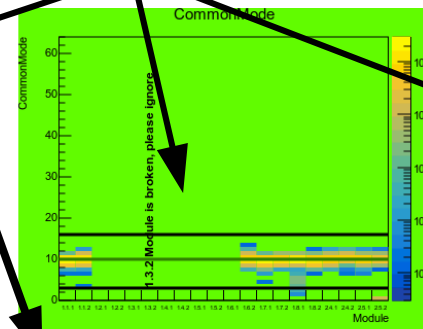
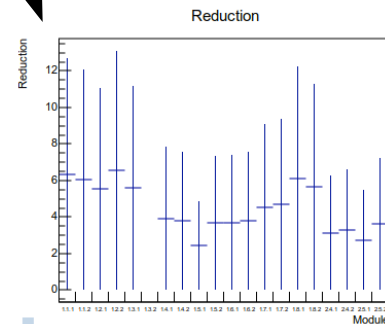
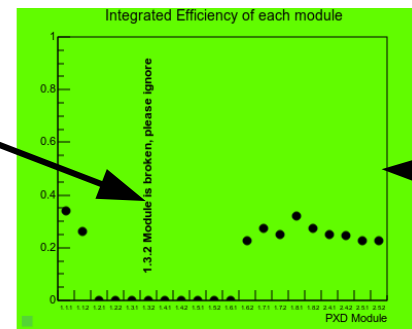
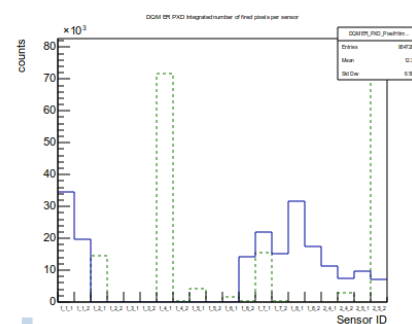
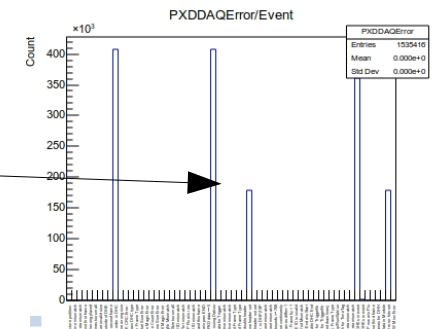
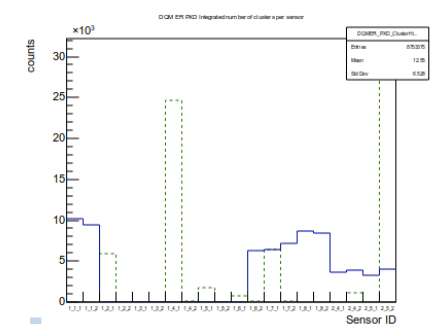
Event with errors show up as missing Efficiency for all modules (not only the one affected by the error)

Event with errors show up as missing
Efficiency for all modules (not only
the one affected by the error

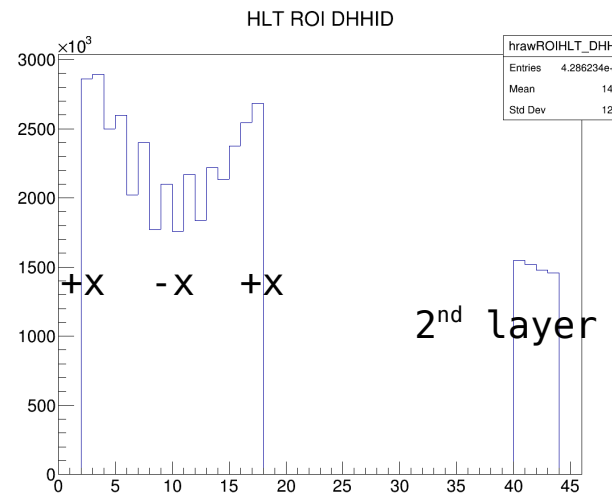
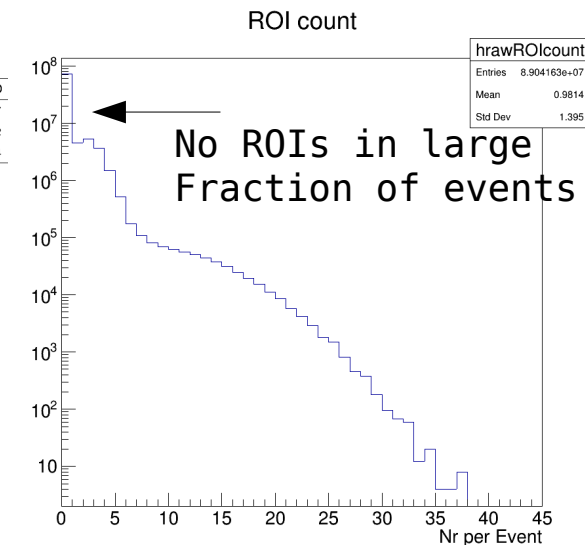
Reasonable number of ROIs and
Distribution on the modules
