# Bubbler system inventory & KLM layer efficiencies

Michele Veronesi  
ISU KLM Meeting  
08/07/2022

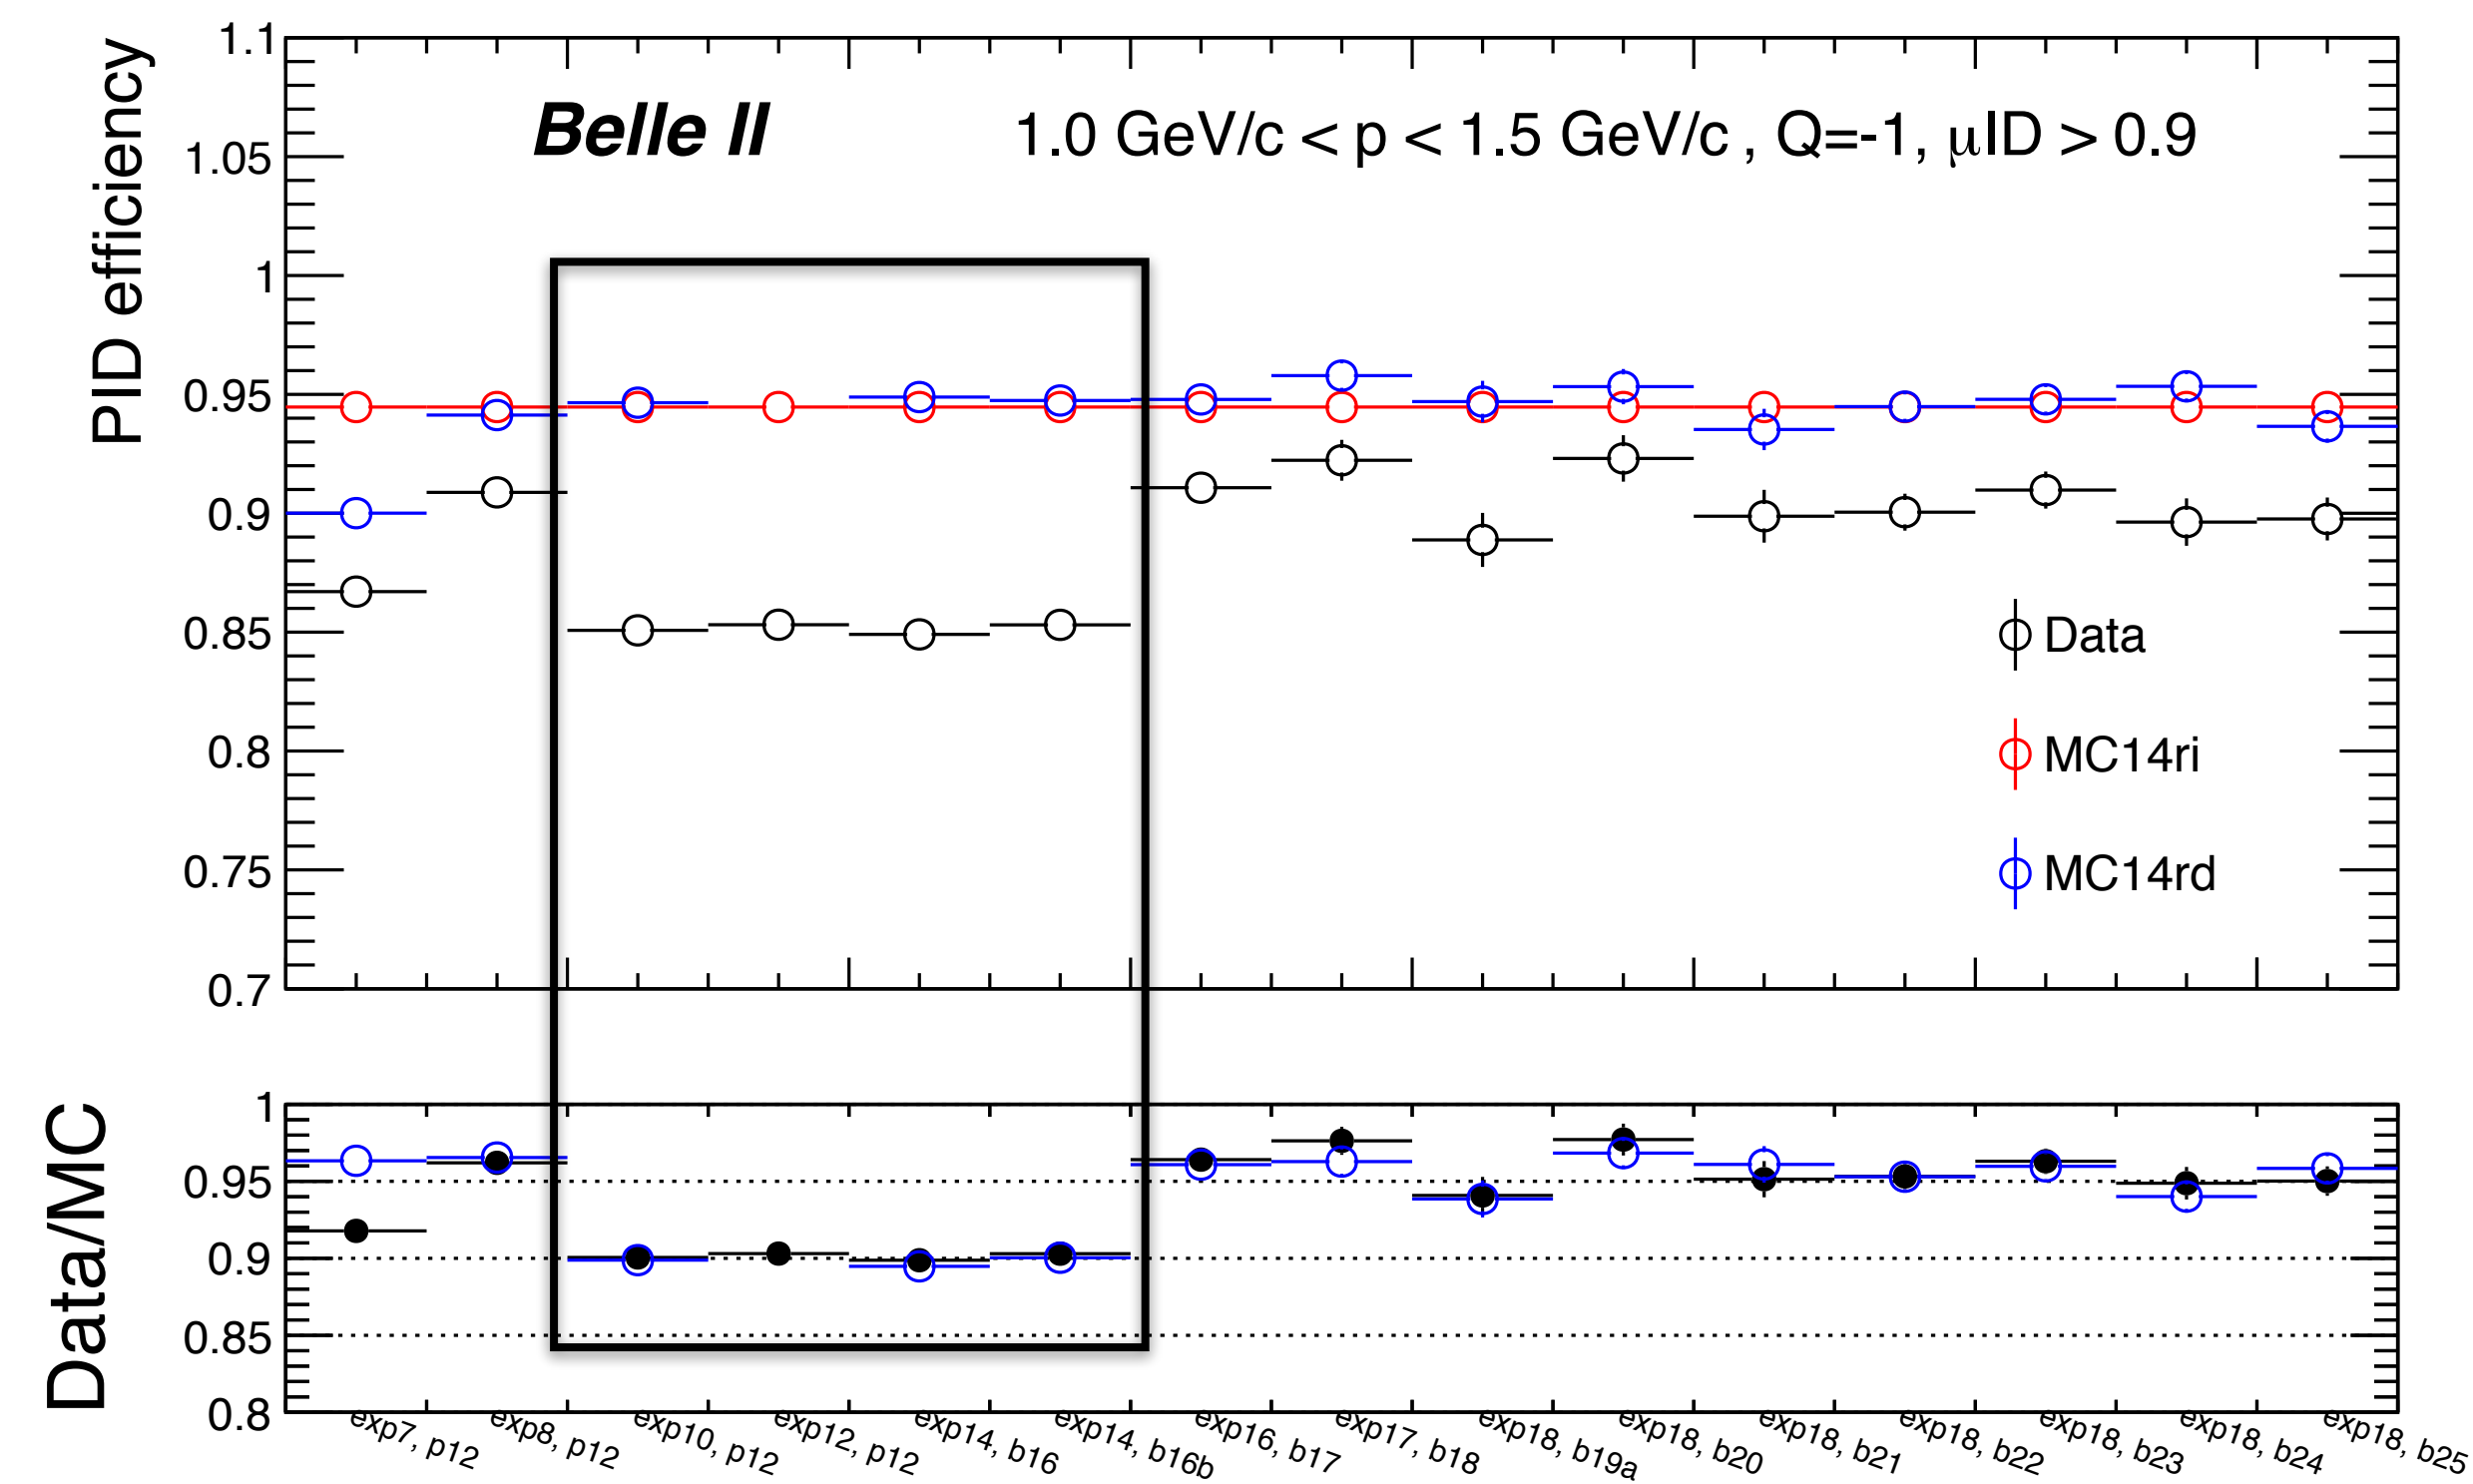
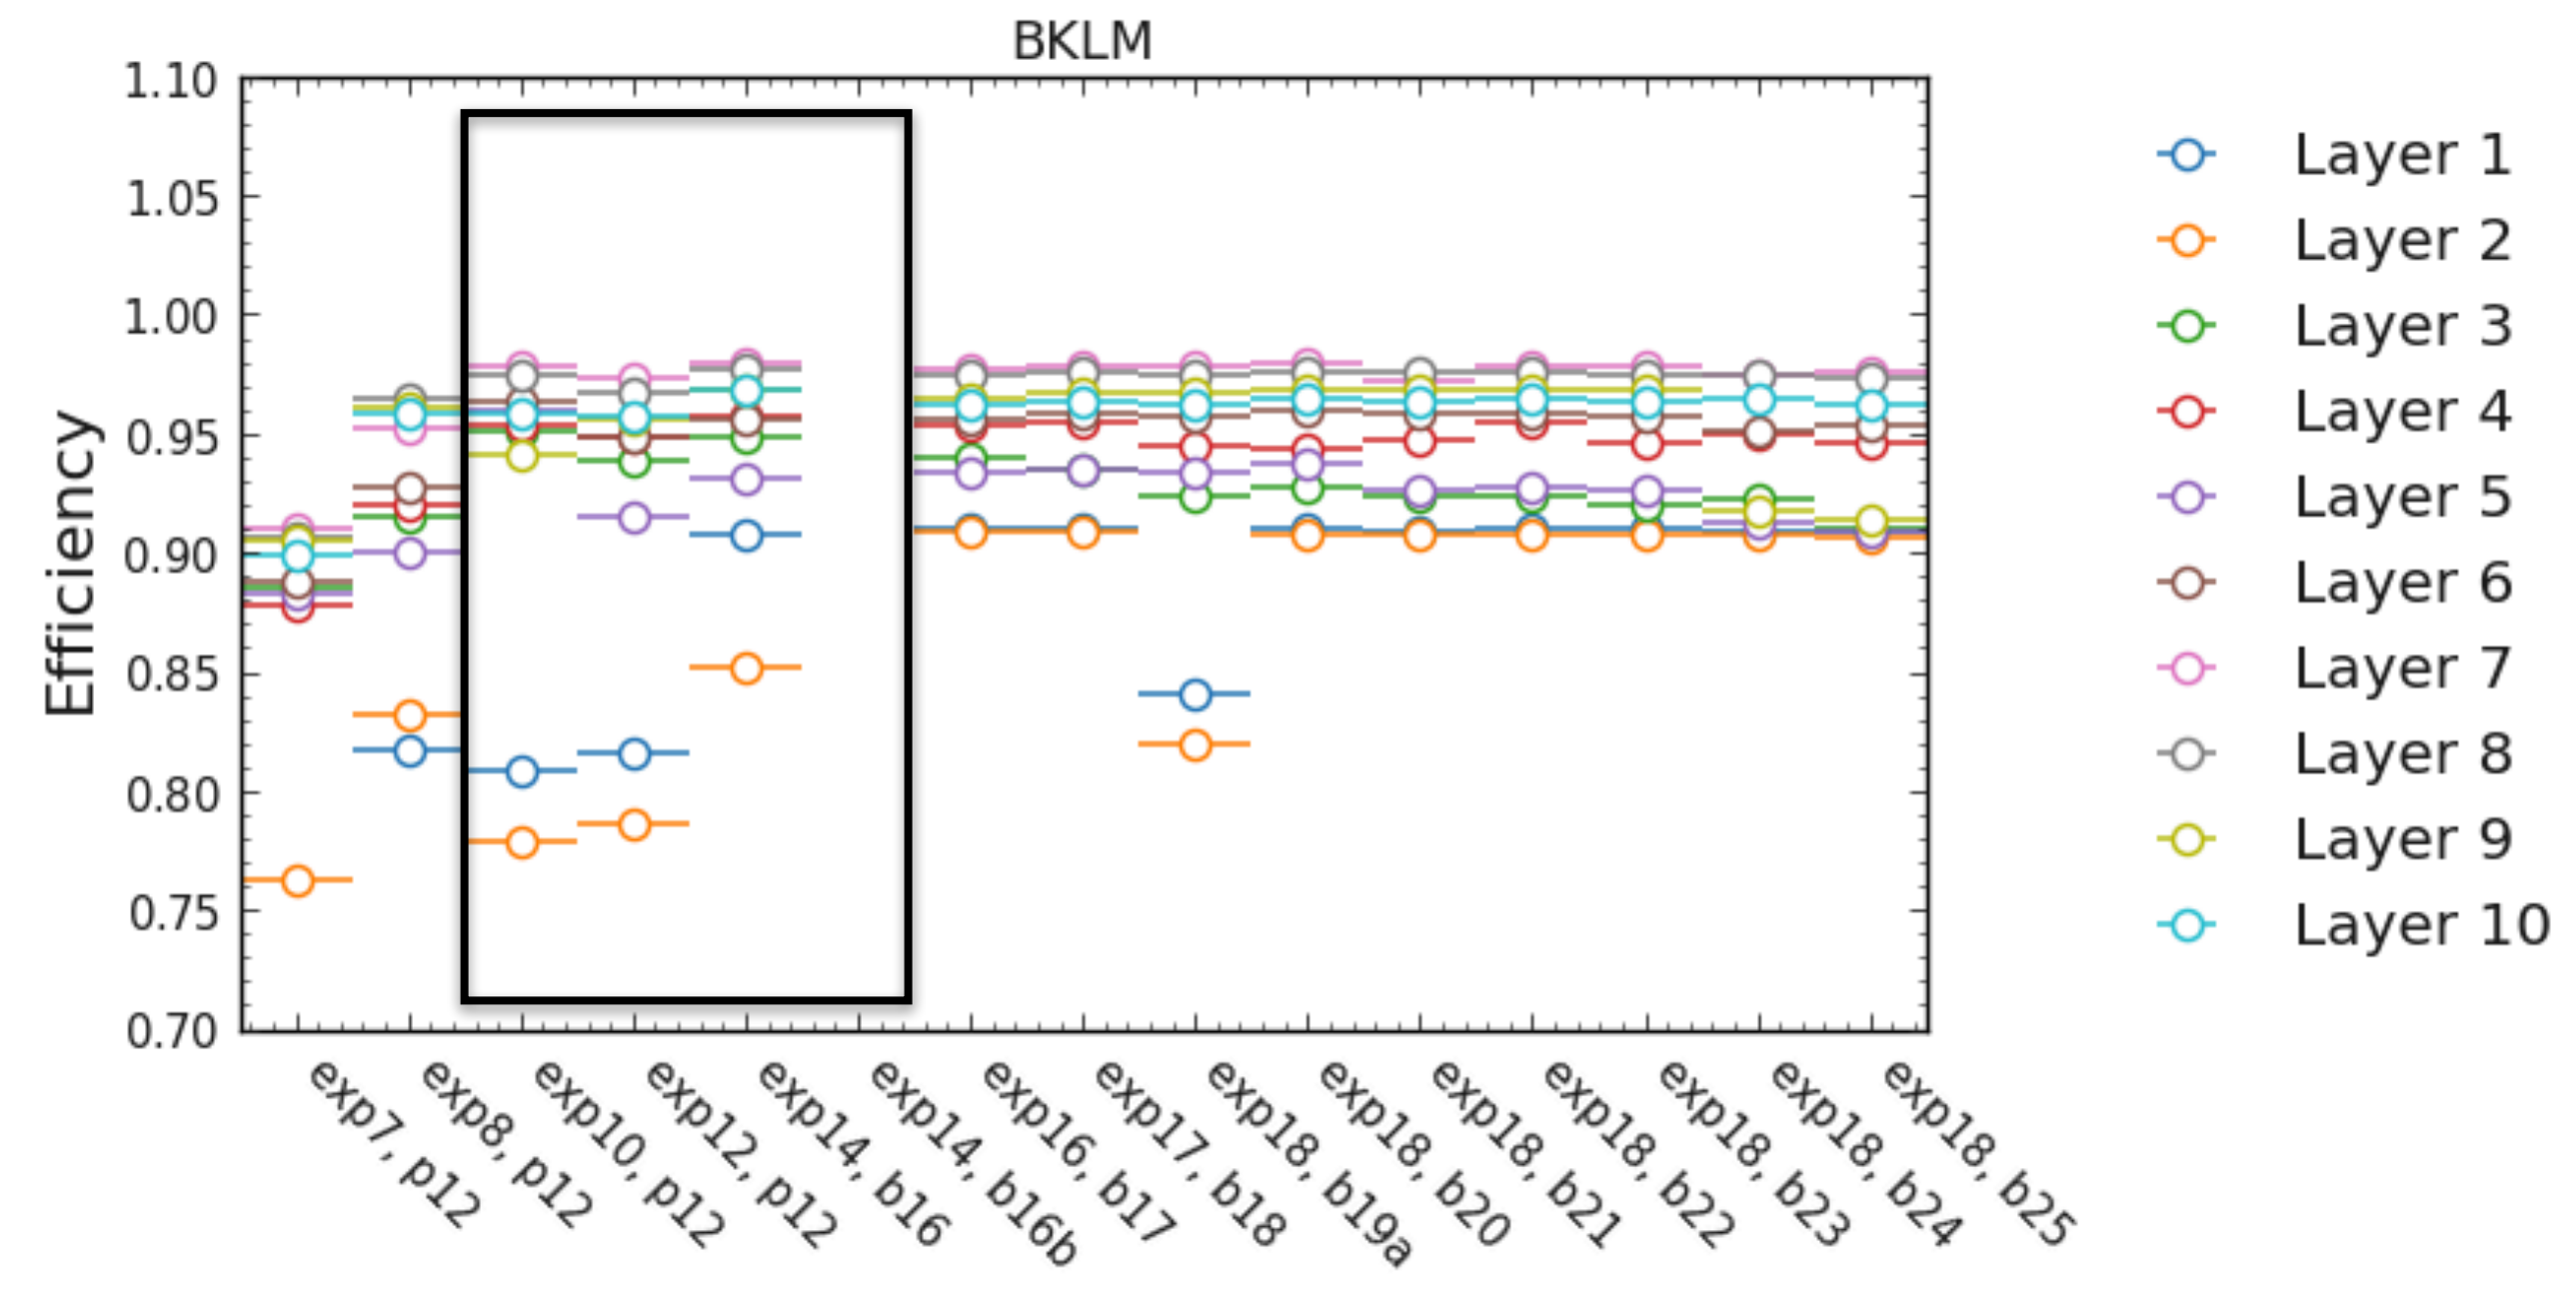
- Could this be explained by the low-momentum tracks in the  $ee \rightarrow e e \mu \mu$  calibration sample (hitting mostly the inner layers of the BKLM)?
