Development at IJClab: Double PClexpress and optical b2tt

LAU Tak-5hun On behalf of IJClab 30^{+h} November 2022

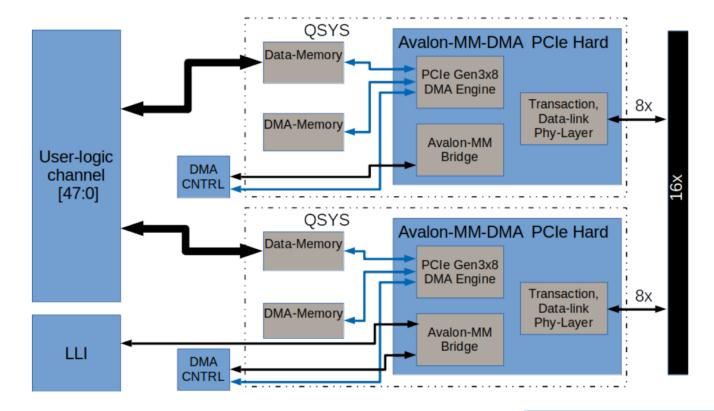
Appendix: The Double DMA interface

Increase data rate from PCIe40 to PC server by using the 2 DMA interfaces available (instead of 1 now)

- Move to quartus 21.3 from 18.1
- Double PCI (The one that I'm working on.)
 - 1. For the moment, uses 1 PCI x8 lane: 50 Gb/s limit.
 - 2. 2 PCI x8 lanes are available in the PCIe40 board: 100 Gb/s transfer is possible.
 - 3. New firmware (git branch doublepci) under test where both PCI lanes are available.
- Optical b2tt (Start working on.)
 - 1. PCle40 has two free SFP optical connections:

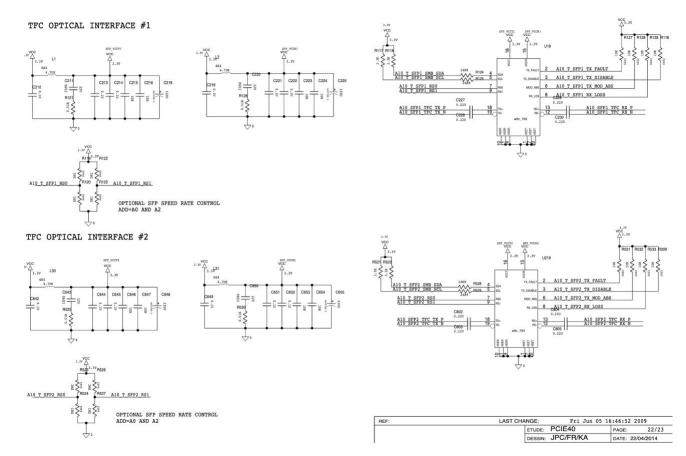
Appendix: B2TT via optical links

- Try to use b2tt directly with optical links into the PCIe40 board.
- Two optical SFP interfaces available on the PCle40 board and not used at the moment.

One link for 'data' transmission in the two directions, one link for 'clock'.
 - 2. development ongoing
