Status and Plans for PXD DAQ, Monitoring and SlowControl

TRG/DAQ Workshop

Björn Spruck

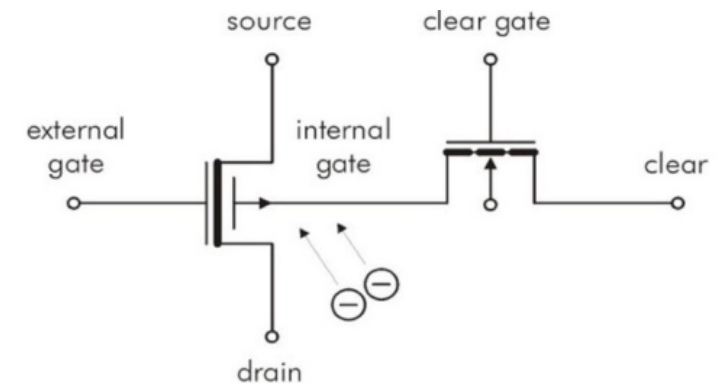
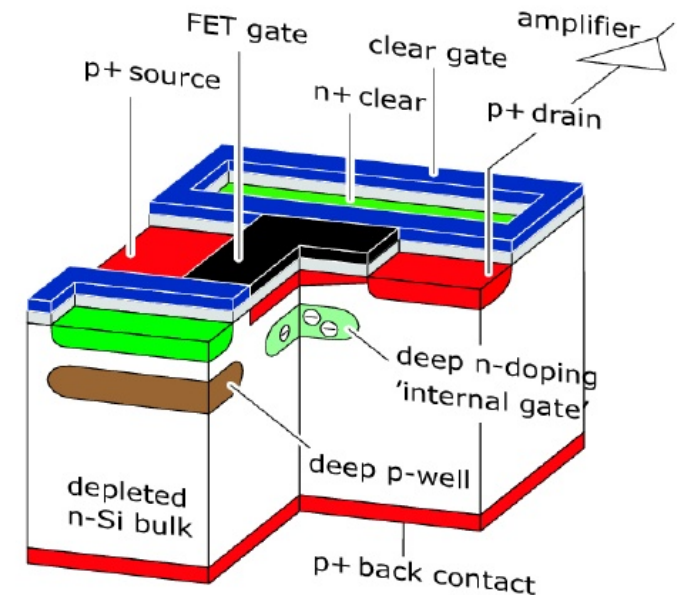
DEPFET Pixel Detector Concept

- Depleted P-channel Field-Effect Transistor pixels on fully depleted silicon bulk
- Fast charge collection (\sim ns) into internal gate
- Readout current is modulated by collected charge
 - Internal amplification, large Signal-to-Noise
- Gate must be cleared after readout
- Low energy consumption and heat dissipation

$$g_q = \frac{\partial I}{\partial q} \approx 500 \frac{pA}{e^-}$$

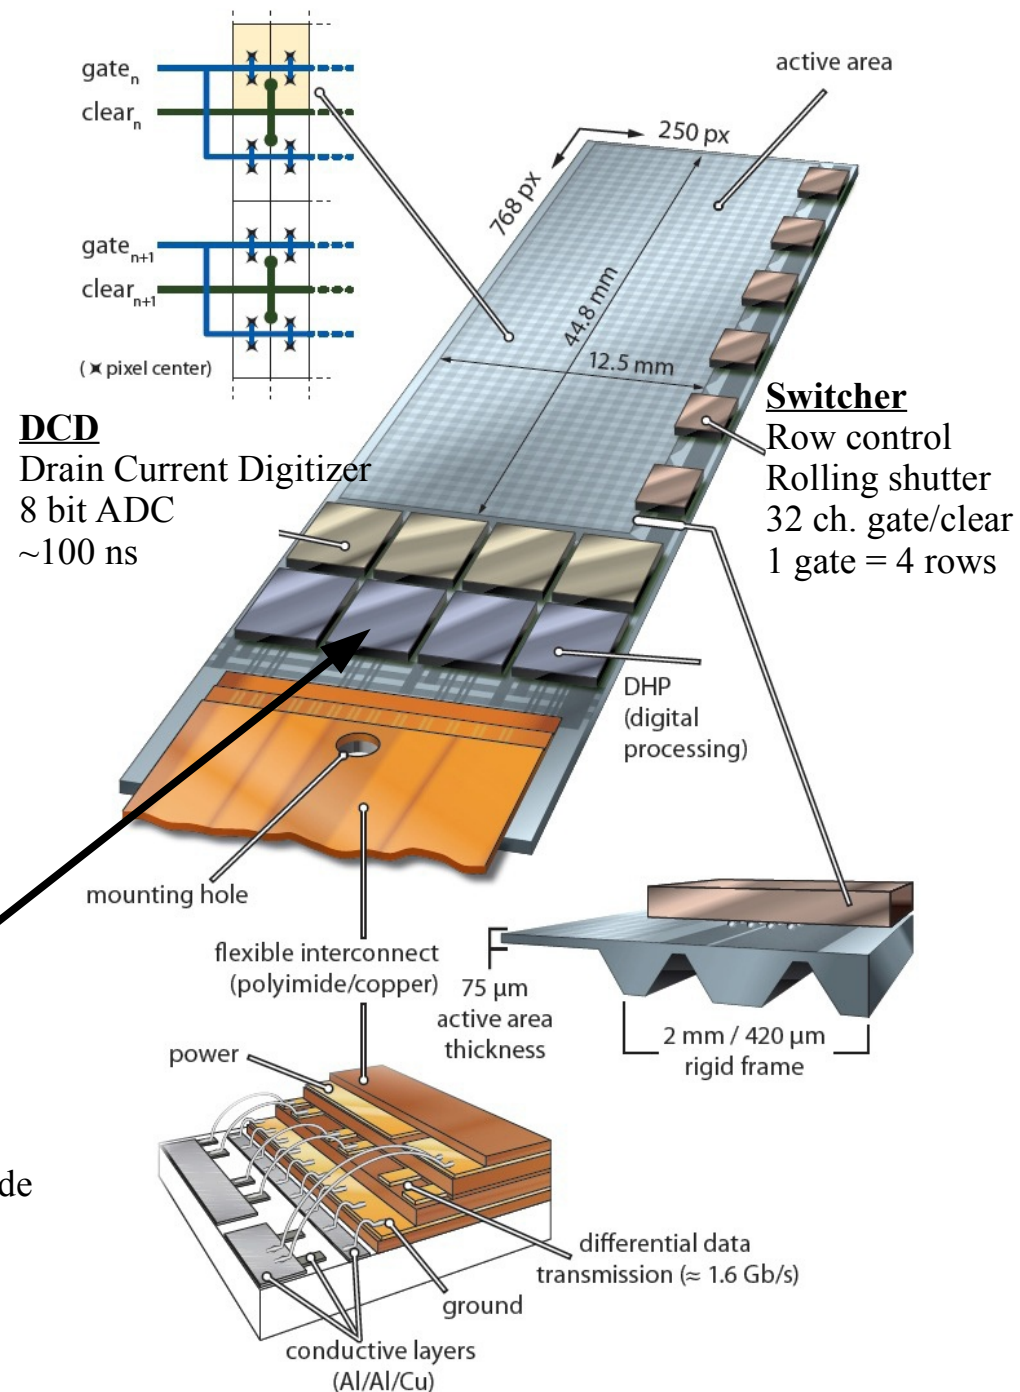
PXD Sensors

- Mechanically self-supporting 75 μm thin sensors
- Pixel size down to 50x55 μm^2
- Rolling shutter read-out \rightarrow low power
- 50kHz \rightarrow 20 μs integration time
- Design: 1% occupancy in layer 1
- 3% occupancy limit (DHP, DAQ, tracking)
- Rad. hard sensor and ASICs
- 40 sensors, 250x768 pixels each
- Power is dissipated mainly in the ASICs at the end of stave
- 2 phase CO₂ cooling

DHP
 Digital processing
 Zero suppression
 Pedestal and common mode correction
 Trigger and timing

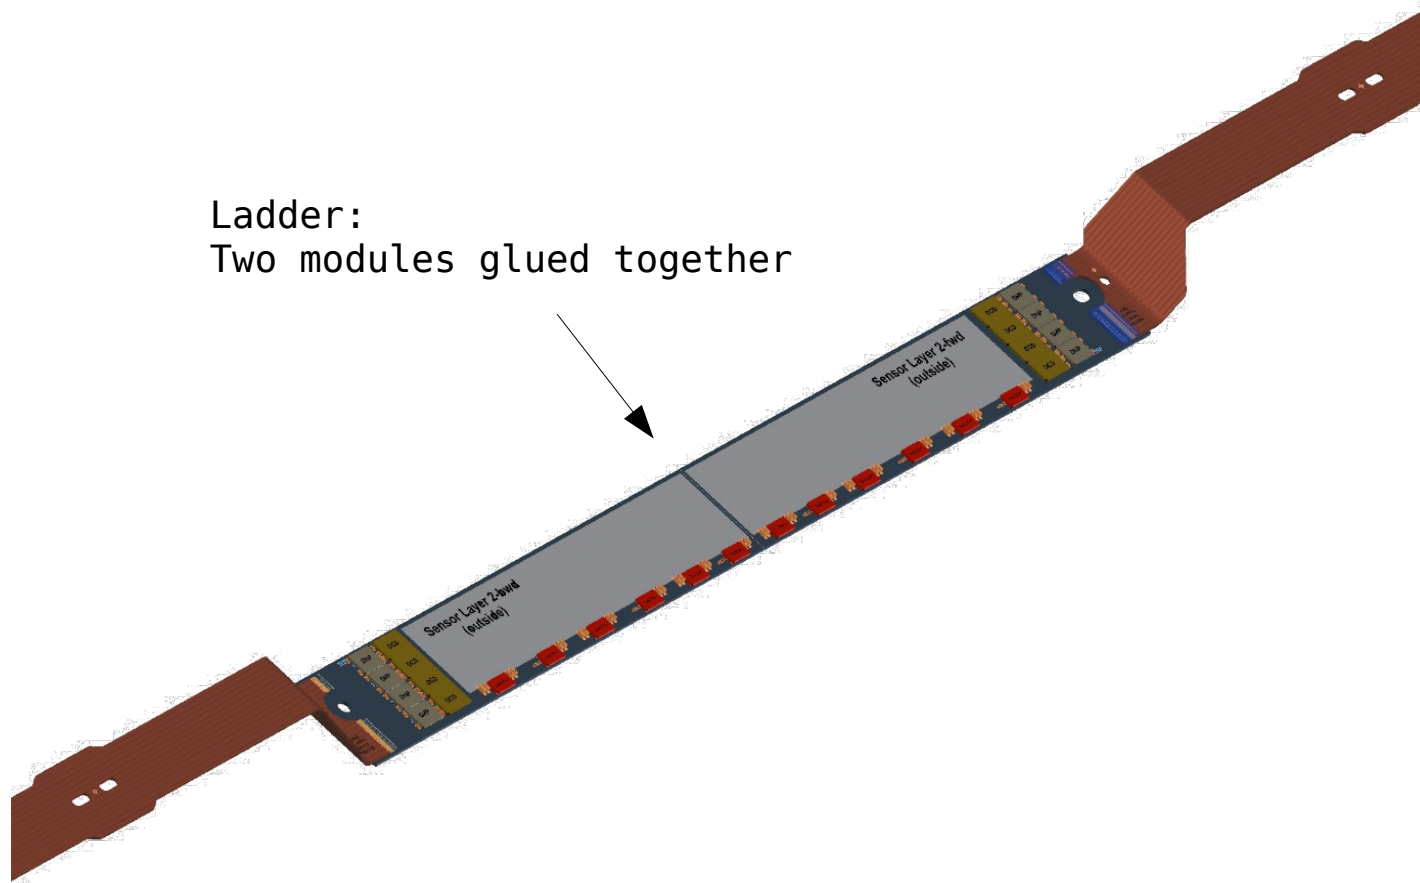
Ladder Gluing

Ladder:
Two modules glued together

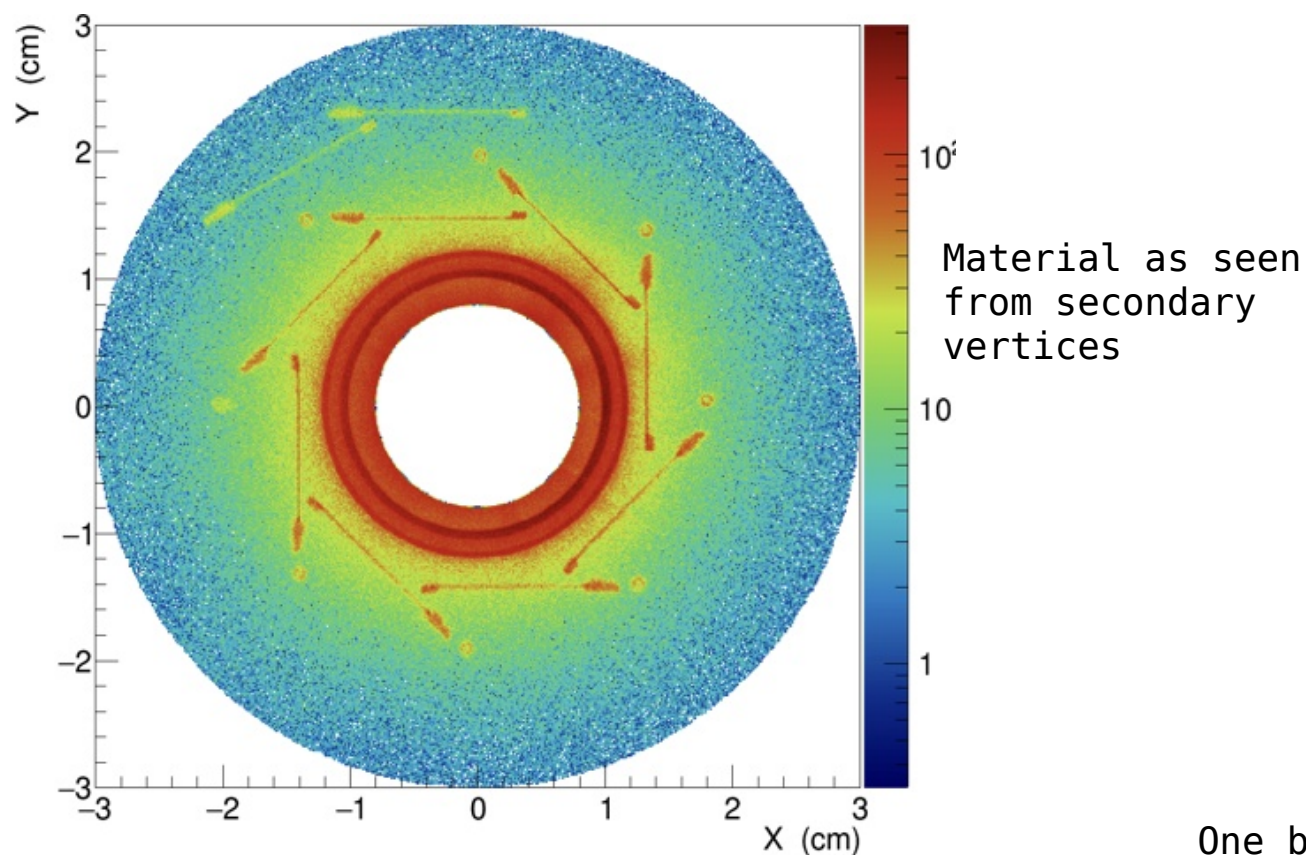
- Phase 3 (2019-2022)
 - Currently only inner layer + 2 outer ladders due to production delay due to low yield in ladder assembly
 - Full PXD replacement installation in LS1/2023
 - No significant change for DAQ/SC, full PXD DAQ chain/interfaces already installed/tested in 2019

One bad quality module, excluded from DAQ

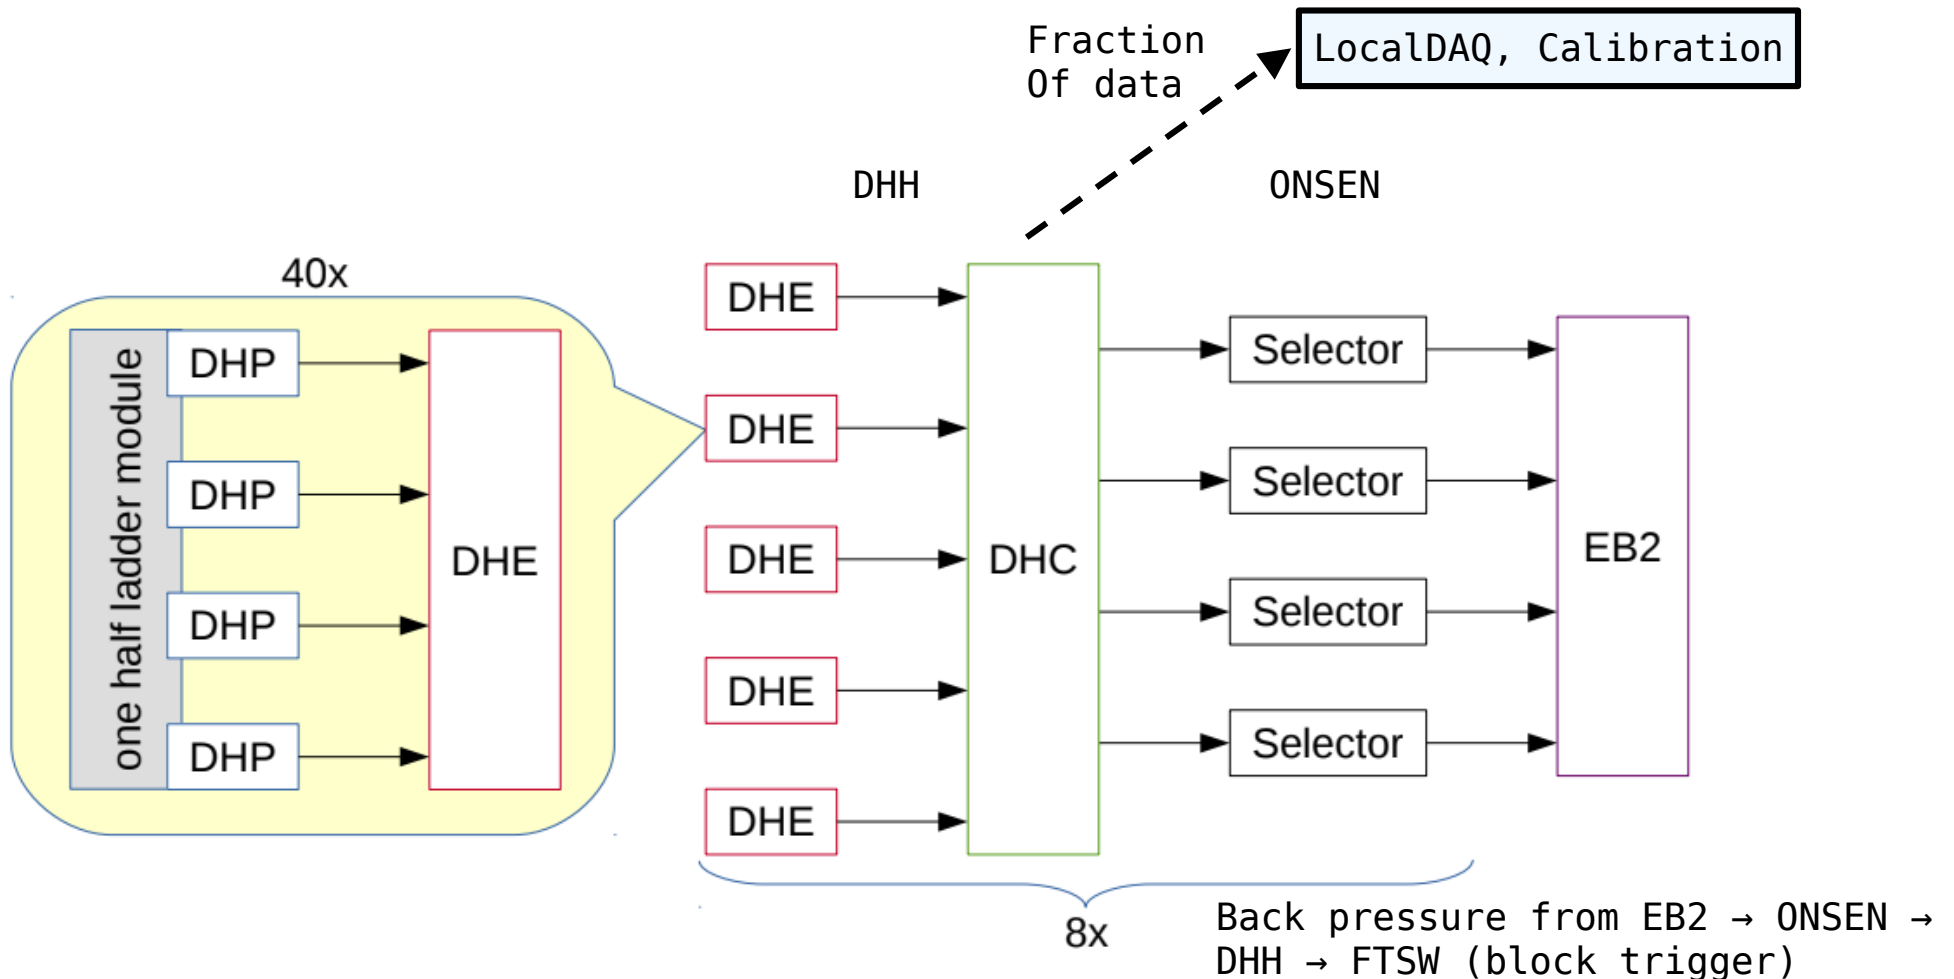
PXD DAQ – Main Data Flow

- Module (DHP ASIC)
- DHH
- ONSEN
- (HLT/DATCON → ONSEN not shown)

- 160 opt links DHP → DHE
- 32 opt links DHC → ONSEN
- 32 Gbit Eth links ONSEN → EB2
- 1Gbit Eth HLT → ONSEN

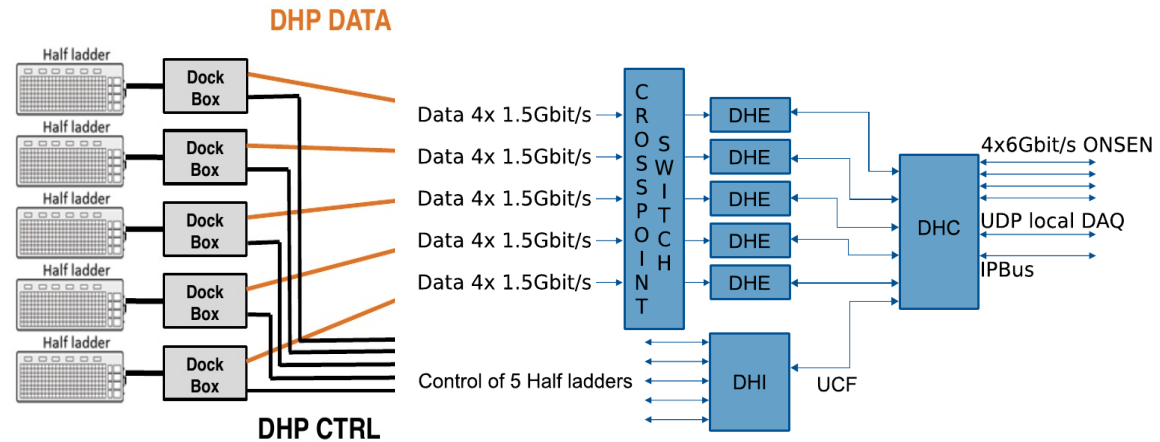
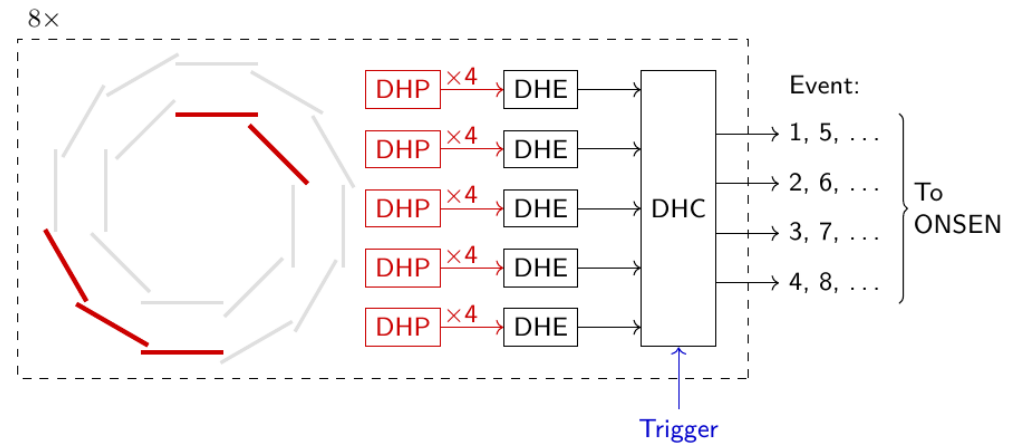
DHH Setup and Scheme

- Different boards involved
 - DHI – module control (JTAG, TRG)
 - DHE – data readout, trigger matching
 - DHC – data concentration
- Optimization
 - Outer layer < inner layer ; phi dependence:
 - → Load balancing (2 inner + 3 outer modules in one DHC), reduces mean rate on DHC output. Sub event building and distributing events on links.
 - → reduce number of links/boards for ONSEN and EB2
 - But: ONSEN and EB2 need to cope with that concept, too
 - System need to know which even data is on which selector and on which link which event arrives

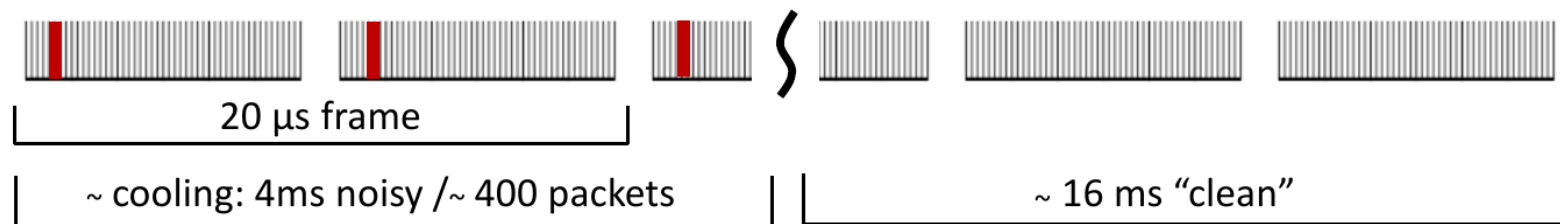
SuperKEKB bunch pattern

- Gating: change the voltages (potentials) such, that no new charge is collected while preserving the already stored charge.
- Gating two times per readout cycle
- Read out continuous during gating, but the data is unusable (and rejected at the frontends)
- → fraction of the detector area is lost
- Large currents → pedestals change

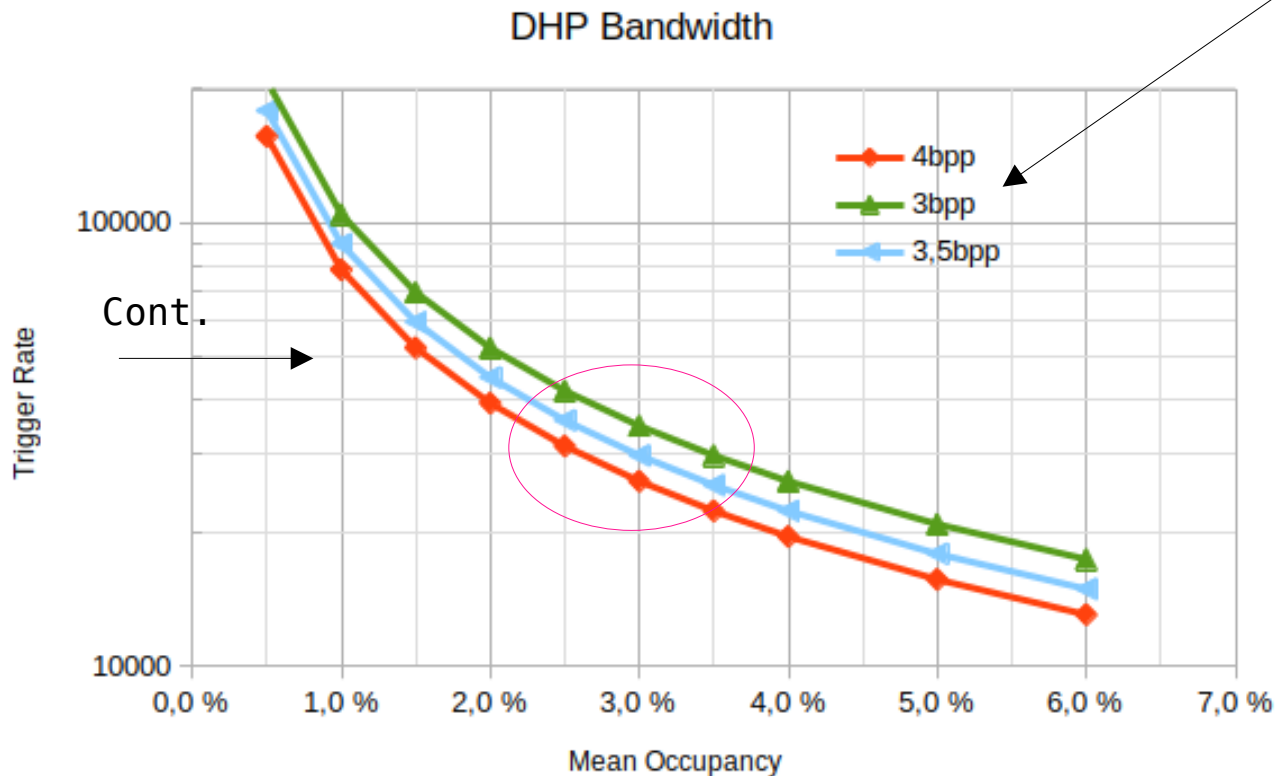
Depends on the distribution of hits on the sensor and cluster topology/size
 4 - all unrelated
 3 - realistic for large occupancy
 $2 < x < 3$ - for injection noise

Overlapping trigger effects are not included, thus numbers $> 20\text{kHz}$ are too pessimistic

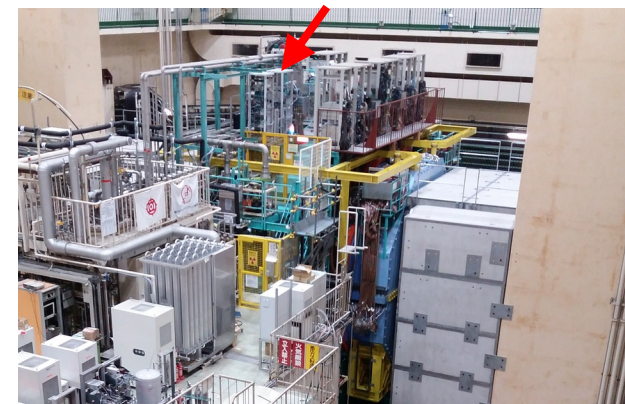
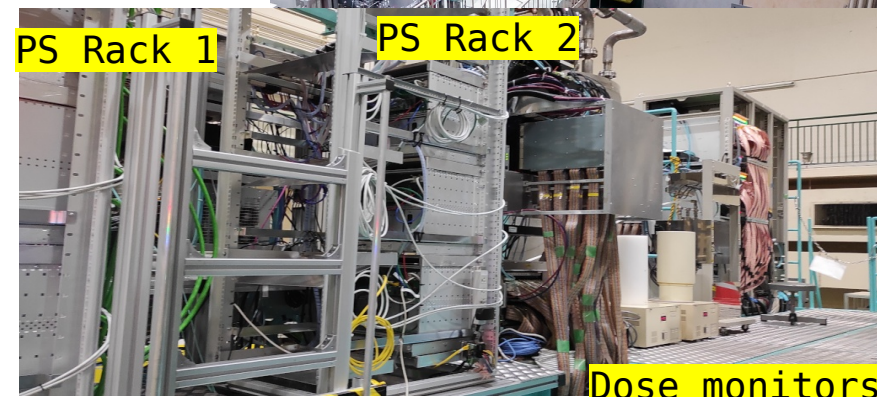
Understood: “Trips” due to Over Voltage Protection

- PXD “HV Trip” rate increased since 2021a, rate $\sim 0.5-1$ per day
 - Issued by the Over-Voltage-Protection board; hard-wired comparitors
 - Uniform channel distribution \rightarrow no real voltage problem?
 - Power supplies located on top of Belle \rightarrow Hint to SEU in PSU?
- Proved by irradiated one PSU module at MAMI (without sensor!)
- Dosimetry at MAMI and Belle show similar rate/neutrons dose
 - ~ 1 OVP / 1mSv neutron dose per PS Unit
- Neutron rate on top of Belle scales with luminosity
 - Expect rate increase by dose and $\times 2$ for PXD2

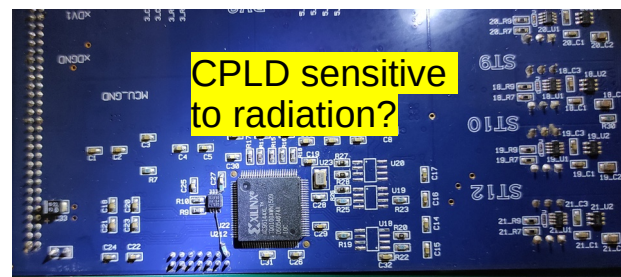
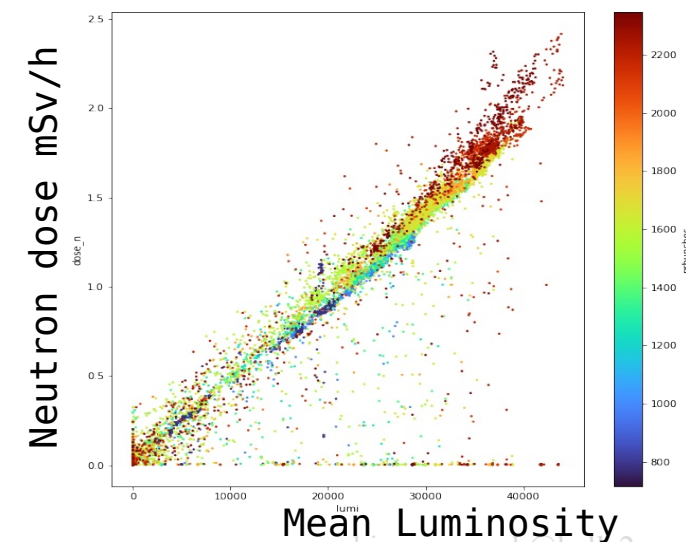
- One OVP board component is over-sensitive to radiation
 - Not expected SEU in electronic equipment at this position at that rate!
 - Does not fit with observations of other equipment at same position, **even so we saw few SEU in micro-controllers (and memories)**
- Possible mitigation (LS1)
 - Add neutron shielding
 - Try to find radhard CPLD replacement

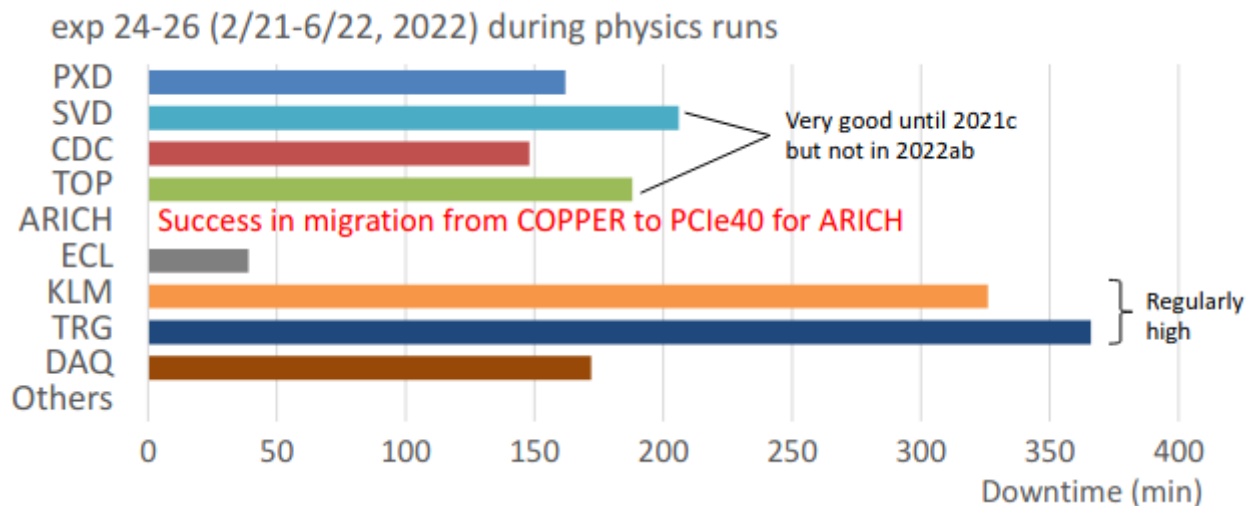
(Major) Downtimes in 2022

- BIIOPS-319
 - Crash of a monitoring PC on top of Belle (SEU?) – 74min due to access (+49min for SKB issue)
- BIIOPS-317
 - Misconfigured ASIC prevent us from taking pedestals (assumed SEU) – 39min
- Several small down times due to SEU recovery (power cycle/talking new pedestals)
 - Not only down time, but impact on data quality if not identified and corrected in time
- After uncontrolled beam loss, several modules were instable (ASICs damaged) → currents flipped even during a run leading to high occupancies and noise
 - → several run stops to take new pedestals, degraded data quality

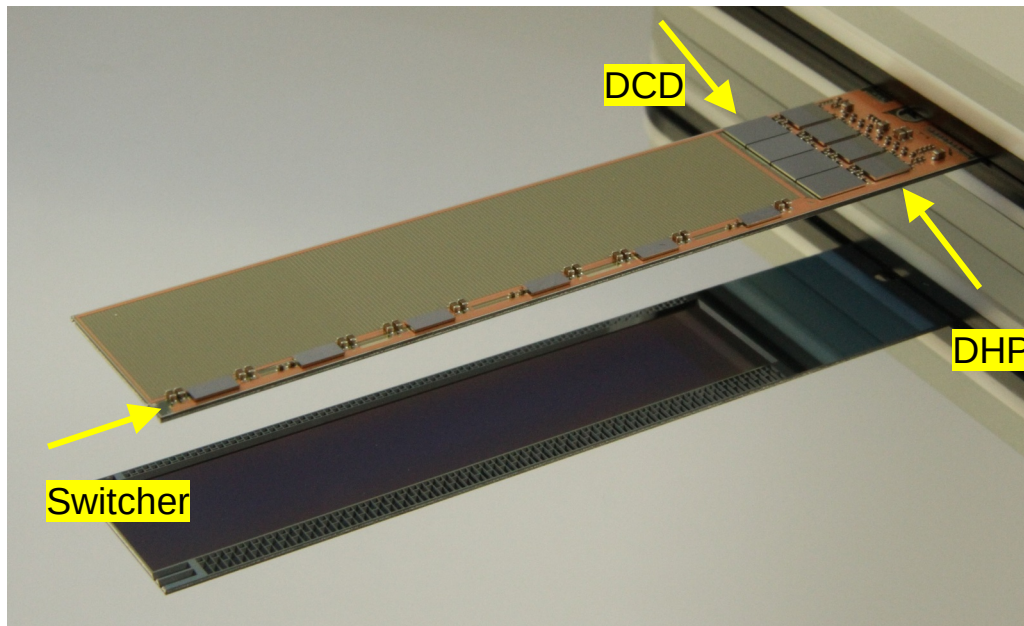
Single Event Upsets in ASICs

- Triple redundant registers in DHP, DCD
 - Bit flip by SEU unlikely but possible!
- Observed for DHP (register monitoring since 2020) and rate is increasing
 - Mitigation: Re-setting registers on-the-fly during a run
- DCD SEU only observed by result (registers cannot be read). Tested blind write to registers every few minutes, but some unwanted effects in one module.
- DHP memories not (yet) monitored

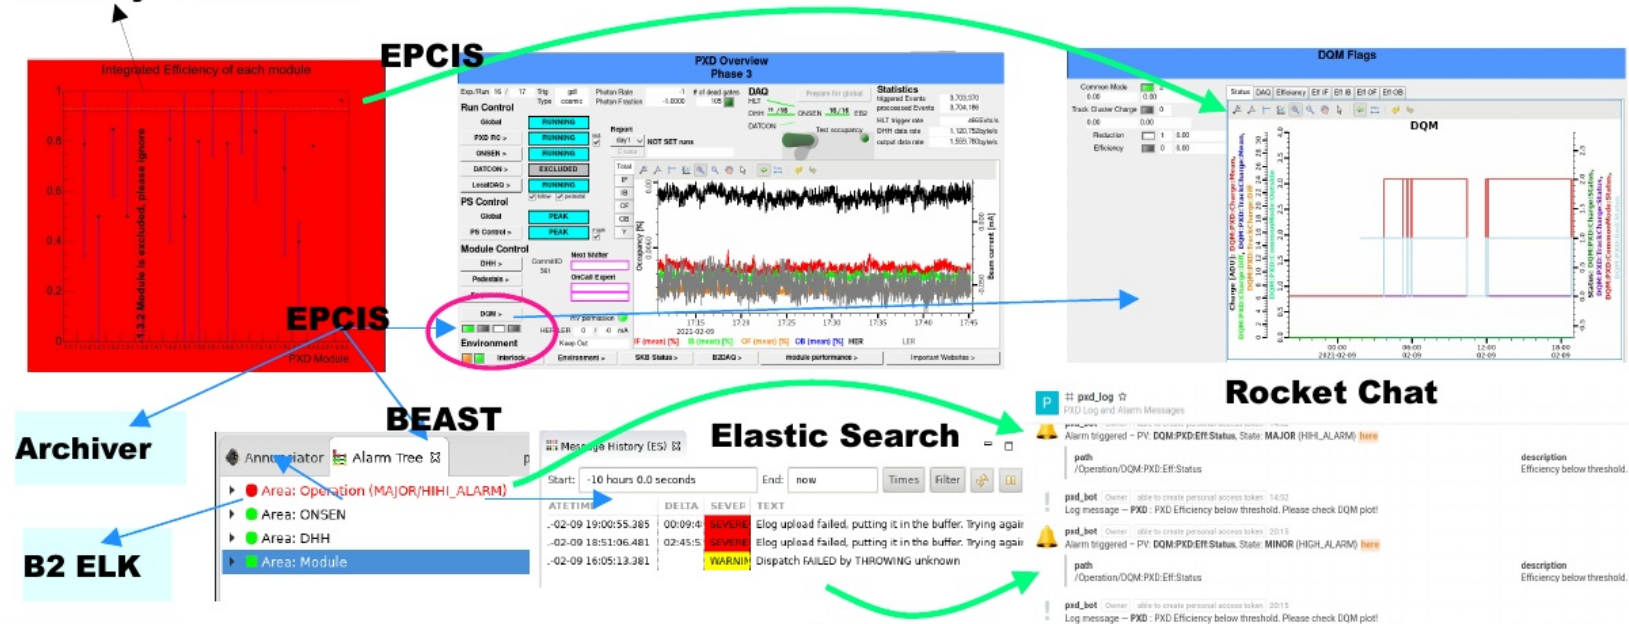
MonObj → MiraBelle

- Histogram “Status” and values exported to EPICS PVs
- Easy to put on Shifter OPI, trend plots, archive
- PV status enter BEAST alarm system
- Alarm → Shifter: CSS Alarm panel, Annunciator (audio), Message History (PXD elastic search server), RocketChat, B2 elastic search server
